Manhole Inspection Summary

Manhole # S01YY1008MH

Location Address: **6207 PARK HEAIGHTS AVE** Cross Street: **W STRATHMORE**

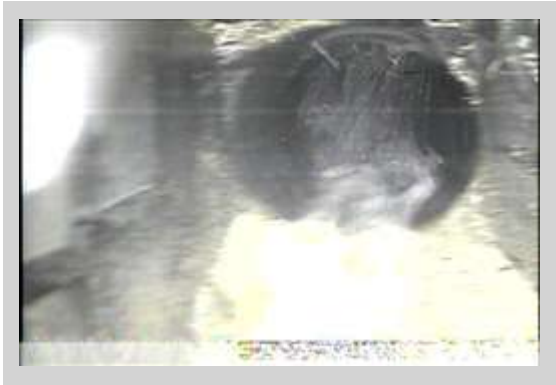
Drop In @ 9 O'Clock

Drop: **Outside** **Rod and Bar**

Angled: **Yes** Reading: **7.82** (ft.)

Inv Depth: **8.82** (ft.)

Drop Condition: **Open**
