CITY OF BALTIMORE WET WEATHER CONSENT DECREE SMOKE AND DYED WATER TESTING FORM		Page 1 of 3
Sewershed: JONES FALLS	Company: REI/DRAYCO	Date: 06/18/08
Test to be Performed: SMOKE	Ground Condition: DRY	Supervisor: ER
Manhole ID: S37QQ_009MH	Test ID: 0994-352	Notifications Made:_X__ (Residents, Fire, 311)

CITY OF BALTIMORE
SMOKE TESTING OBSERVATION SUMMARY
JONES FALLS SEWERSHED
BALTIMORE CITY PROJECT 994
REI/DRAYCO

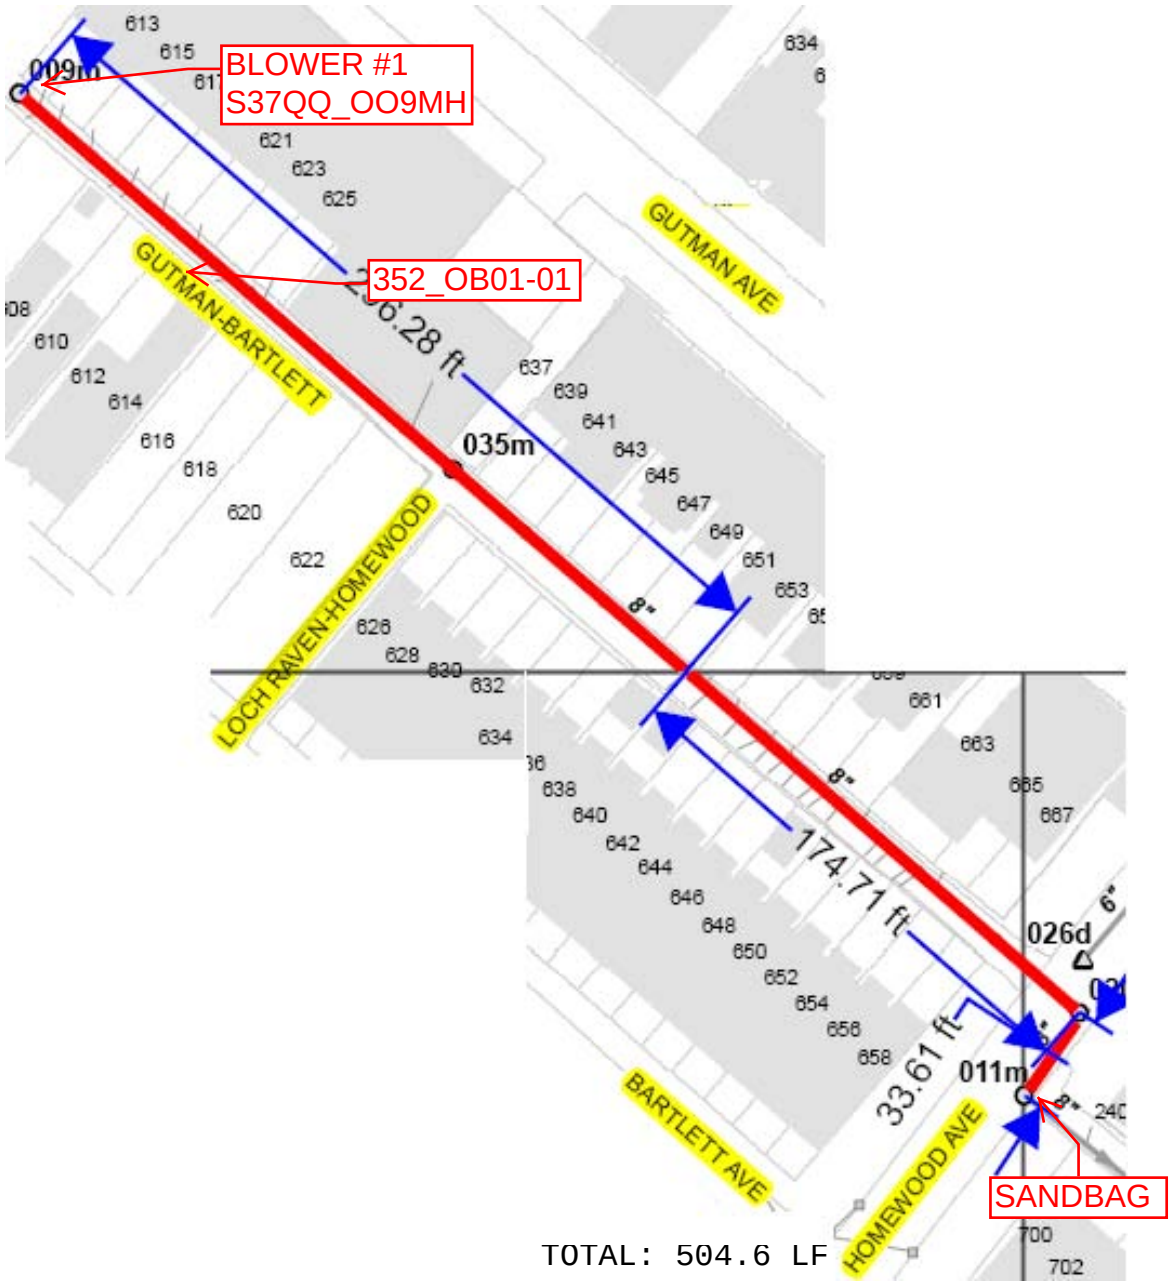
Defect No.	Address	Source Type	Location	Sector	Drainage Area	Severity	Photo Number
1	612 BARTLETT AVE.	03	08	01	1	03	352_OB01-01

Comments: CLEAN OUT - AT GRADE. MISSING CAP.
