Smoke and Dye Testing Summary

High Level Sewershed

Test ID	Test Type	Date Inspected	Company / Super.	Blower MH	Ground Condition	Notification Made?	Total Length
S1028-141	Smoke	11/17/2008	ADS/TM	S11SS1007MH	Dry	Yes	1,057.63

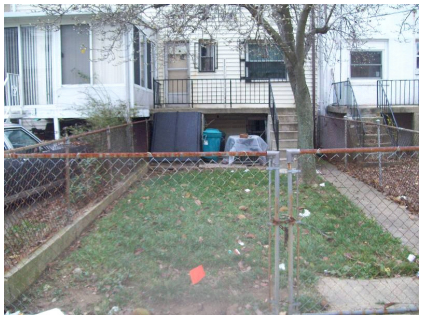
Picture \S1028-141-OB01-P01.jpg
Comments Back of house, 5016 Pembridge Ave.

Obs_ID S1028-141-OB01
Address 5016 Pembridge Ave
Status Private
Source Cleanout
Location Yard - back
Nearest MH S11QQ1011MH
Comments Smoke from cleanout in back yard. 5016 Pembridge Ave.

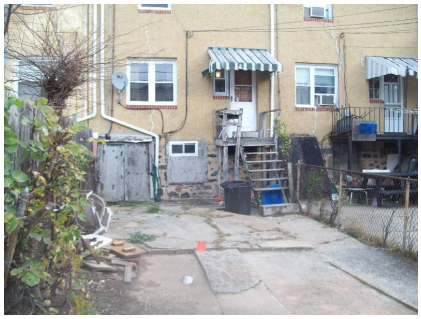
Picture \S1028-141-OB02-P01.jpg
Comments Back of house, 5015 Chalgrove Ave.

Obs_ID S1028-141-OB02
Address 5015 Chalgrove Ave
Status Private
Source Cleanout
Location Yard - back
Nearest MH S11QQ1011MH
Comments Smoke from cleanout in back yard. 5015 Chalgrove Ave.
