City of Baltimore Wet Weather Consent Decree Smoke and Dyed Water Testing Form		Page 1 of 2
Sewershed : Gwynn Falls	**Company :** URS	**Date :** 10/31/2009
Test to be Performed : Smoke : X Dyed Water : _	**Ground Condition :** Dry : X Damp : _ Wet : _	**Supervisor :** Ryan Lamont
Manhole ID : S01S__029MH	**Test ID :** S1032-002019	**Notifications (Residents, Fire, 311) :** Yes

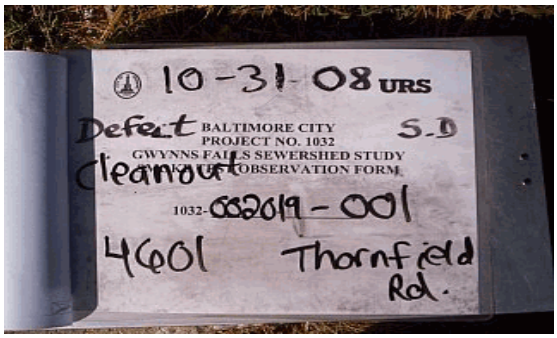
Location: N/A; Type: Cleanout; Smoke: Heavy; Status: Private Property
