City of Baltimore Wet Weather Consent Decree Smoke and Dyed Water Testing Form

Sewershed : Gwynn Falls	**Company :** URS	**Date :** 11/07/2008
Test to be Performed : Smoke : X Dyed Water : __	**Ground Condition :** Dry : X Damp : __ Wet : __	**Supervisor :** Ryan Lamont
Manhole ID : S04O__014MH	**Test ID :** S1032-002065	**Notifications (Residents, Fire, 311) :** Yes

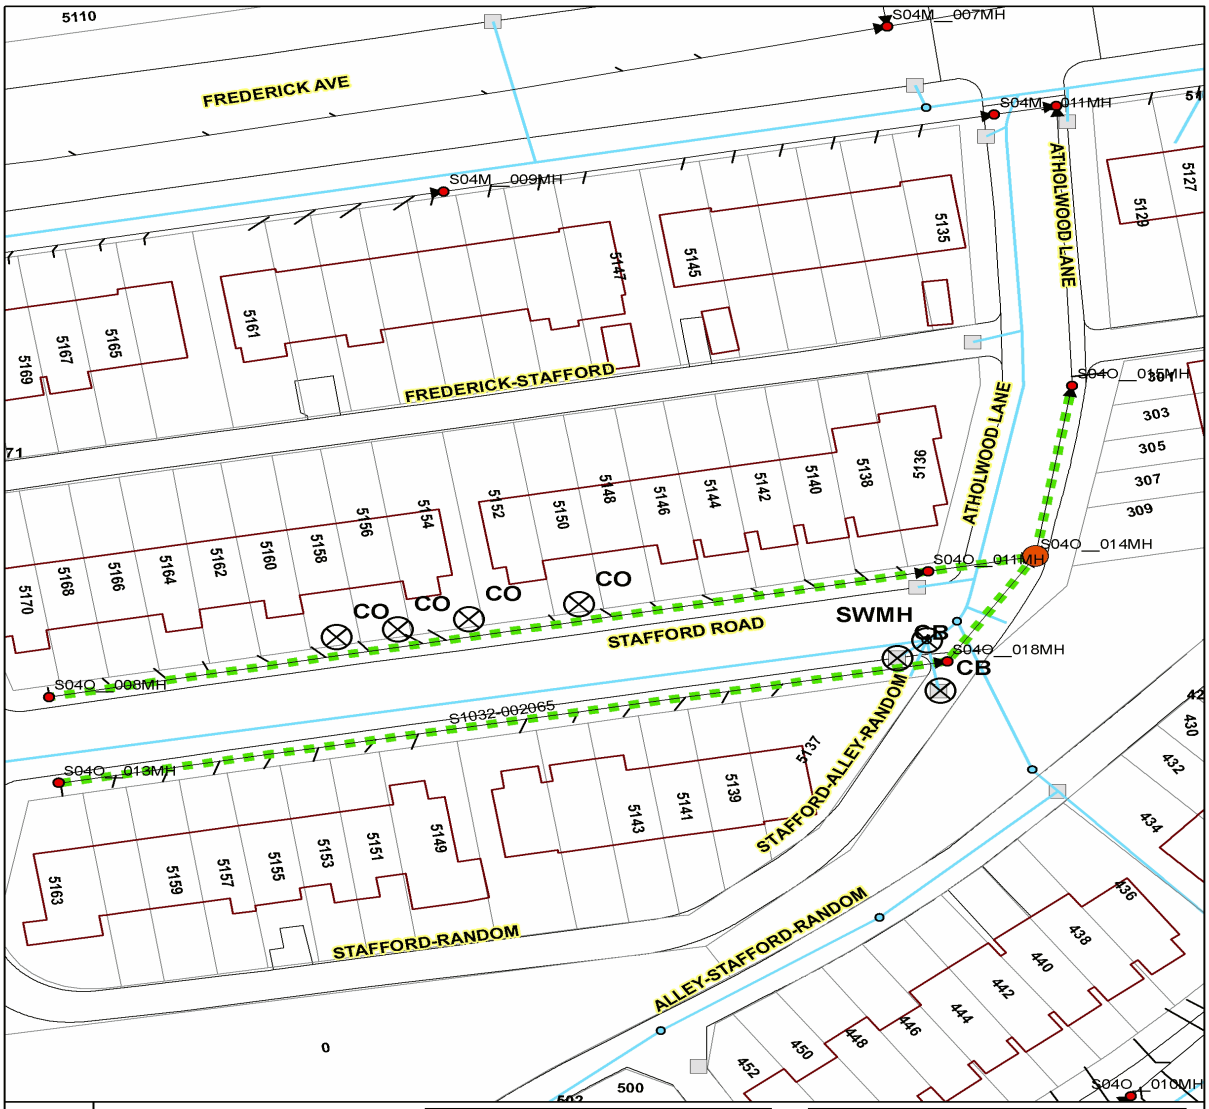
Field Sketch : (Show All Manholes with Numbers, Blower Placement Location, Sandbag or Isolation Locations, Street Names, Building Addresses and Locations, Defect Locations and Photograph Numbers)

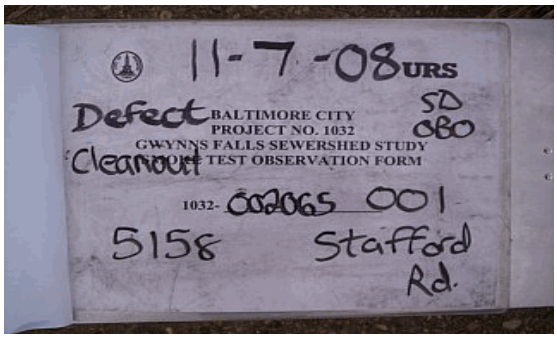
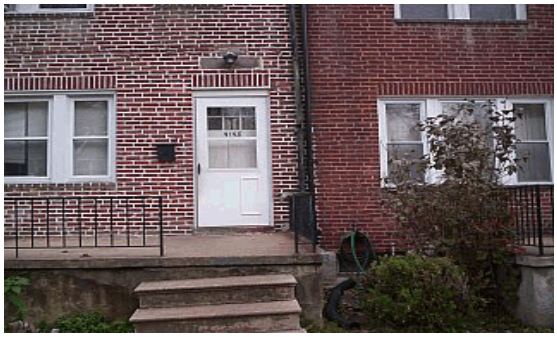
Location: N/A; Type: Cleanout; Smoke: Heavy; Status: Private Property

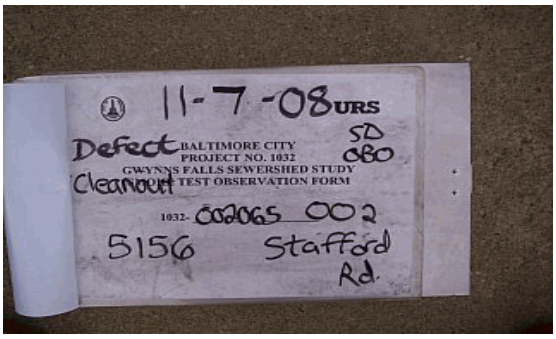
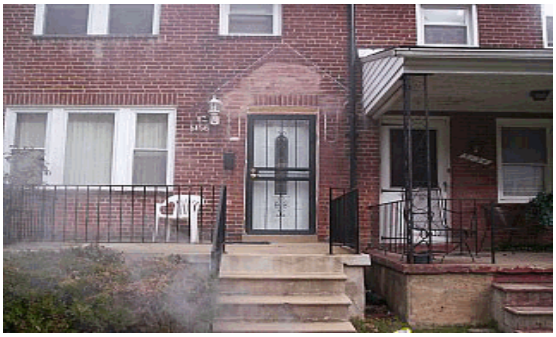
Location: N/A; Type: Cleanout; Smoke: Heavy; Status: Private Property

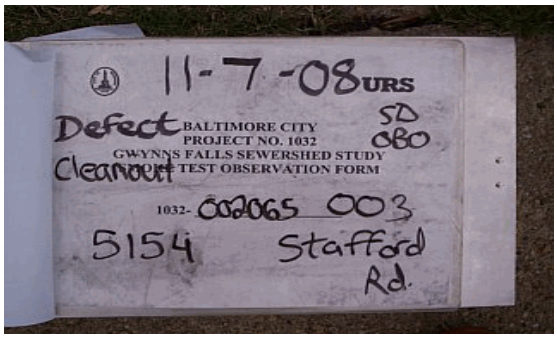
Location: N/A; Type: Cleanout; Smoke: Heavy; Status: Private Property

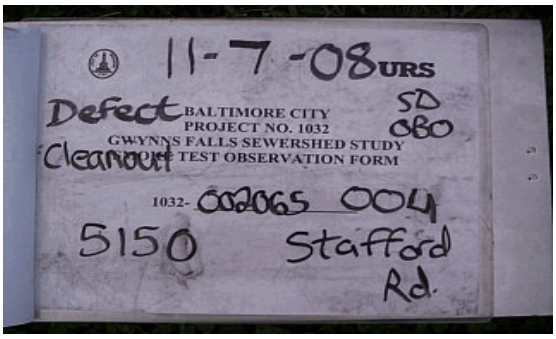
Location: N/A; Type: Cleanout; Smoke: Medium; Status: Private Property

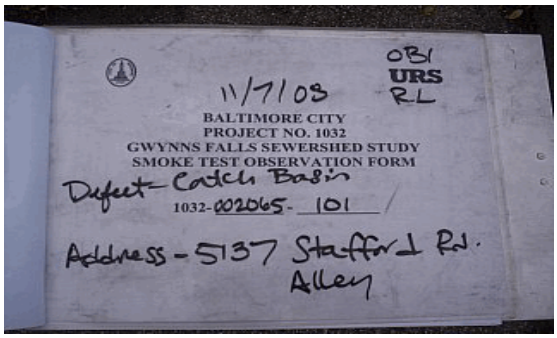
Location: N/A; Type: Catch Basin; Smoke: Heavy; Status: Public ROW
