City of Baltimore Wet Weather Consent Decree Smoke and Dyed Water Testing Form

Sewershed : Gwynn Falls	**Company :** URS	**Date :** 05/20/2009
Test to be Performed : Smoke : X Dyed Water : __	**Ground Condition :** Dry : X Damp : __ Wet : __	**Supervisor :** Ryan Lamont
Manhole ID : S02S__005MH	**Test ID :** S1032-003002	**Notifications (Residents, Fire, 311) :** Yes

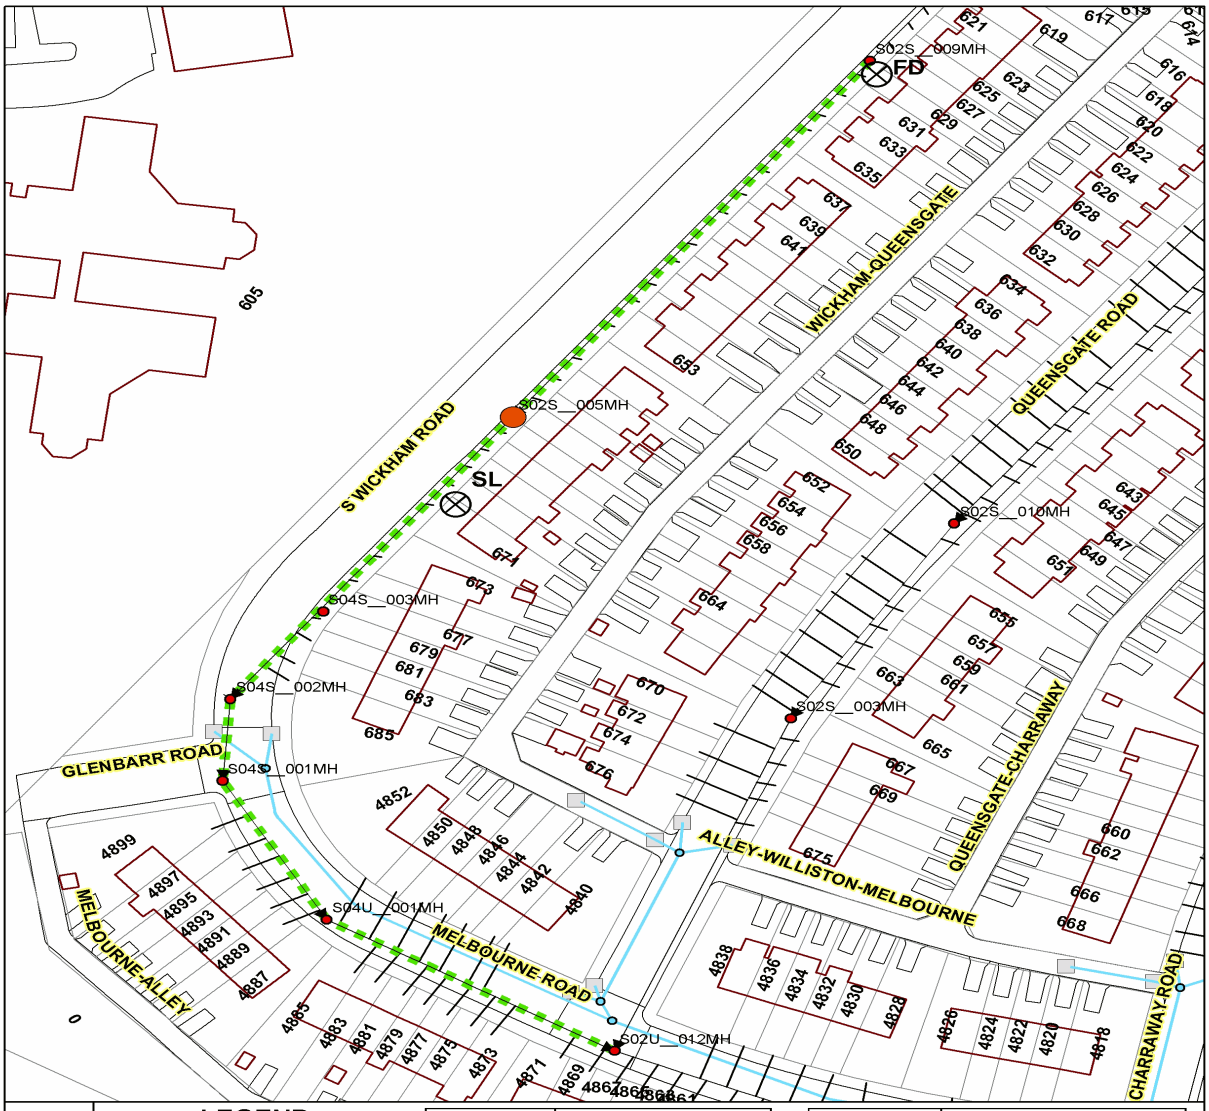
Field Sketch : (Show All Manholes with Numbers, Blower Placement Location, Sandbag or Isolation Locations, Street Names, Building Addresses and Locations, Defect Locations and Photograph Numbers)

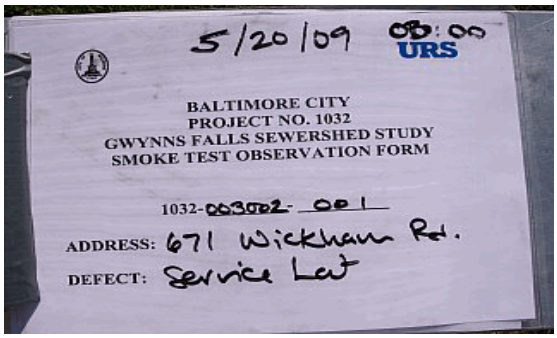
Location: N/A; Type: Service Lateral; Smoke: Light; Status: Private Property

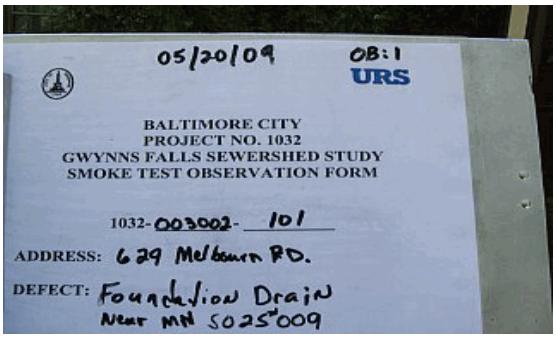
Location: N/A; Type: Foundation Drain; Smoke: Medium; Status: Public ROW
