City of Baltimore Wet Weather Consent Decree Smoke and Dyed Water Testing Form

Sewershed : Gwynn Falls	**Company :** URS	**Date :** 05/18/2009
Test to be Performed : Smoke : X Dyed Water : __	**Ground Condition :** Dry : X Damp : __ Wet : __	**Supervisor :** Ryan Lamont
Manhole ID : S01U__007MH	**Test ID :** S1032-003009	**Notifications (Residents, Fire, 311) :** Yes

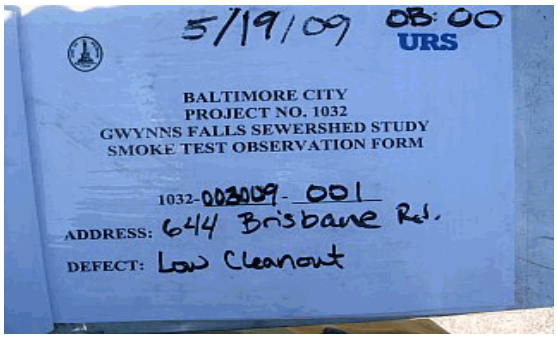
Location: N/A; Type: Cleanout; Smoke: Heavy; Status: Private Property

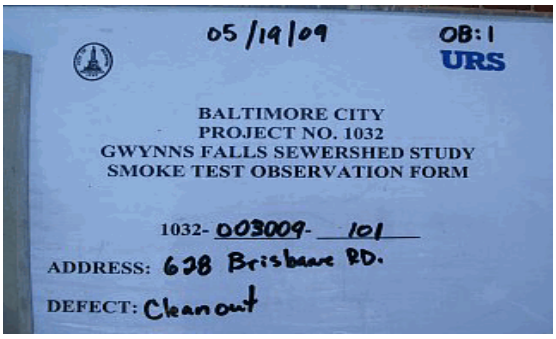
Location: N/A; Type: Cleanout; Smoke: Medium; Status: Private Property
