City of Baltimore Wet Weather Consent Decree Smoke and Dyed Water Testing Form		Page 1 of 3
Sewershed : Gwynn Falls	**Company :** URS	**Date :** 07/06/2009
Test to be Performed : Smoke : X Dyed Water : __	**Ground Condition :** Dry : X Damp : __ Wet : __	**Supervisor :** Ryan Lamont
Manhole ID : S08G__002MH	**Test ID :** S1032-006001	**Notifications (Residents, Fire, 311) :** Yes

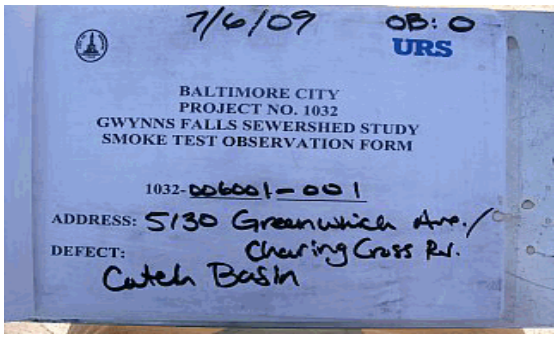
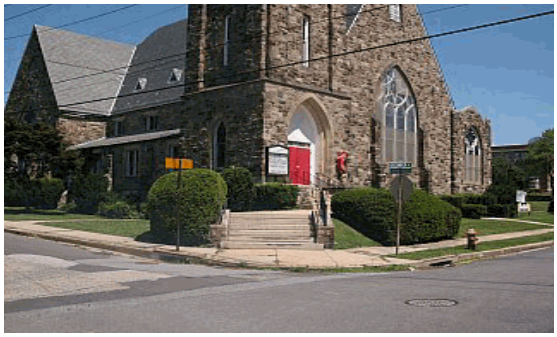
Location: N/A; Type: Catch Basin; Smoke: Heavy; Status: Public ROW

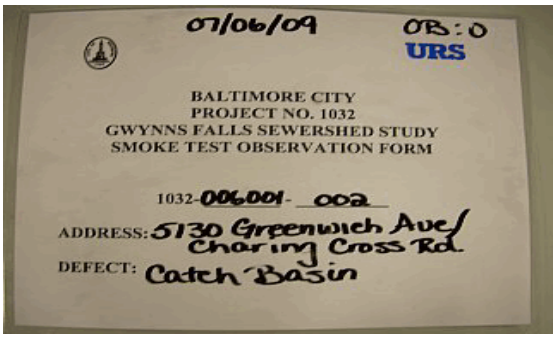
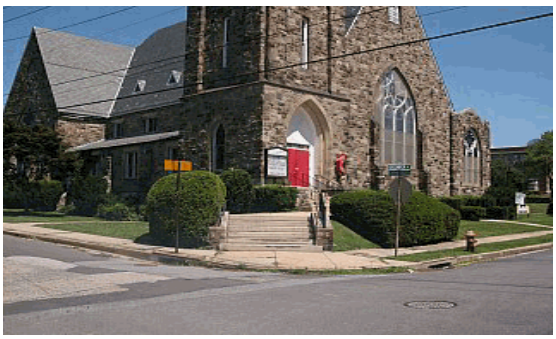
Location: N/A; Type: Catch Basin; Smoke: Heavy; Status: Public ROW

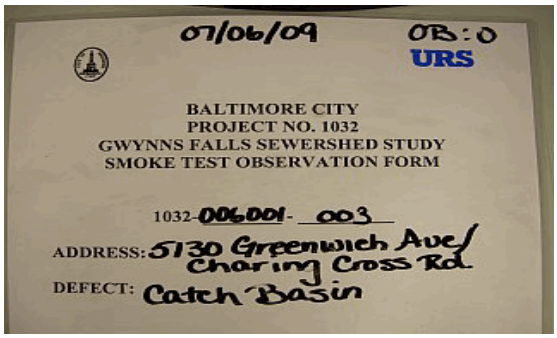
Location: N/A; Type: Catch Basin; Smoke: Heavy; Status: Public ROW

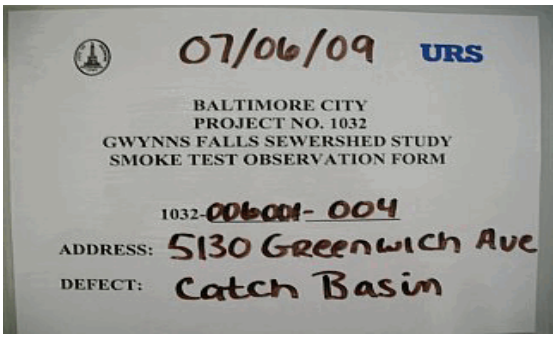
Location: N/A; Type: Catch Basin; Smoke: Heavy; Status: Public ROW
