City of Baltimore Wet Weather Consent Decree Smoke and Dyed Water Testing Form		Page 1 of 2
Sewershed : Gwynn Falls	**Company :** URS	**Date :** 07/07/2009
Test to be Performed : Smoke : X Dyed Water : __	**Ground Condition :** Dry : X Damp : __ Wet : __	**Supervisor :** Ryan Lamont
Manhole ID : S08O__017MH	**Test ID :** S1032-006008	**Notifications (Residents, Fire, 311) :** Yes

City of Baltimore Wet Weather Consent Decree Smoke and Dyed Water Testing Form		Page 2 of 2
Sewershed : Gwynn Falls	**Company :** URS	**Date :** 07/07/2009
Test to be Performed : Smoke : X Dyed Water : __	**Ground Condition :** Dry : X Damp : __ Wet : __	**Supervisor :** Ryan Lamont
Manhole ID : S08O__017MH	**Test ID :** S1032-006008	**Notifications (Residents, Fire, 311) :** Yes

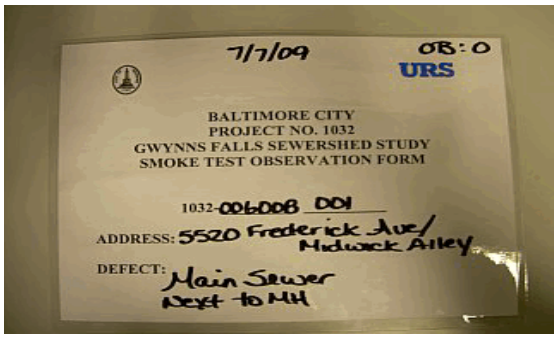
Location: N/A; Type: Main Sewer; Smoke: Heavy; Status: Public ROW
