City of Baltimore Wet Weather Consent Decree Smoke and Dyed Water Testing Form

Sewershed : Gwynn Falls	**Company :** URS	**Date :** 07/07/2009
Test to be Performed : Smoke : X Dyed Water : __	**Ground Condition :** Dry : X Damp : __ Wet : __	**Supervisor :** Ryan Lamont
Manhole ID : S04M__021MH	**Test ID :** S1032-006013	**Notifications (Residents, Fire, 311) :** Yes

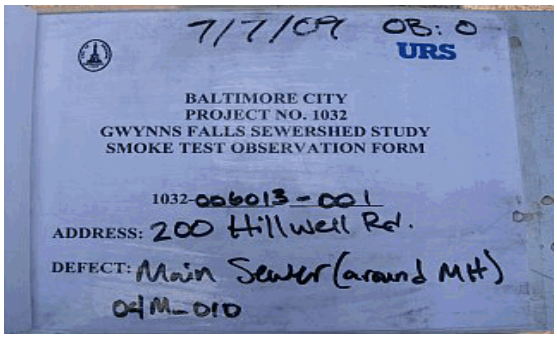
Location: N/A; Type: Main Sewer; Smoke: Heavy; Status: Public ROW
