City of Baltimore Wet Weather Consent Decree Smoke and Dyed Water Testing Form		Page 1 of 2
Sewershed : Gwynn Falls	**Company :** URS	**Date :** 07/20/2009
Test to be Performed : Smoke : X Dyed Water : __	**Ground Condition :** Dry : X Damp : __ Wet : __	**Supervisor :** Ryan Lamont
Manhole ID : S06I__009MH	**Test ID :** S1032-007007	**Notifications (Residents, Fire, 311) :** Yes

City of Baltimore Wet Weather Consent Decree Smoke and Dyed Water Testing Form		Page 2 of 2
Sewershed : Gwynn Falls	**Company :** URS	**Date :** 07/20/2009
Test to be Performed : Smoke : X Dyed Water : __	**Ground Condition :** Dry : X Damp : __ Wet : __	**Supervisor :** Ryan Lamont
Manhole ID : S06I__009MH	**Test ID :** S1032-007007	**Notifications (Residents, Fire, 311) :** Yes

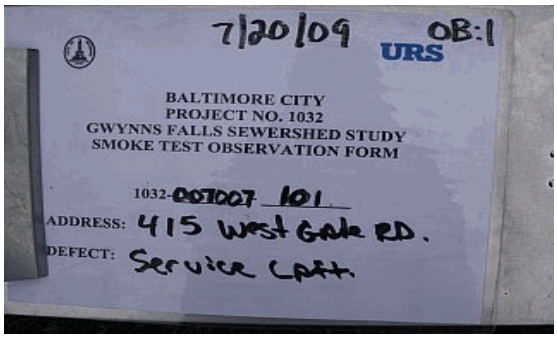
ID

Location: N/A; Type: Service Lateral; Smoke: Medium; Status: Private Property
