City of Baltimore Wet Weather Consent Decree Smoke and Dyed Water Testing Form		Page 1 of 2
Sewershed : Gwynn Falls	**Company :** URS	**Date :** 07/09/2009
Test to be Performed : Smoke : X Dyed Water : __	**Ground Condition :** Dry : X Damp : __ Wet : __	**Supervisor :** Ryan Lamont
Manhole ID : S02AA_015MH	**Test ID :** S1032-018017	**Notifications (Residents, Fire, 311) :** Yes

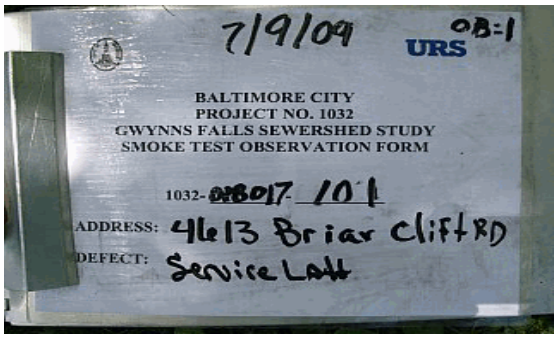
ID

Location: N/A; Type: Service Lateral; Smoke: Medium; Status: Private Property

Defect
