City of Baltimore Wet Weather Consent Decree Smoke and Dyed Water Testing Form		Page 1 of 2
Sewershed : Gwynn Falls	**Company :** URS	**Date :** 07/09/2009
Test to be Performed : Smoke : X Dyed Water : __	**Ground Condition :** Dry : X Damp : __ Wet : __	**Supervisor :** Ryan Lamont
Manhole ID : S04AA_006MH	**Test ID :** S1032-018018	**Notifications (Residents, Fire, 311) :** Yes

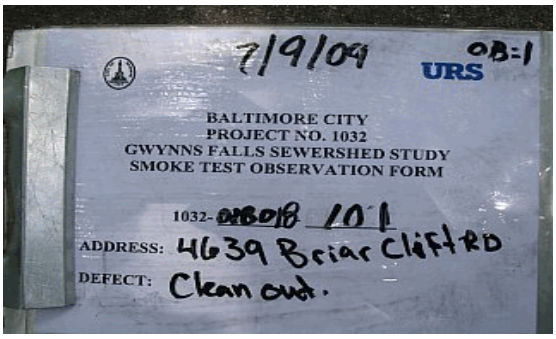
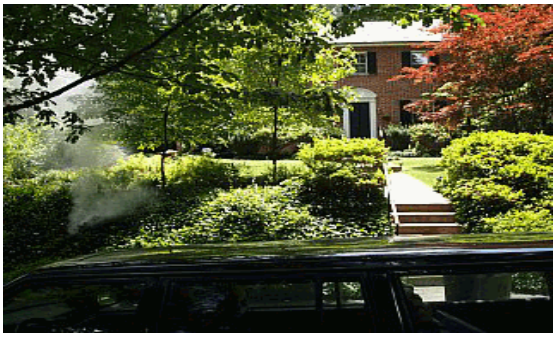
Location: N/A; Type: Cleanout; Smoke: Heavy; Status: Private Property
