City of Baltimore Wet Weather Consent Decree Smoke and Dyed Water Testing Form		Page 1 of 2
Sewershed : Gwynn Falls	**Company :** URS	**Date :** 11/10/2008
Test to be Performed : Smoke : X Dyed Water : __	**Ground Condition :** Dry : X Damp : __ Wet : __	**Supervisor :** Ryan Lamont
Manhole ID : S02C__001MH	**Test ID :** S1032-019005	**Notifications (Residents, Fire, 311) :** Yes

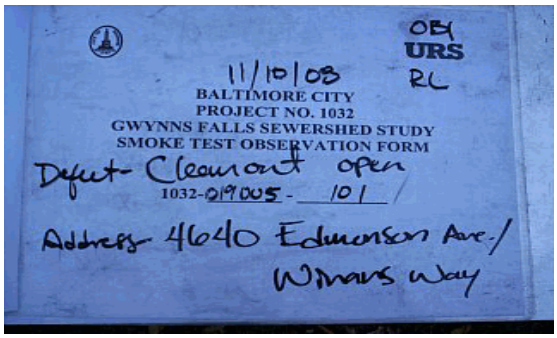
ID

Location: N/A; Type: Cleanout; Smoke: Heavy; Status: Private Property
