City of Baltimore Wet Weather Consent Decree Smoke and Dyed Water Testing Form		Page 1 of 2
Sewershed : Gwynn Falls	**Company :** URS	**Date :** 11/10/2008
Test to be Performed : Smoke : X Dyed Water : __	**Ground Condition :** Dry : X Damp : __ Wet : __	**Supervisor :** Ryan Lamont
Manhole ID : S04A__012MH	**Test ID :** S1032-019007	**Notifications (Residents, Fire, 311) :** Yes

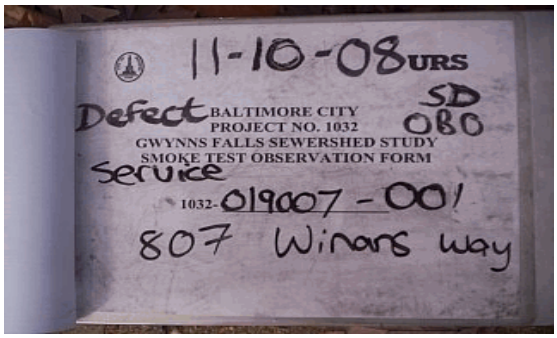
ID

Location: N/A; Type: Service Lateral; Smoke: Light; Status: Public ROW

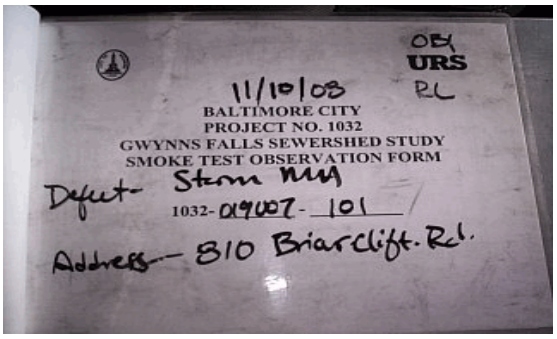
ID

Location: N/A; Type: Storm Manhole; Smoke: Light; Status: Public ROW
