City of Baltimore Wet Weather Consent Decree Smoke and Dyed Water Testing Form

Sewershed : Gwynn Falls	**Company :** URS	**Date :** 11/11/2008
Test to be Performed : Smoke : X Dyed Water : __	**Ground Condition :** Dry : X Damp : __ Wet : __	**Supervisor :** Ryan Lamont
Manhole ID : S06A__020MH	**Test ID :** S1032-019019	**Notifications (Residents, Fire, 311) :** Yes

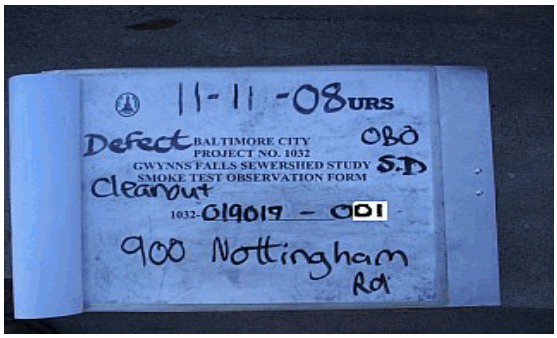
Location: N/A; Type: Cleanout; Smoke: Heavy; Status: Private Property
