City of Baltimore Wet Weather Consent Decree Smoke and Dyed Water Testing Form		Page 1 of 3
Sewershed : Gwynn Falls	**Company :** URS	**Date :** 11/17/2008
Test to be Performed : Smoke : X Dyed Water : __	**Ground Condition :** Dry : X Damp : __ Wet : __	**Supervisor :** Ryan Lamont
Manhole ID : S06A__016MH	**Test ID :** S1032-019033	**Notifications (Residents, Fire, 311) :** Yes

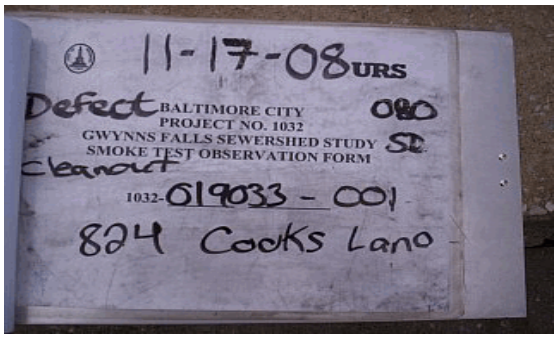
Location: N/A; Type: Cleanout; Smoke: Medium; Status: Private Property

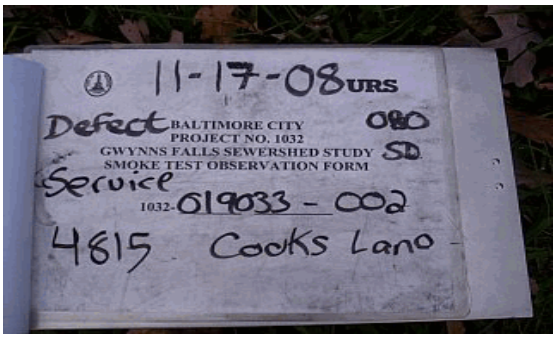
Location: N/A; Type: Service Lateral; Smoke: Light; Status: Private Property

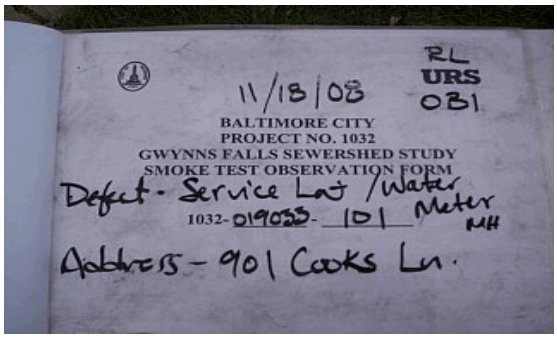
Location: N/A; Type: Service Lateral; Smoke: Light; Status: Public ROW
