City of Baltimore Wet Weather Consent Decree Smoke and Dyed Water Testing Form

Sewershed : Gwynn Falls	**Company :** URS	**Date :** 09/15/2008
Test to be Performed : Smoke : X Dyed Water : __	**Ground Condition :** Dry : X Damp : __ Wet : __	**Supervisor :** Ryan Lamont
Manhole ID : S05UU_012MH	**Test ID :** S1032-022002	**Notifications (Residents, Fire, 311) :** Yes

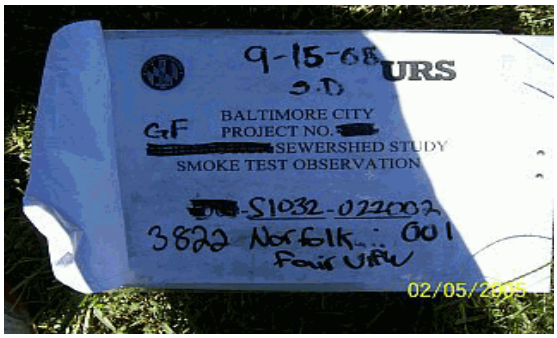
Location: N/A; Type: Cleanout; Smoke: Medium; Status: Private Property
