City of Baltimore Wet Weather Consent Decree Smoke and Dyed Water Testing Form

Sewershed : Gwynn Falls	**Company :** URS	**Date :** 09/19/2008
Test to be Performed : Smoke : X Dyed Water : __	**Ground Condition :** Dry : X Damp : __ Wet : __	**Supervisor :** Ryan Lamont
Manhole ID : S01SS_009MH	**Test ID :** S1032-022020	**Notifications (Residents, Fire, 311) :** Yes

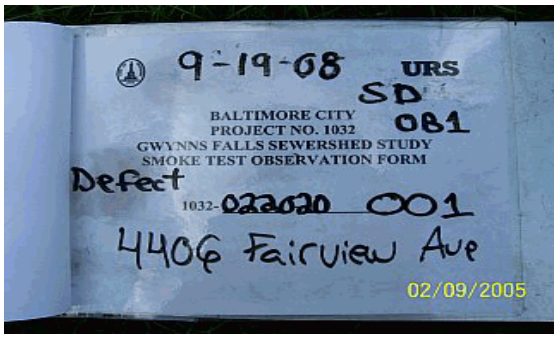
Location: N/A; Type: Cleanout; Smoke: Medium; Status: Private Property

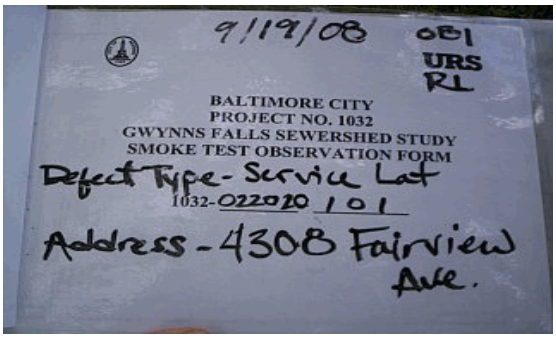
Location: N/A; Type: Service Lateral; Smoke: Medium; Status: Private Property
