City of Baltimore Wet Weather Consent Decree Smoke and Dyed Water Testing Form		Page 1 of 2
Sewershed : Gwynn Falls	**Company :** URS	**Date :** 09/23/2008
Test to be Performed : Smoke : X Dyed Water : __	**Ground Condition :** Dry : X Damp : __ Wet : __	**Supervisor :** John Daly
Manhole ID : S03SS_022MH	**Test ID :** S1032-022033	**Notifications (Residents, Fire, 311) :** Yes

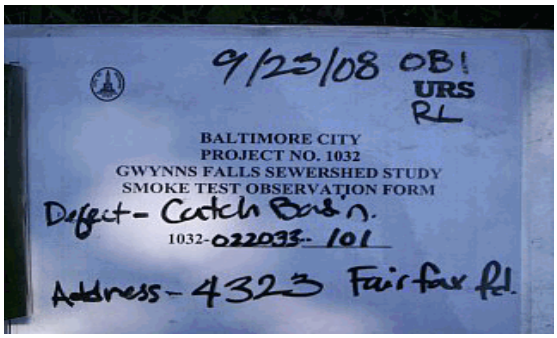
Location: N/A; Type: Catch Basin; Smoke: Light; Status: Public ROW
