City of Baltimore Wet Weather Consent Decree Smoke and Dyed Water Testing Form

Sewershed : Gwynn Falls	**Company :** URS	**Date :** 09/25/2008
Test to be Performed : Smoke : X Dyed Water : __	**Ground Condition :** Dry : X Damp : __ Wet : __	**Supervisor :** Ryan Lamont
Manhole ID : S03SS_002MH	**Test ID :** S1032-022047	**Notifications (Residents, Fire, 311) :** Yes

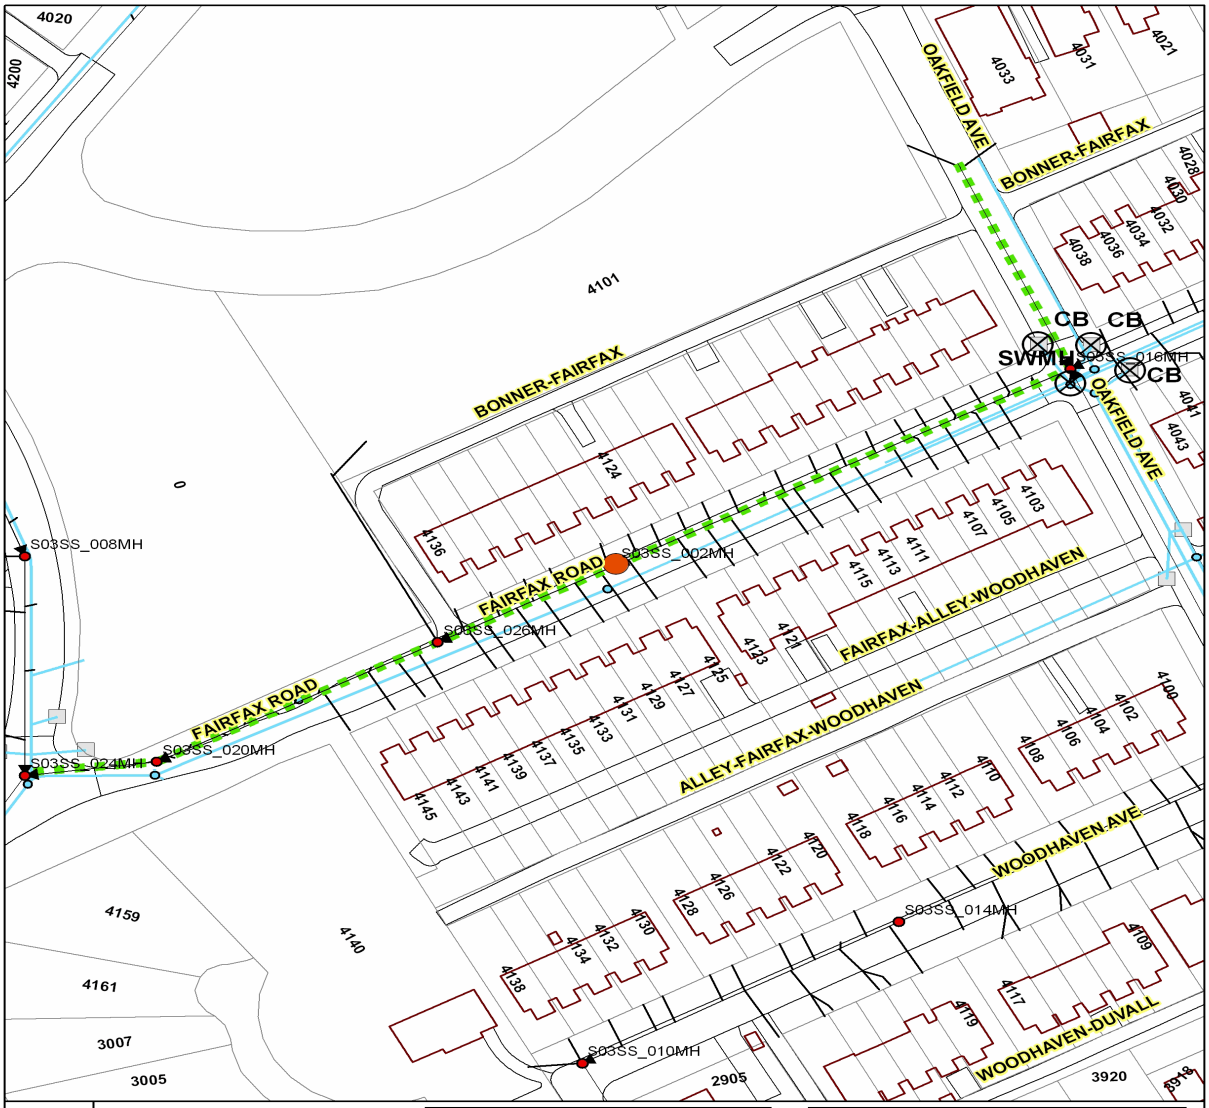
Field Sketch : (Show All Manholes with Numbers, Blower Placement Location, Sandbag or Isolation Locations, Street Names, Building Addresses and Locations, Defect Locations and Photograph Numbers)

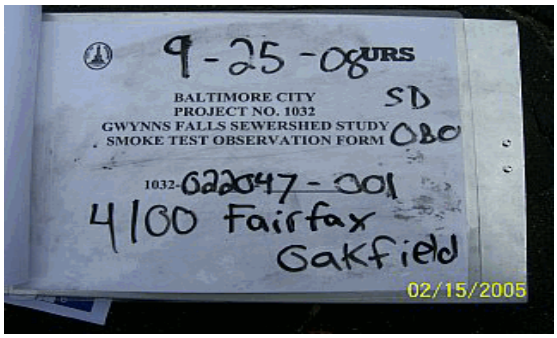
ID

Location: N/A; Type: Storm Manhole; Smoke: Medium; Status: Public ROW

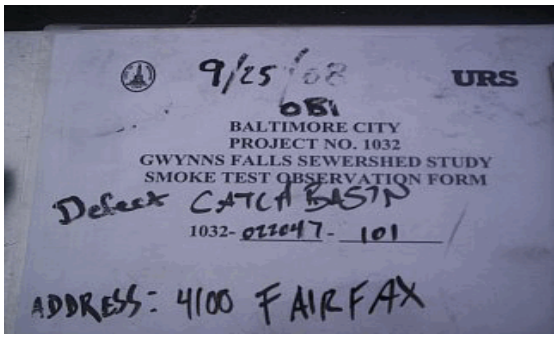
ID

Location: N/A; Type: Catch Basin; Smoke: Medium; Status: Public ROW

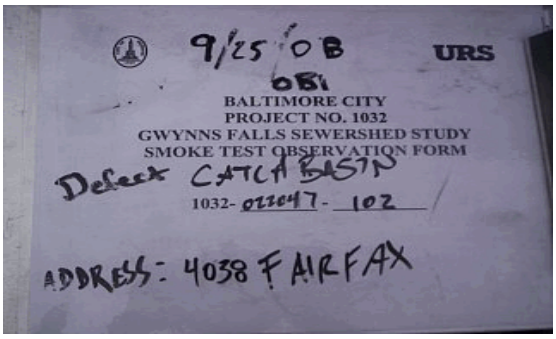
ID

Location: N/A; Type: Catch Basin; Smoke: Medium; Status: Public ROW
