City of Baltimore Wet Weather Consent Decree Smoke and Dyed Water Testing Form

Sewershed : Gwynn Falls	**Company :** URS	**Date :** 07/17/2009
Test to be Performed : Smoke : X Dyed Water : __	**Ground Condition :** Dry : X Damp : __ Wet : __	**Supervisor :** John Daly
Manhole ID : S04MM_002MH	**Test ID :** S1032-023016	**Notifications (Residents, Fire, 311) :** Yes

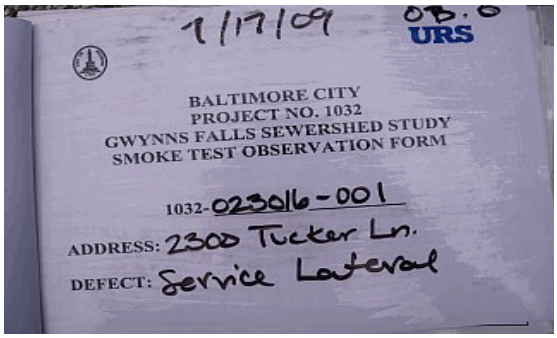
ID

Location: N/A; Type: Service Lateral; Smoke: Medium; Status: Private Property

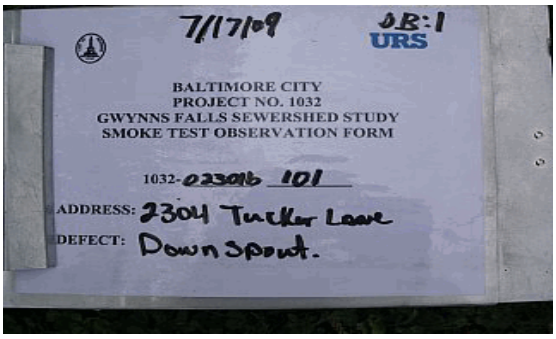
ID

Location: N/A; Type: Downspout; Smoke: Medium; Status: Private Property
