City of Baltimore Wet Weather Consent Decree Smoke and Dyed Water Testing Form		Page 1 of 2
Sewershed : Gwynn Falls	**Company :** URS	**Date :** 07/17/2009
Test to be Performed : Smoke : X Dyed Water : __	**Ground Condition :** Dry : X Damp : __ Wet : __	**Supervisor :** Ryan Lamont
Manhole ID : S08KK_009MH	**Test ID :** S1032-023023	**Notifications (Residents, Fire, 311) :** Yes

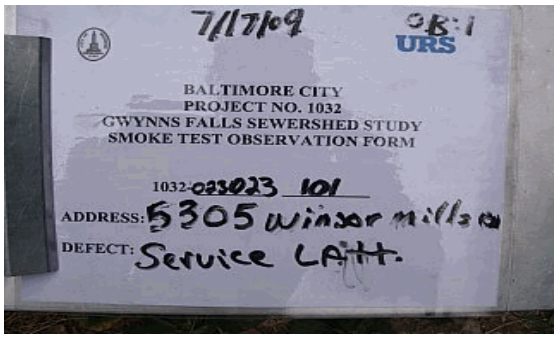
ID

Location: N/A; Type: Service Lateral; Smoke: Medium; Status: Private Property
