City of Baltimore Wet Weather Consent Decree Smoke and Dyed Water Testing Form		Page 1 of 2
Sewershed : Gwynn Falls	**Company :** URS	**Date :** 07/02/2009
Test to be Performed : Smoke : X Dyed Water : __	**Ground Condition :** Dry : X Damp : __ Wet : __	**Supervisor :** Ryan Lamont
Manhole ID : S03WW_027MH	**Test ID :** S1032-025007	**Notifications (Residents, Fire, 311) :** Yes

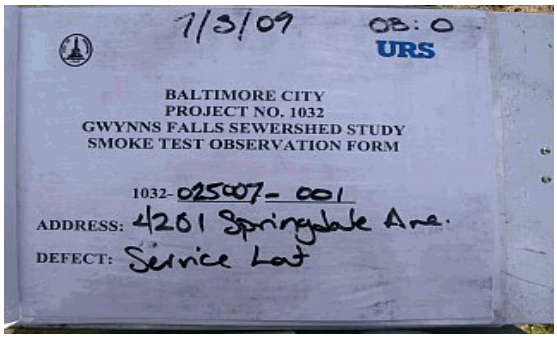
Location: N/A; Type: Service Lateral; Smoke: Medium; Status: Private Property

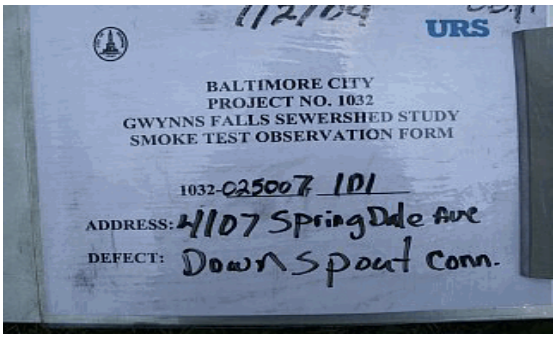
Location: N/A; Type: Downspout Connection; Smoke: Medium; Status: Private Property
