City of Baltimore Wet Weather Consent Decree Smoke and Dyed Water Testing Form		Page 1 of 3
Sewershed : Gwynn Falls	**Company :** URS	**Date :** 06/29/2009
Test to be Performed : Smoke : X Dyed Water : _	**Ground Condition :** Dry : X Damp : _ Wet : _	**Supervisor :** Ryan Lamont
Manhole ID : S01EE1004MH	**Test ID :** S1032-027034	**Notifications (Residents, Fire, 311) :** Yes

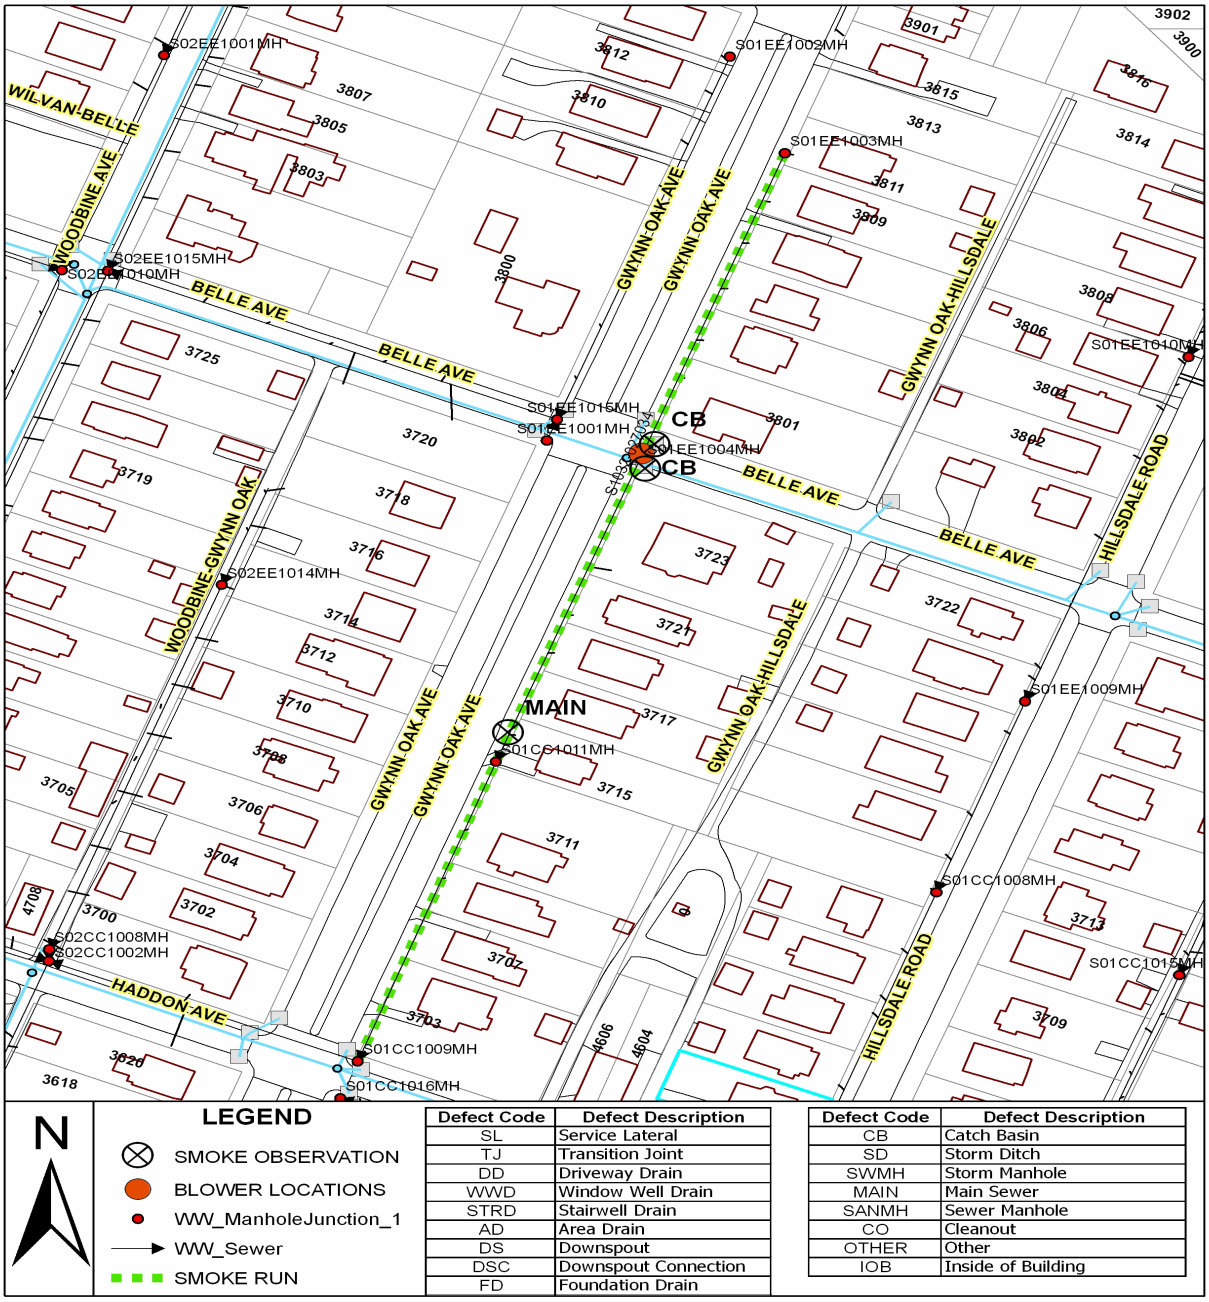
Field Sketch : (Show All Manholes with Numbers, Blower Placement Location, Sandbag or Isolation Locations, Street Names, Building Addresses and Locations, Defect Locations and Photograph Numbers)

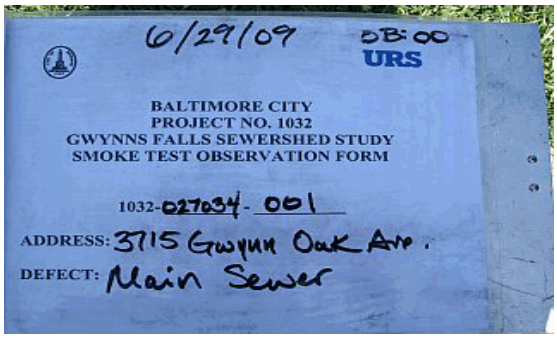
ID

Location: N/A; Type: Main Sewer; Smoke: Light; Status: Public ROW

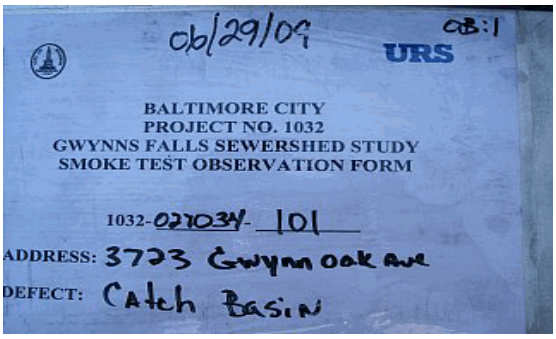
ID

Location: N/A; Type: Catch Basin; Smoke: Heavy; Status: Public ROW

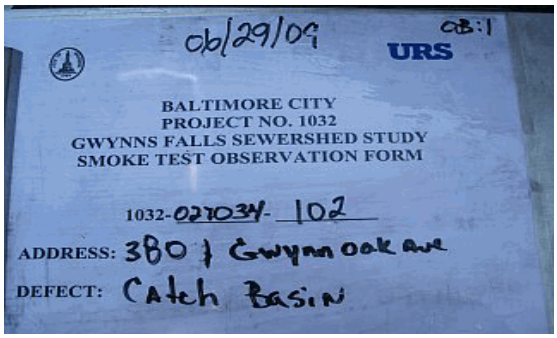
ID

Location: N/A; Type: Catch Basin; Smoke: Light; Status: Public ROW
