City of Baltimore Wet Weather Consent Decree Smoke and Dyed Water Testing Form

Sewershed : Gwynn Falls	**Company :** URS	**Date :** 06/29/2009
Test to be Performed : Smoke : X Dyed Water : __	**Ground Condition :** Dry : X Damp : __ Wet : __	**Supervisor :** Ryan Lamont
Manhole ID : S01CC1006MH	**Test ID :** S1032-027039	**Notifications (Residents, Fire, 311) :** Yes

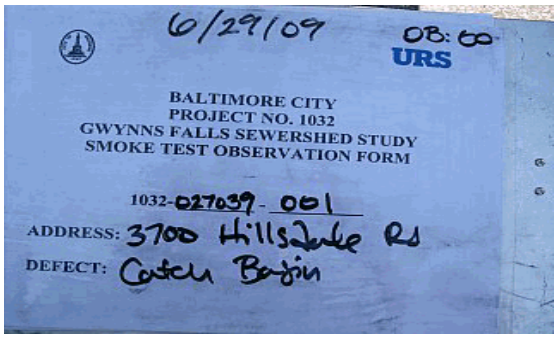
Location: N/A; Type: Catch Basin; Smoke: Light; Status: Public ROW

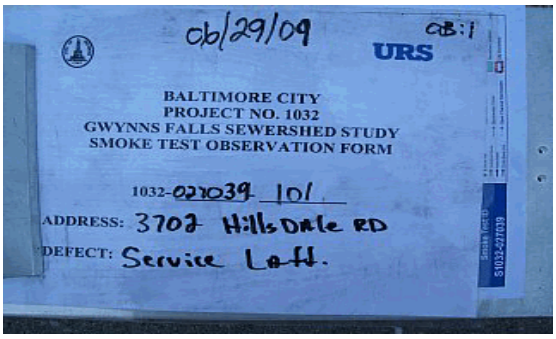
Location: N/A; Type: Service Lateral; Smoke: Medium; Status: Private Property
