City of Baltimore Wet Weather Consent Decree Smoke and Dyed Water Testing Form		Page 1 of 4
Sewershed : Gwynn Falls	**Company :** URS	**Date :** 10/29/2008
Test to be Performed : Smoke : X Dyed Water : __	**Ground Condition :** Dry : X Damp : __ Wet : __	**Supervisor :** Ryan Lamont
Manhole ID : S04CC1019MH	**Test ID :** S1032-028004	**Notifications (Residents, Fire, 311) :** Yes

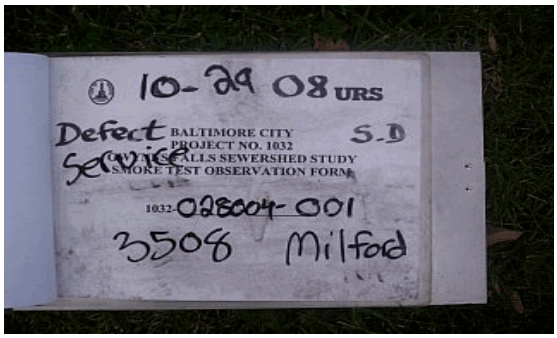
Location: N/A; Type: Service Lateral; Smoke: Medium; Status: Public ROW

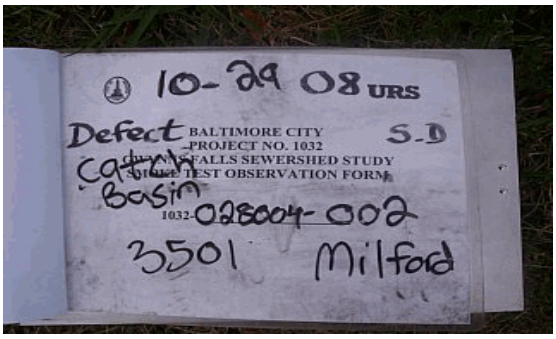
Location: N/A; Type: Catch Basin; Smoke: Light; Status: Public ROW

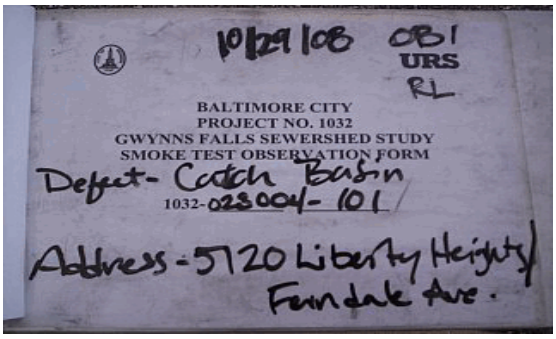
Location: N/A; Type: Catch Basin; Smoke: Medium; Status: Public ROW

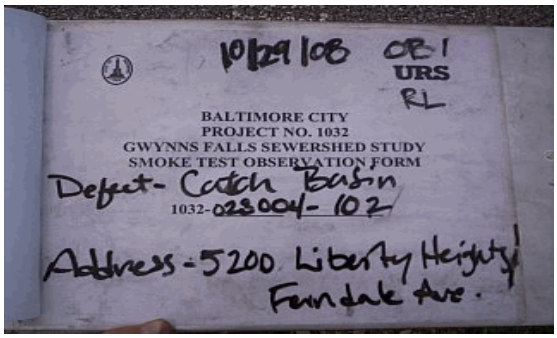
Location: N/A; Type: Catch Basin; Smoke: Medium; Status: Public ROW

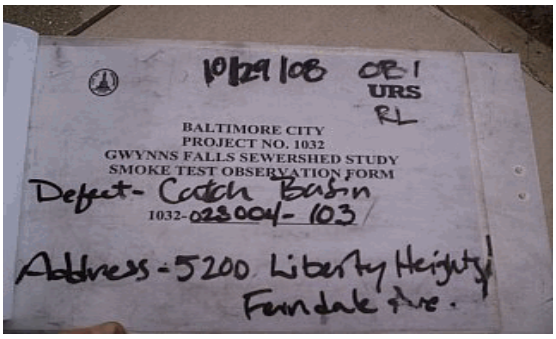
Location: N/A; Type: Catch Basin; Smoke: Light; Status: Public ROW
