City of Baltimore Wet Weather Consent Decree Smoke and Dyed Water Testing Form		Page 1 of 2
Sewershed : Gwynn Falls	**Company :** URS	**Date :** 10/29/2008
Test to be Performed : Smoke : X Dyed Water : __	**Ground Condition :** Dry : X Damp : __ Wet : __	**Supervisor :** Ryan Lamont
Manhole ID : S04GG1020MH	**Test ID :** S1032-028014	**Notifications (Residents, Fire, 311) :** Yes

City of Baltimore Wet Weather Consent Decree Smoke and Dyed Water Testing Form		Page 2 of 2
Sewershed : Gwynn Falls	**Company :** URS	**Date :** 10/29/2008
Test to be Performed : Smoke : X Dyed Water : __	**Ground Condition :** Dry : X Damp : __ Wet : __	**Supervisor :** Ryan Lamont
Manhole ID : S04GG1020MH	**Test ID :** S1032-028014	**Notifications (Residents, Fire, 311) :** Yes

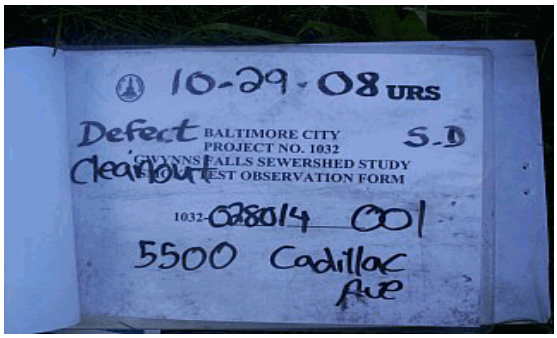
Location: N/A; Type: Cleanout; Smoke: Medium; Status: Private Property

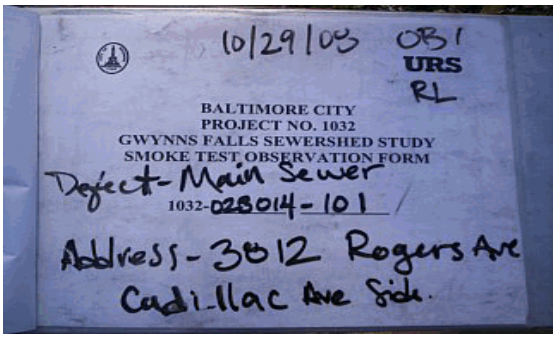
Location: N/A; Type: Main Sewer; Smoke: Light; Status: Private Property
