City of Baltimore Wet Weather Consent Decree Smoke and Dyed Water Testing Form		Page 1 of 2
Sewershed : Gwynn Falls	**Company :** URS	**Date :** 10/29/2008
Test to be Performed : Smoke : X Dyed Water : __	**Ground Condition :** Dry : X Damp : __ Wet : __	**Supervisor :** Ryan Lamont
Manhole ID : S04AA1008MH	**Test ID :** S1032-028020	**Notifications (Residents, Fire, 311) :** Yes

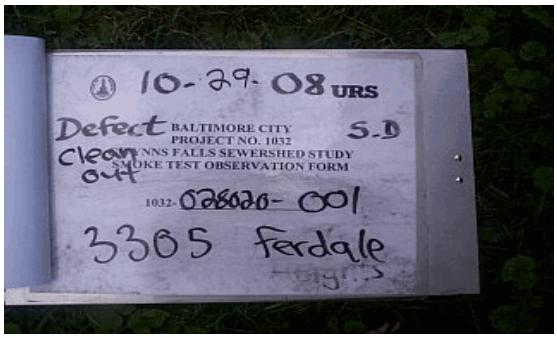
Location: N/A; Type: Cleanout; Smoke: Light;
Status: Private Property
