City of Baltimore Wet Weather Consent Decree Smoke and Dyed Water Testing Form

Sewershed : Gwynn Falls	**Company :** URS
Test to be Performed : Smoke : X Dyed Water : __	**Ground Condition :** Dry : X Damp : __ Wet : __
Manhole ID : S05OO1002MH	**Test ID :** S1032-034010

Date : 10/08/2008

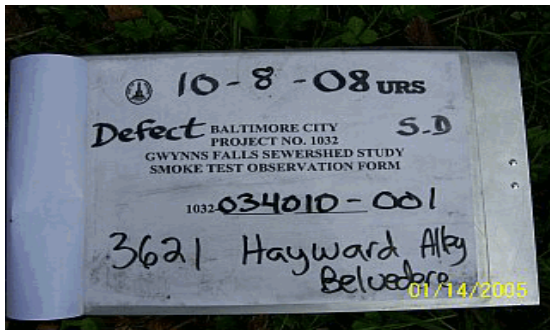
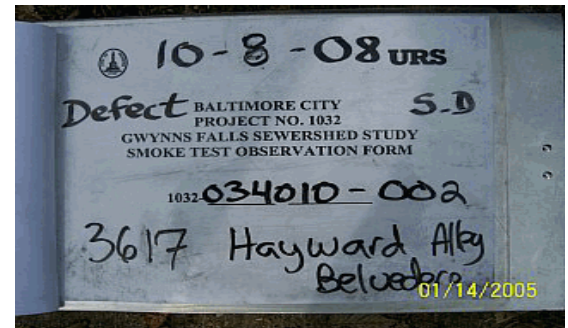
Location: N/A; Type: Service Lateral; Smoke: Medium; Status: Public ROW

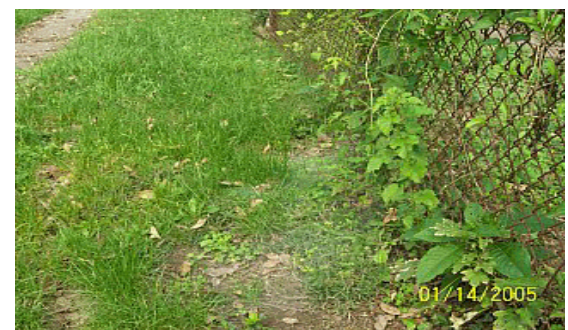
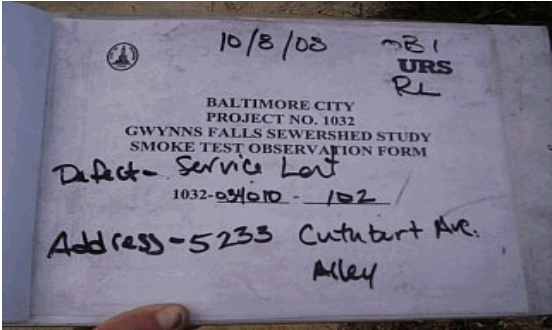
Location: N/A; Type: Service Lateral; Smoke: Medium; Status: Private Property
