City of Baltimore Wet Weather Consent Decree Smoke and Dyed Water Testing Form

Sewershed : Gwynn Falls	**Company :** URS	**Date :** 10/09/2008
Test to be Performed : Smoke : X Dyed Water : __	**Ground Condition :** Dry : X Damp : __ Wet : __	**Supervisor :** Ryan Lamont
Manhole ID : S07KK1010MH	**Test ID :** S1032-034022	**Notifications (Residents, Fire, 311) :** Yes

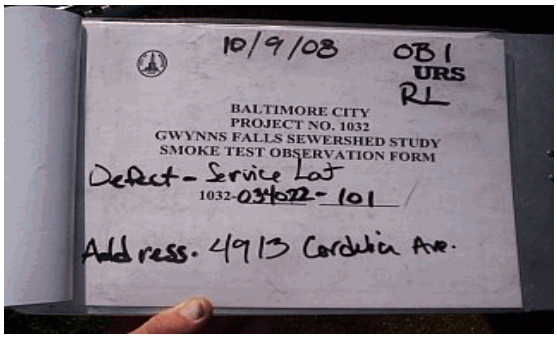
Location: N/A; Type: Service Lateral; Smoke: Light; Status: Private Property
