Manhole Inspection Summary — Manhole # S15C__029MH

Record Plat: **15C** Node: **029** Status: **Found** Insp Date: **7/2/08 4:59 PM**

Location Address: **REAR 2628 EDMONSON** Cross Street: **CLAMONT**

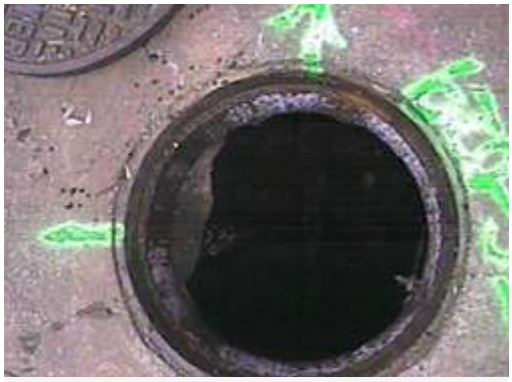
Condition: ☐ Sound ☐ Cracked ☐ Root Intrusion ☐ Loose Brick ☑ **Deteriorated**

Infiltration: ☐ None ☐ Joint ☐ Cracks ☐ Mortar ☐ Roots ☑ **Wall**

Defect 2

INFILTRATION CORBEL

Defect 1

DETERIORATED FRAME ADJUSTMENT
