Manhole Inspection Summary — Manhole # S31I__036MH

Record Plat: **31I** Node: **036** Status: **Found** Insp Date: **10/29/08 12:57 PM**

Location Address: **338 w pratt st** Cross Street: **s eutaw st**

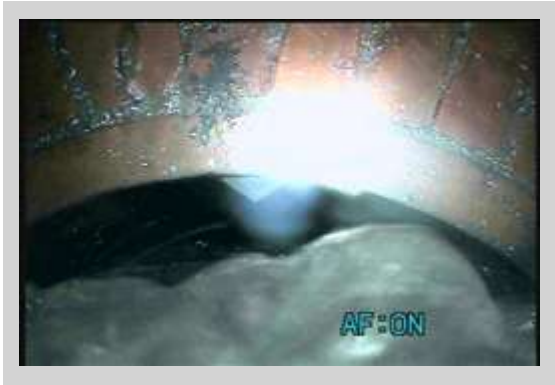
Pipe Out @ 12 OClock

water flow to high to see in pipe
