Manhole Inspection Summary — Manhole # S43II_024MH

Record Plat: **43II** Node: **024** Status: **Found** Insp Date: **3/11/08 3:23 PM**

Location Address: **1600 LANVALE ST** Cross Street: **BOND ST**

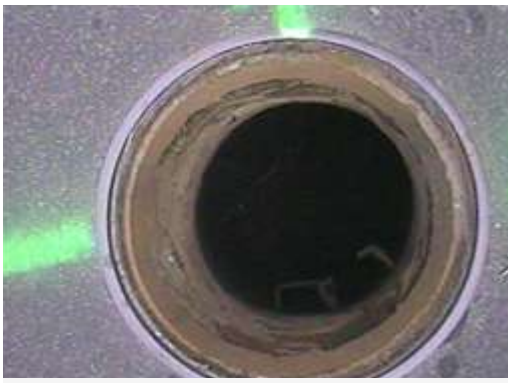
Defect 1

Frame Offset: **1** (in.) Condition: ☑ Sound ☐ Cracked ☐ Leaks

FRAME OFFSET
