Manhole Inspection Summary — Manhole # S45G__019MH

Record Plat: **45G** Node: **019** Status: **Found** Insp Date: **7/15/08 9:32 AM**

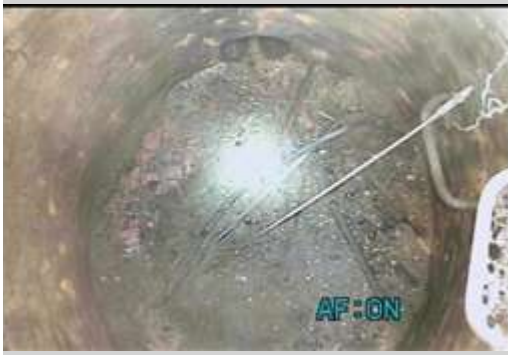
Condition: ☐ Sound ☑ **Cracked** ☐ Root Intrusion ☐ Loose Brick ☑ **Deteriorated**

Condition: ☐ Sound ☐ Cracked ☐ Root Intrusion ☐ Deteriorated ☐ Leaks ☑ **Debris**

Steps Count: **3** Missing: **0** ☑ **Corroded**

cover has a pole stick in it

channel debris

corroded steps

cracked chimney frame adj
