SUBJECT: Inspection Report
Safety-Kleen Systems, Inc., Pekin, IL
ILD 093 862 811

Facility: Safety-Kleen Systems, Inc.
R.R.#3, 14299 VFW Road
Pekin, IL 61554
ILD 093 862 811

INTERIOR TANK INSPECTION AND INTEGRITY CERTIFICATION USED OIL TANK AND INSULATED USED OIL TANK

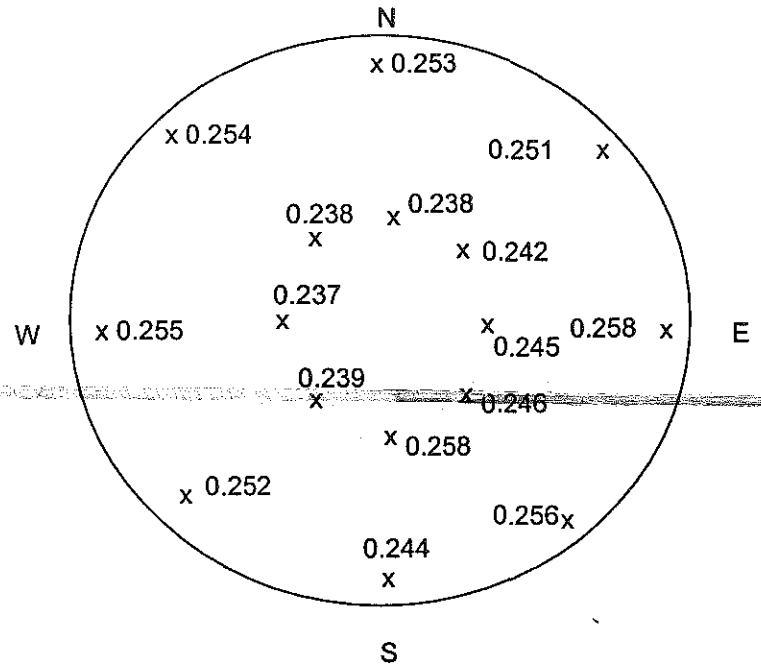
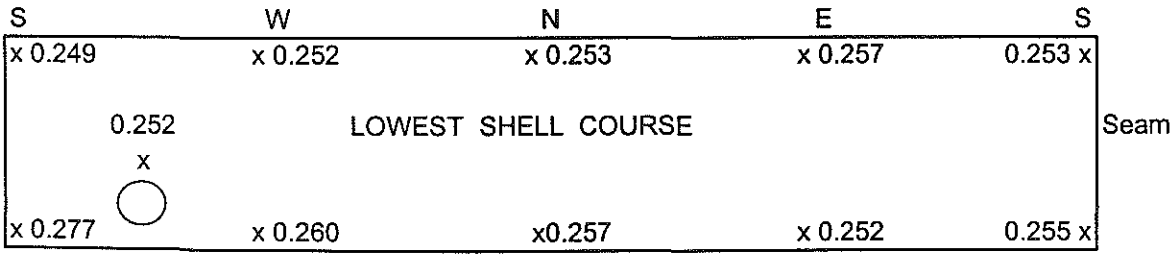
FIGURE 1 - INSULATED USED OIL TANK ULTRASONICS

Tank integrity is considered adequate for continued service.

SAFETY-KLEEN PEKIN
ULTRASONIC TANK THICKNESS READINGS
TANK 2 - INSULATED USED OIL TANK

MEASURES SHOWN IN INCHES
AVERAGE BOTTOM THICKNESS = 0.248 in.

AVERAGE SHELL THICKNESS = 0.256 in.

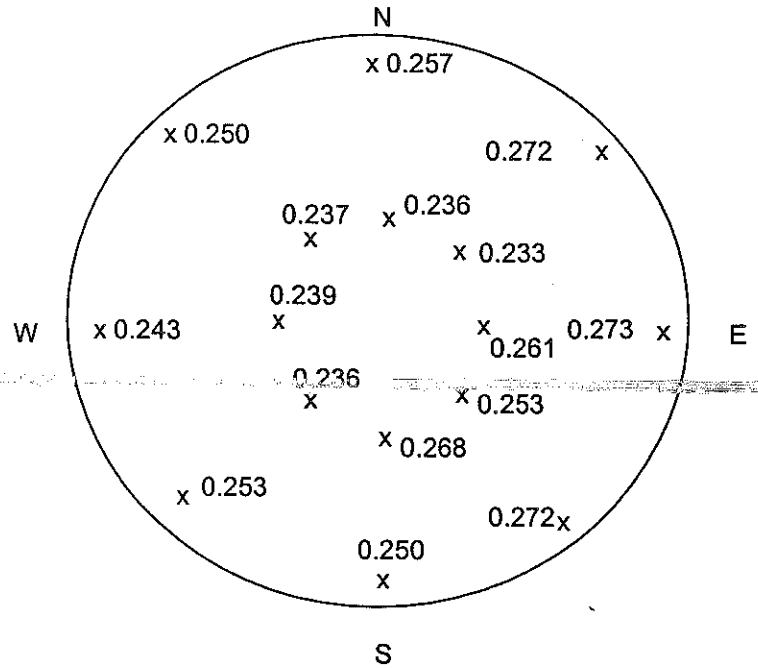
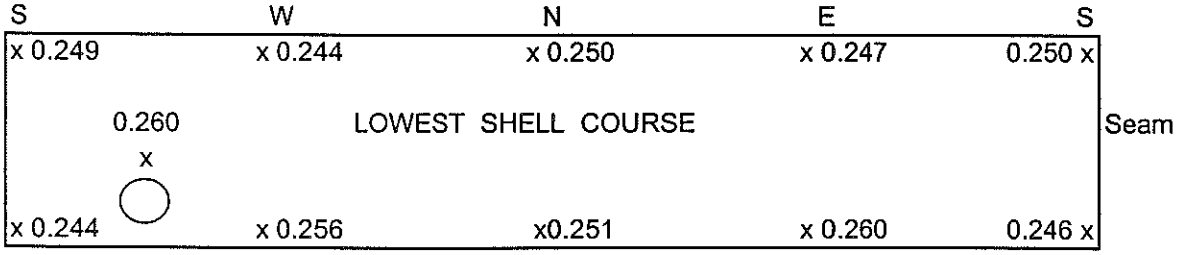
FIGURE 2 - USED OIL TANK ULTRASONICS

SAFETY-KLEEN PEKIN
ULTRASONIC TANK THICKNESS READINGS
TANK 4 - USED OIL TANK

MEASURES SHOWN IN INCHES
AVERAGE BOTTOM THICKNESS = 0.252 in.

AVERAGE SHELL THICKNESS = 0.251 in.

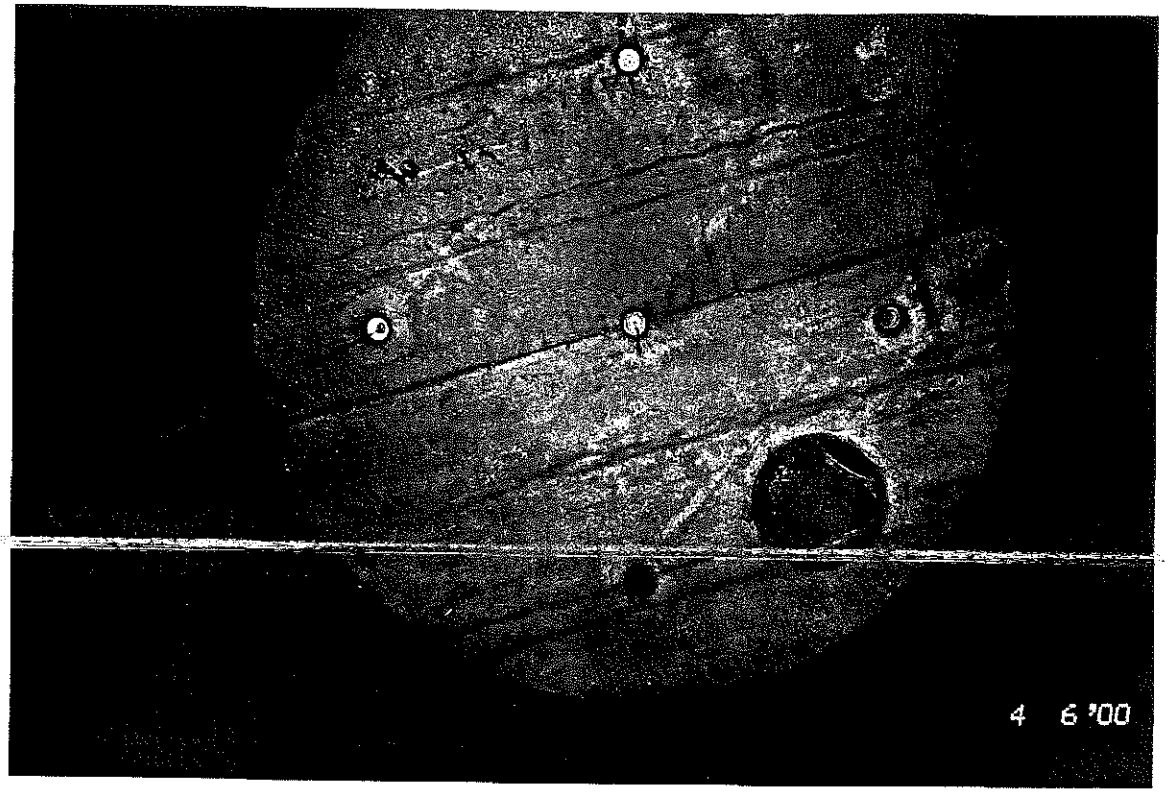
1. INSIDE VIEW OF ROOF

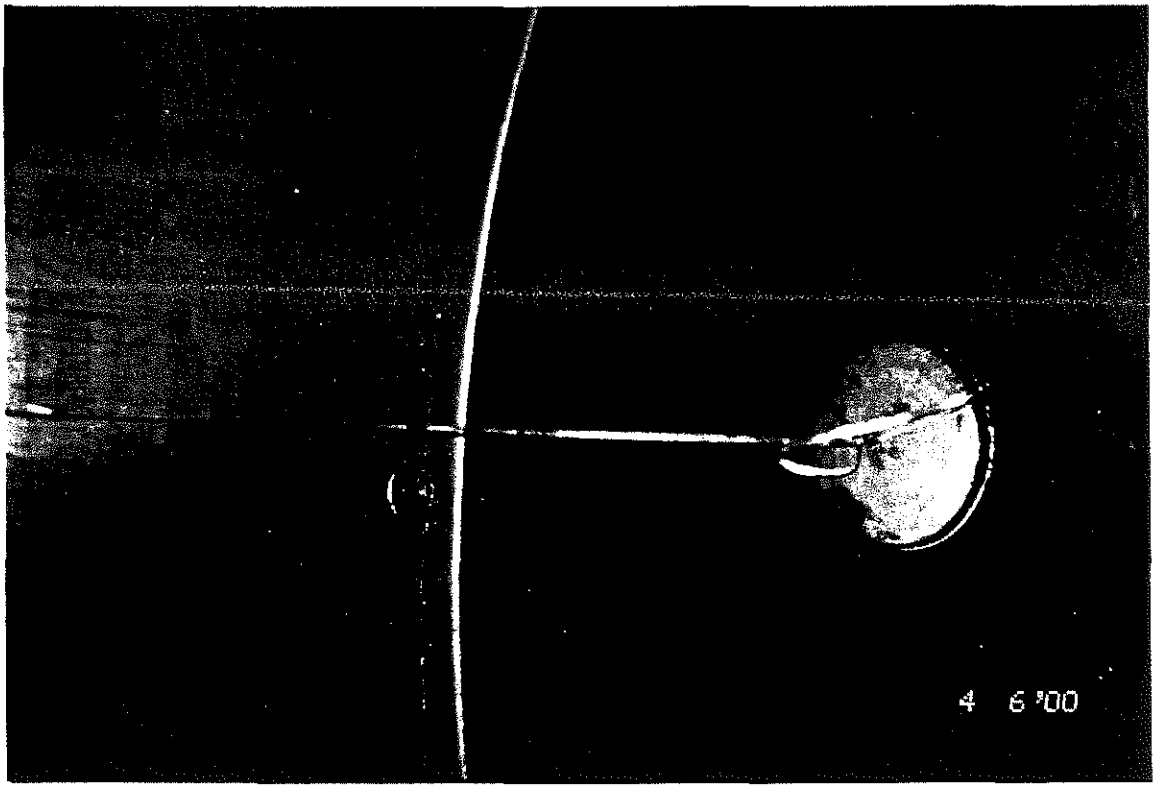
2. INSIDE VIEW OF BOTTOM, SIDE & LEVEL FLOAT

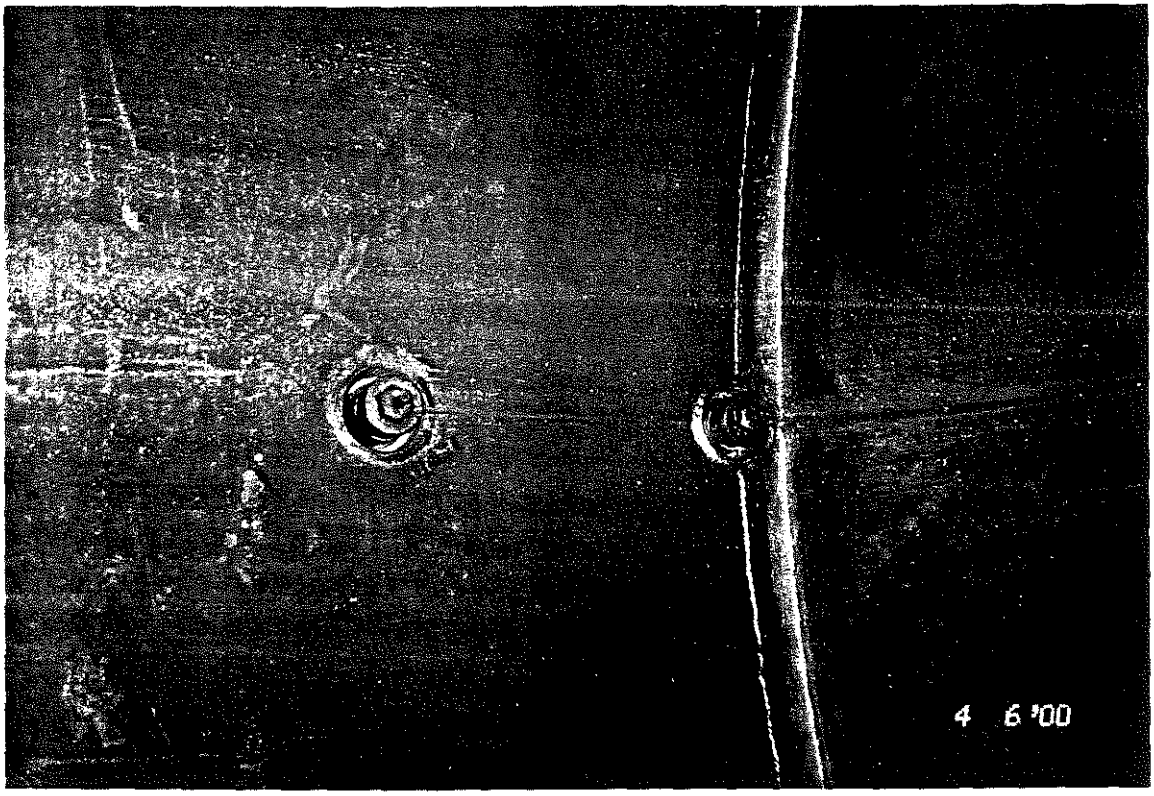
4. INLET VALVES, BOTTOM & SIDE SEAM

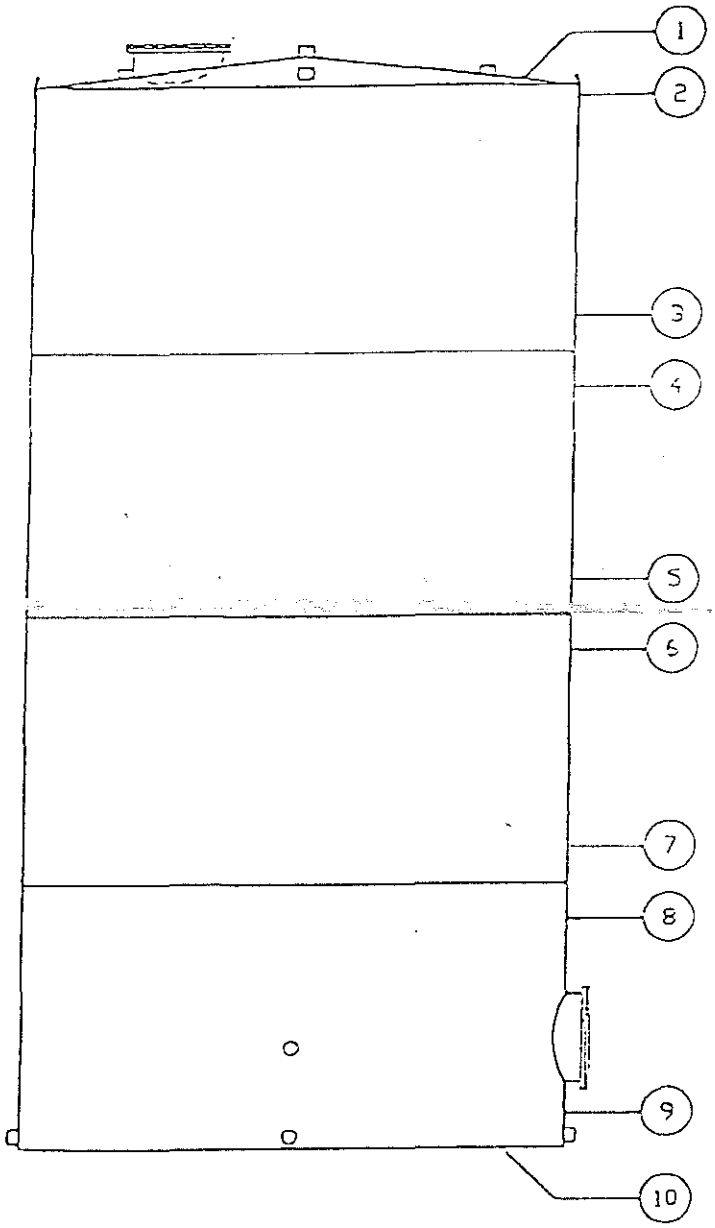
SAFETY-KLEEN PEKIN
ULTRASONIC TANK THICKNESS READINGS
SPENT SOLVENT TANK

Readings by: B. Rucker
Readings adjusted for paint thickness

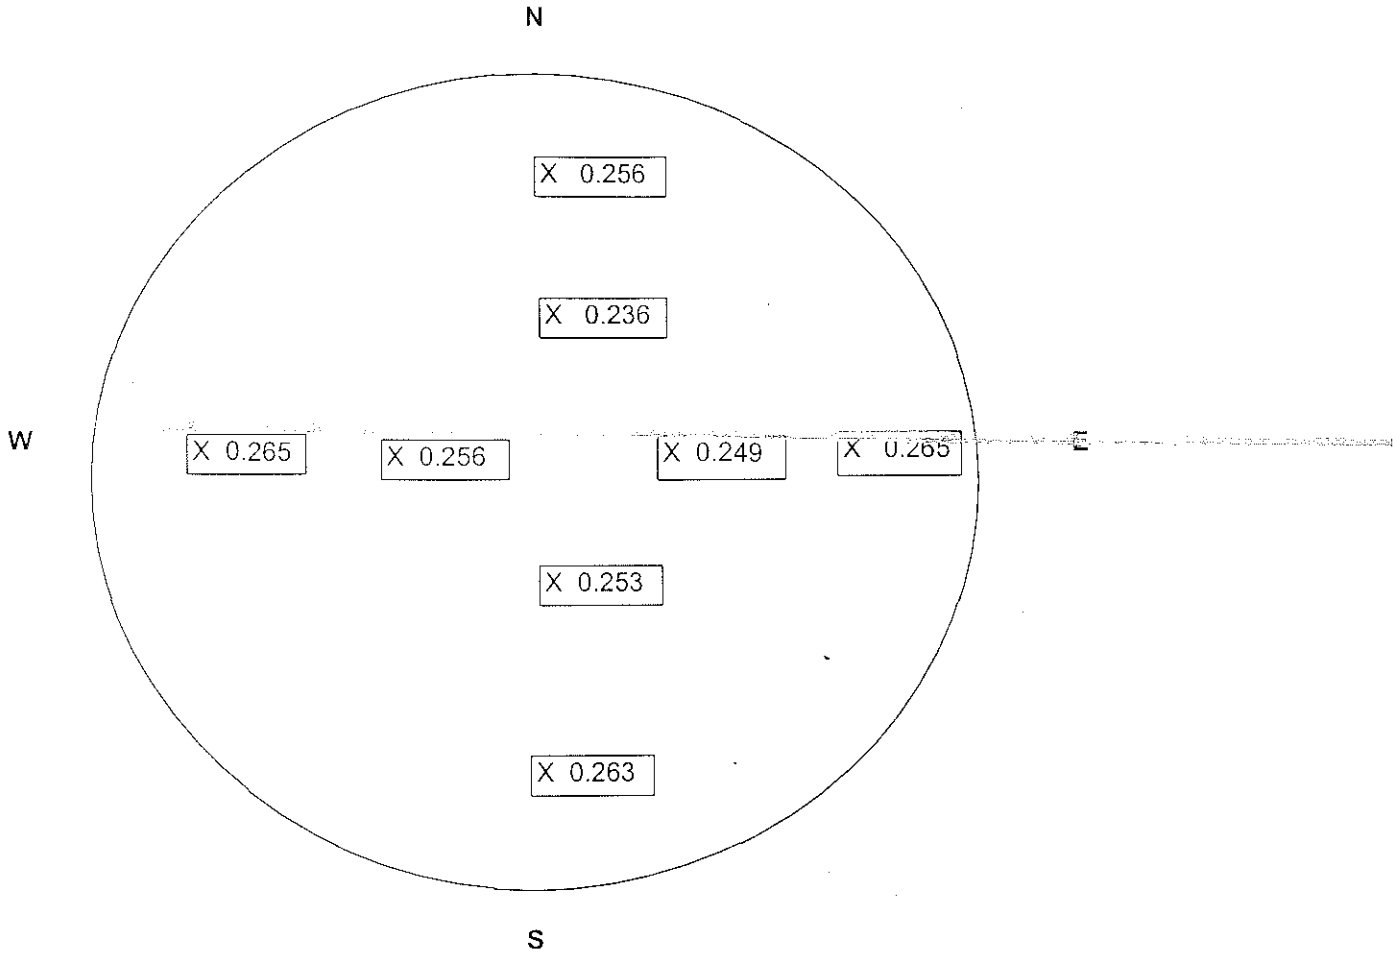
Tank integrity is considered adequate for continued service.

MEASURES SHOWN IN INCHES.
AVERAGE THICKNESS = 0.255 in.

MINIMUM TANK THICKNESS = 0.240 in. (UL142)

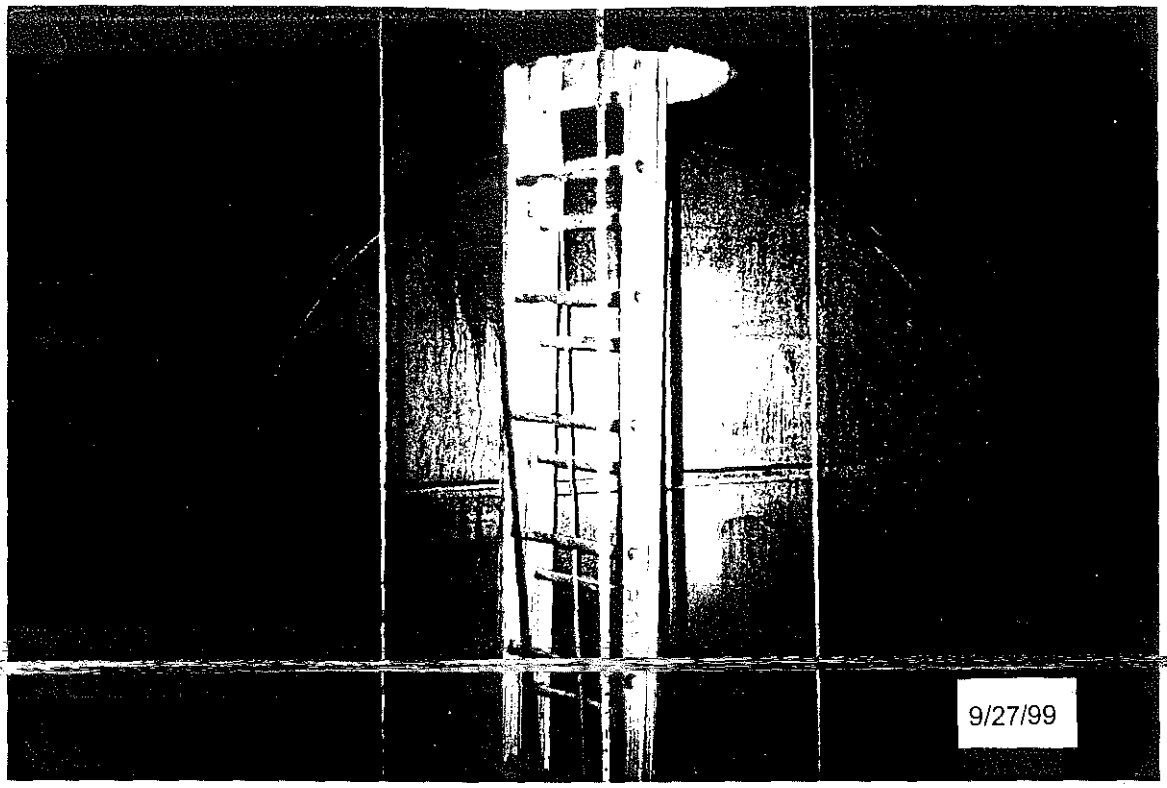
PHOTO 1 - NORTH END

Photos 1 and 2 show the ends of the tank. Photos 3 and 4 show the south end and a view of the side of the tank. These photos show very limited rust spotting. Review of the video confirms this finding. No cracking of tank welds is noted. The tank end photos show no corrosion with clean end welds.
