GOVERNMENT OF THE DISTRICT OF COLUMBIA
District Department of the Environment

Illicit Discharge Investigation Report

Case Number: 100330
Complaint: Routine monthly facility inspection
Location: 1711 1st St., SW (Super Salvage, Inc.)
Date Incident Reported: March 30, 2010
Date of Investigation: March 30, 2010
Name of Inspector(s): Ibrahim Famuditimi and Jacob Zangrilli

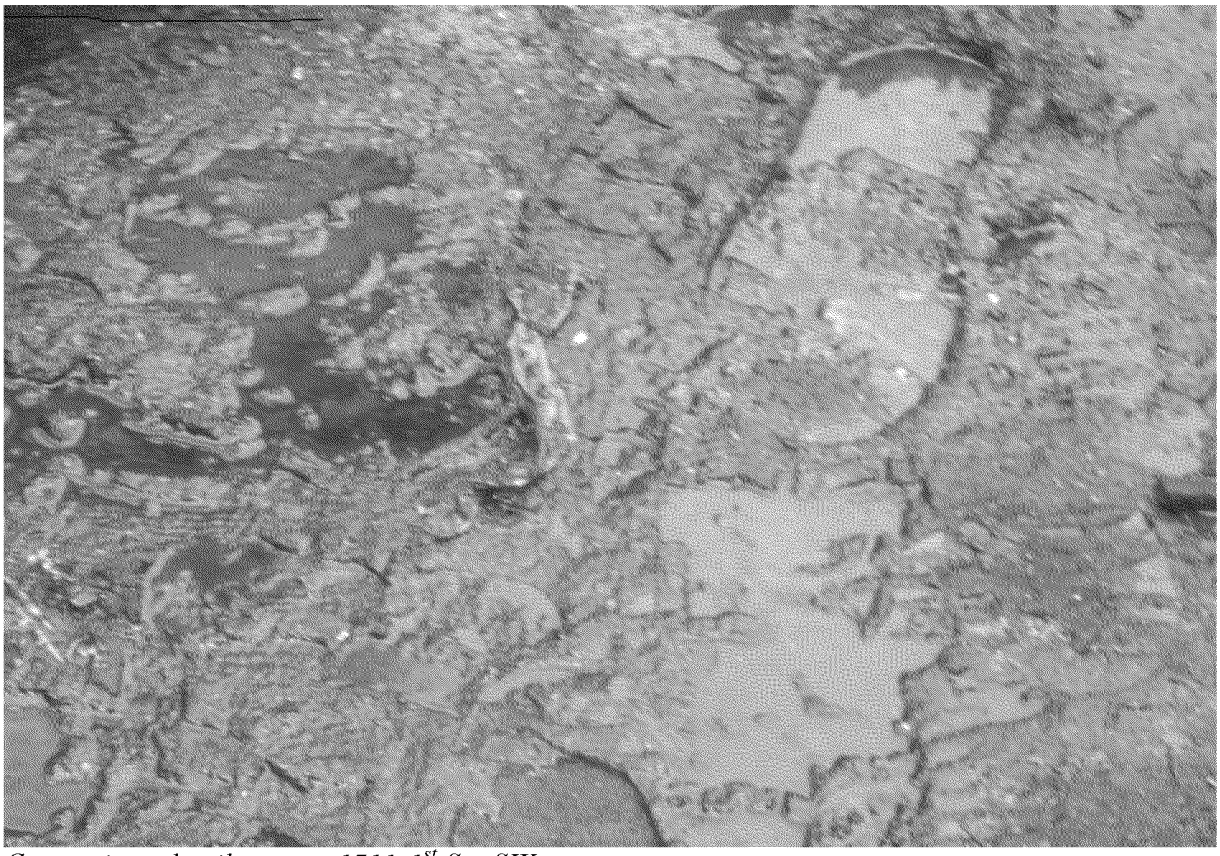
Inspectors noticed various types of fluids leaking from storage boxes left on the grounds of the property, automotive parts, and also from buildings on the property. Upon asking why fluids were coming out of the buildings, inspectors were told that they had a malfunction with the hydraulic equipment the day prior, and they are working on fixing that problem. During the time of inspection, the hydraulic equipment was turned off. Inspectors also noticed what seemed to be a concrete hole in the ground. Mr. Bullock told inspectors it was used for collecting runoff fluids on the property. Mr. Bullock stated that this "runoff collection unit" is later pumped into the pond of the back of the building. An employee on site disagreed with Mr. Bullock and said that contractors came to pump liquids from the concrete hole, and that it was a closed catchment system. When asked to see documentation that such fluids are been picked up, Super Salvage was unable to locate the paper work.

Equipment building with fluids coming out it at 1711 1st St., SW
