Appendix B
Photograph Log and Photographs

Photograph Log

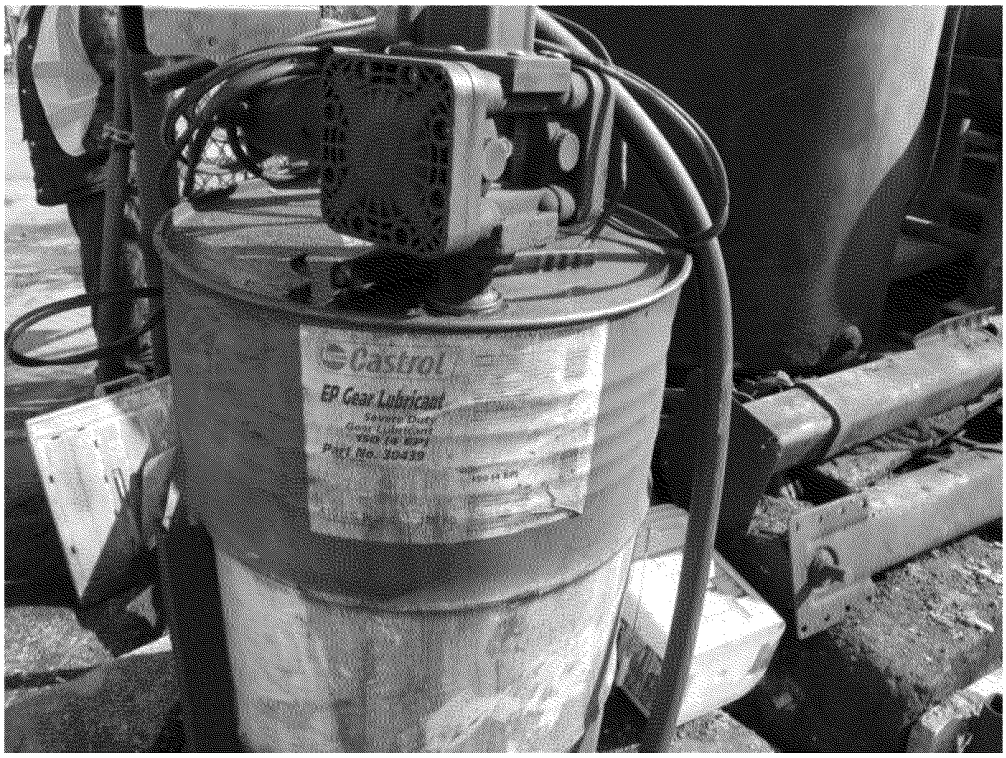
Photograph 3. Barrel on wooden pallets at Entrance 1 of the site.

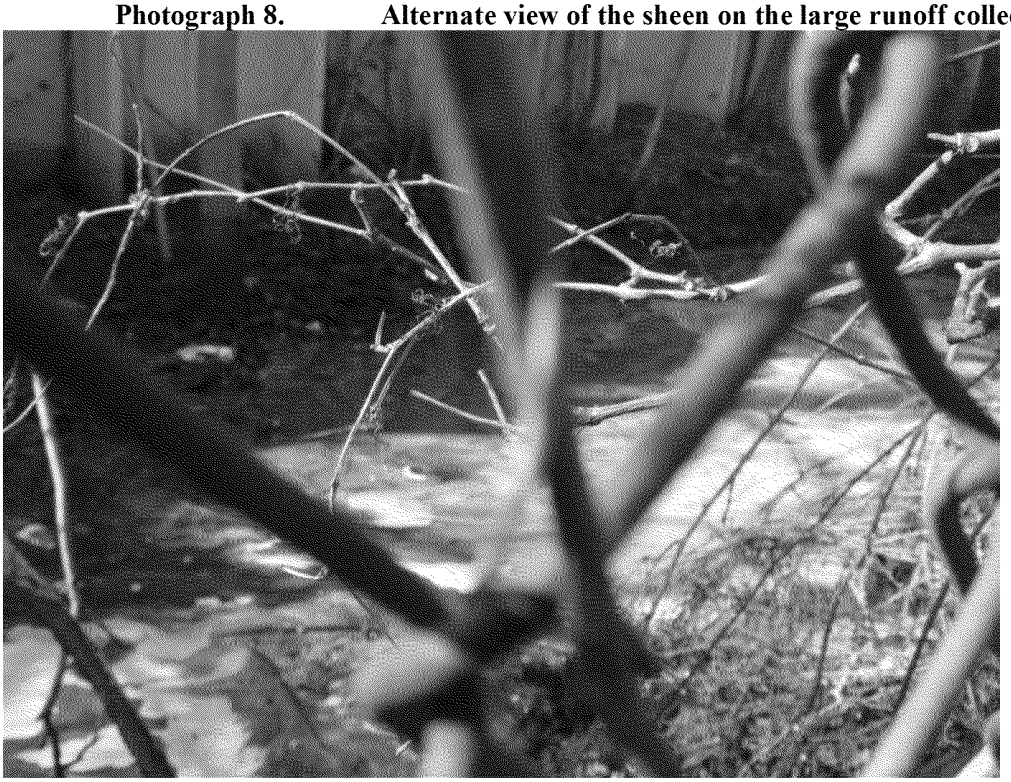
Photograph 8. Alternate view of the sheen on the large runoff collection pond.

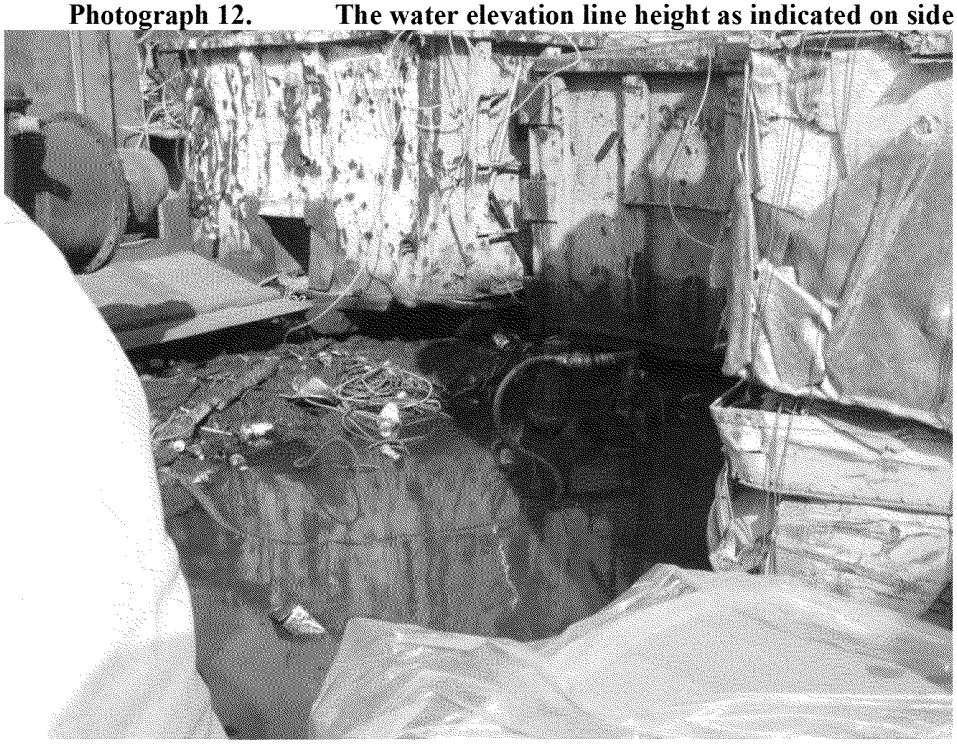
Photograph 12. The water elevation line height as indicated on side of the building.

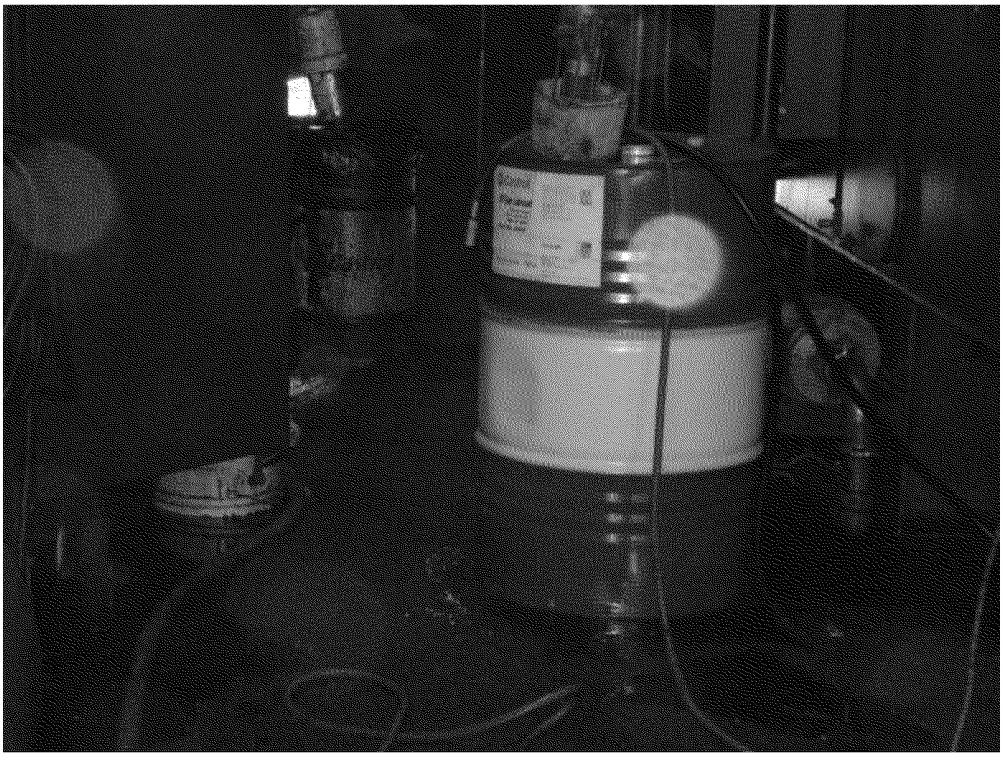
Photograph 21. Alternate view of Photograph 20.

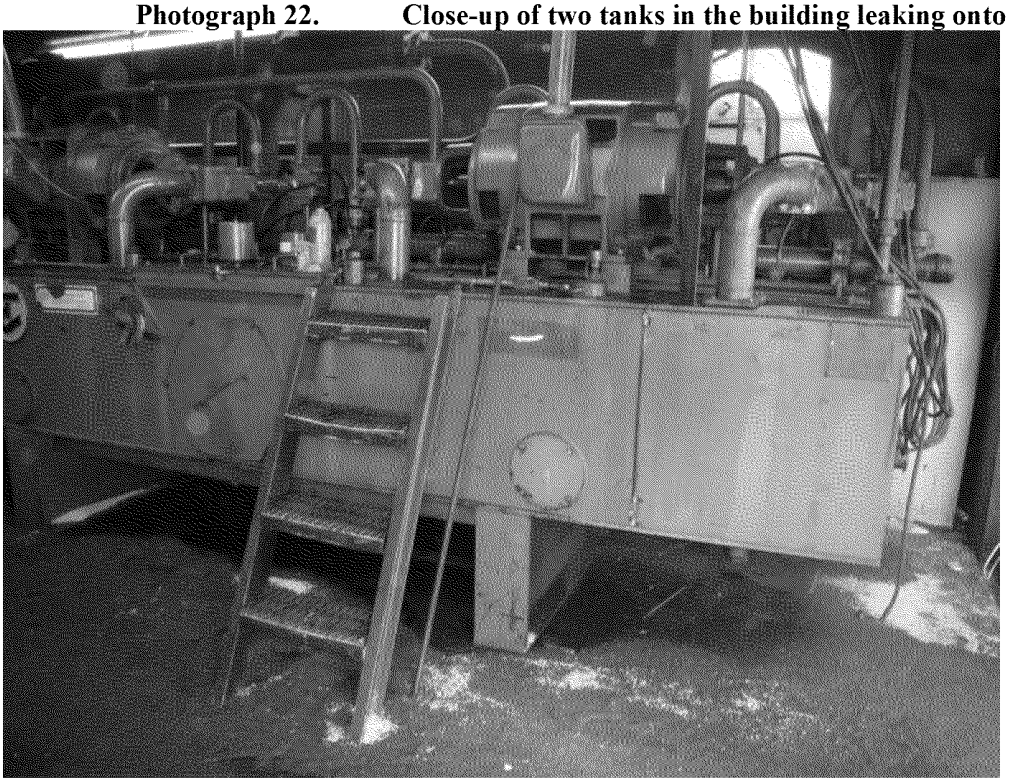
Photograph 22. Close-up of two tanks in the building leaking onto the floor.

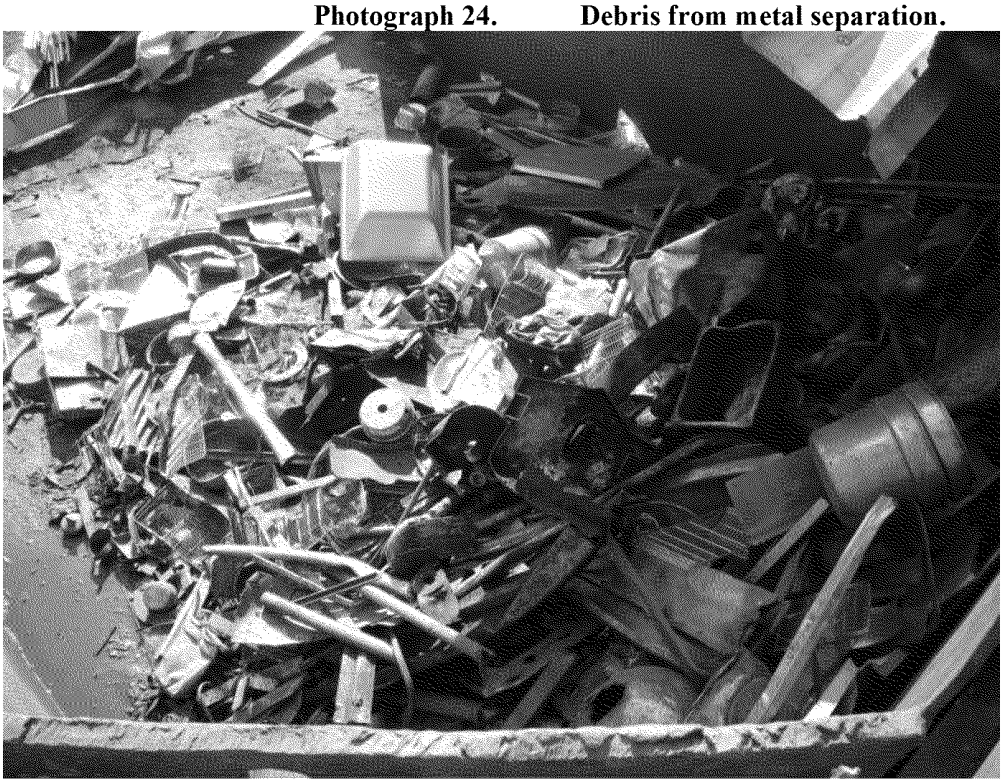
Photograph 24. Debris from metal separation.

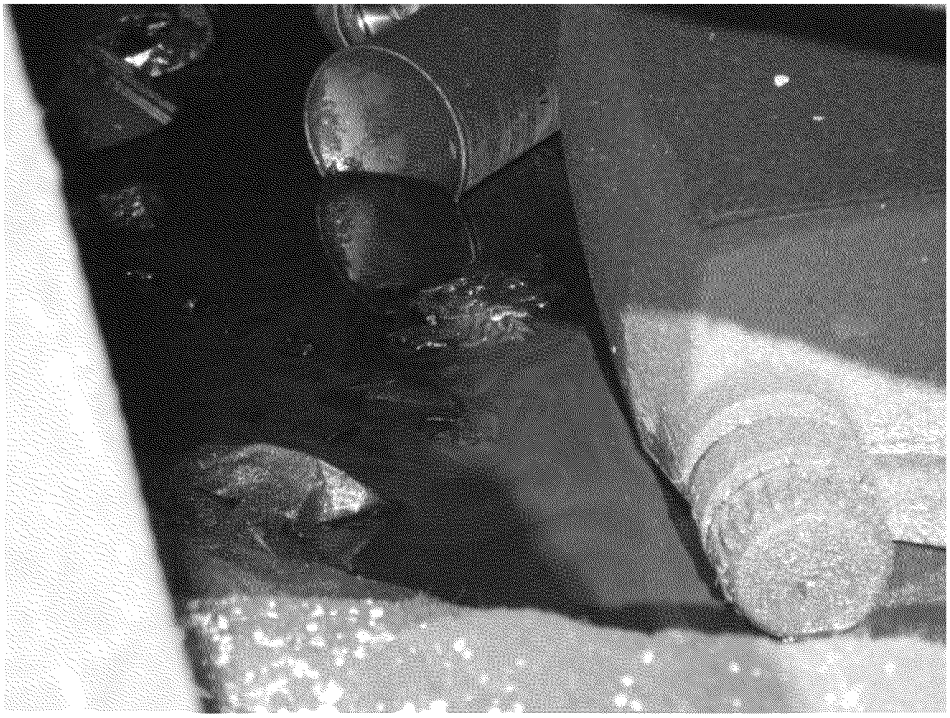
Photograph 67. Close-up view of what appears to be oil pooled under tanks near Entrance 1.
