Illicit Discharge Investigation Report

Case Number: 100330
Complaint: Routine monthly facility inspection
Location: 1711 1st St., SW (Super Salvage, Inc.)
Date Incident Reported: March 30, 2010
Date of Investigation: March 30, 2010
Name of Inspector(s): Ibrahim Famuditimi and Jacob Zangrilli

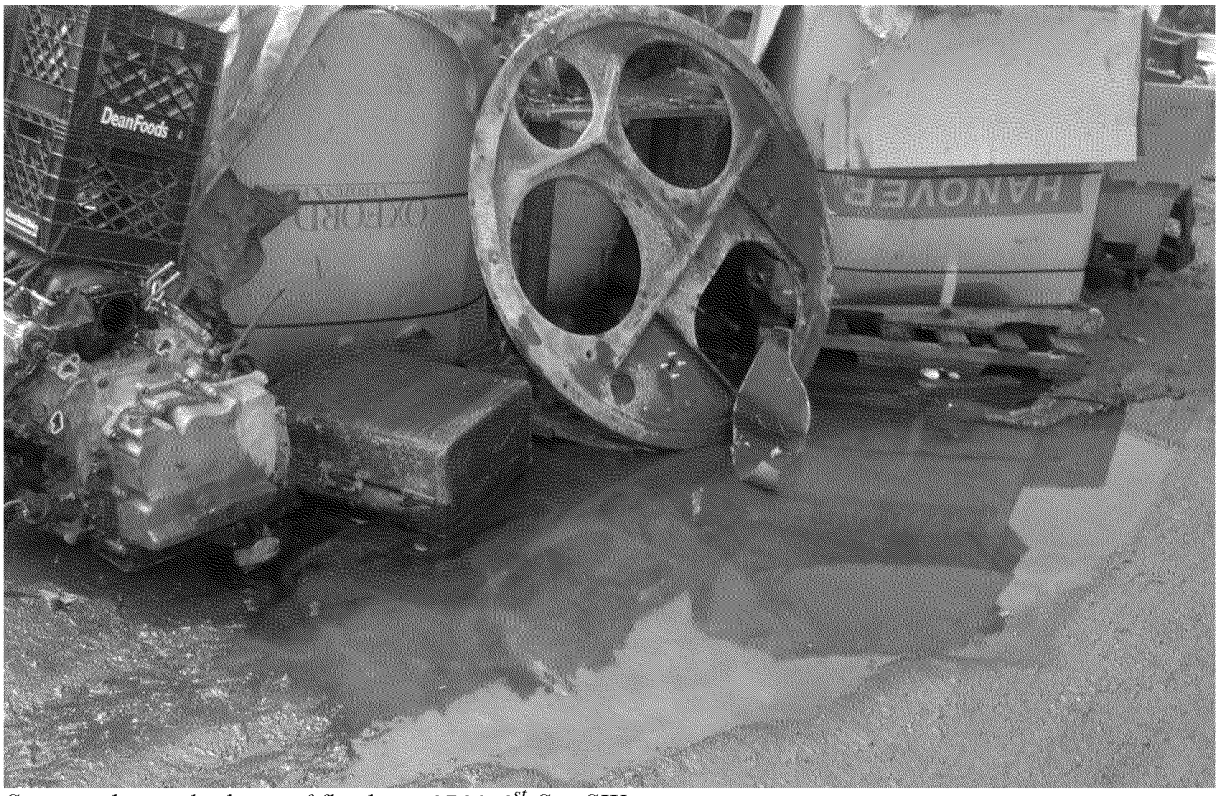
Best management practices and spill prevention plans by Super Salvage Inc were very poor or non-existant as there is no visible evidence of any forms of absorbent materials being used to clean spills. The maintenance of disposal records and manifests was found to be poor.

Waste material storage at 1711 1st St., SW

Water Quality Division inspectors are recommending that we have a multi-media inspection that also includes other District and Federal agencies. Directives should be issued to prevent future contaminated runoff from impacting ground or surface water in the District.

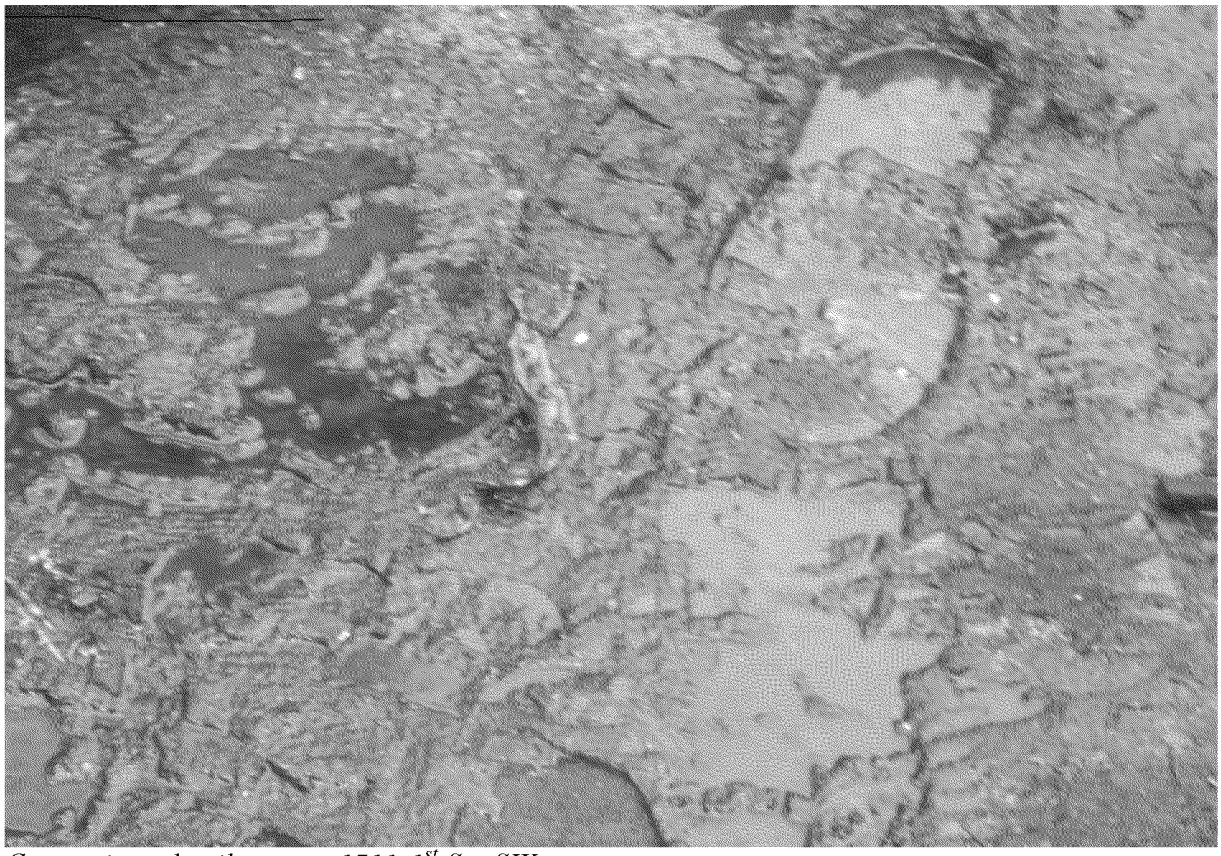
Inspectors noticed various types of fluids leaking from storage boxes left on the grounds of the property, automotive parts, and also from buildings on the property. Upon asking why fluids were coming out of the buildings, inspectors were told that they had a malfunction with the hydraulic equipment the day prior, and they are working on fixing that problem. During the time of inspection, the hydraulic equipment was turned off. Inspectors also noticed what seemed to be a concrete hole in the ground. Mr. Bullock told inspectors it was used for collecting runoff fluids on the property. Mr. Bullock stated that this "runoff collection unit" is later pumped into the pond of the back of the building. An employee on site disagreed with Mr. Bullock and said that contractors came to pump liquids from the concrete hole, and that it was a closed catchment system. When asked to see documentation that such fluids are been picked up, Super Salvage was unable to locate the paper work.

Equipment building with fluids coming out it at 1711 1st St., SW
