Appendix B
Photograph Log and Photographs

Photograph Log

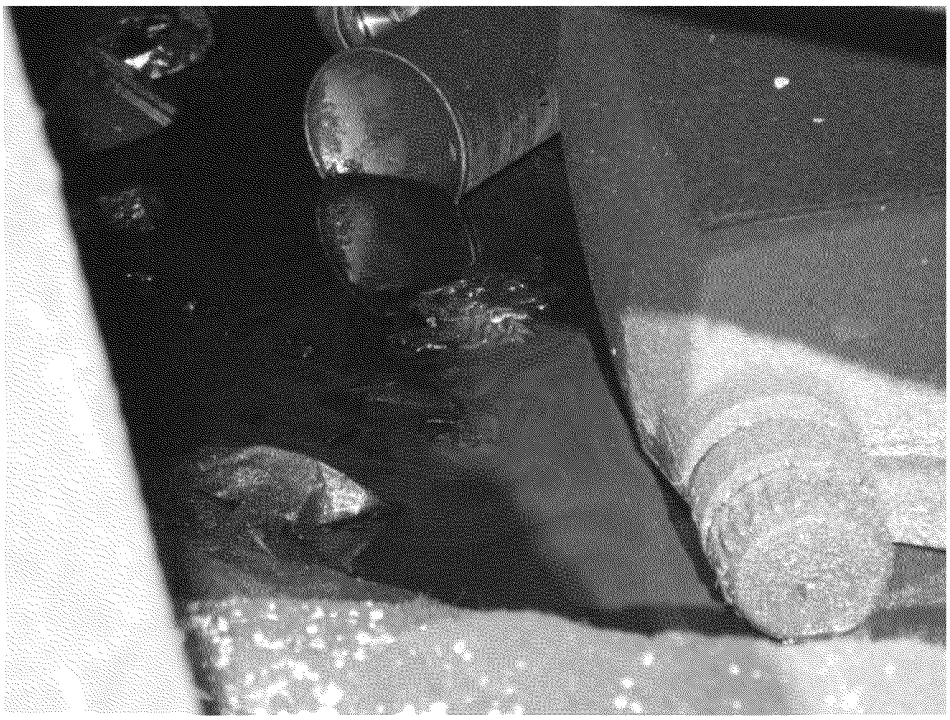
Photograph 67. Close-up view of what appears to be oil pooled under tanks near Entrance 1.
