XRF Results – 5/28/2013

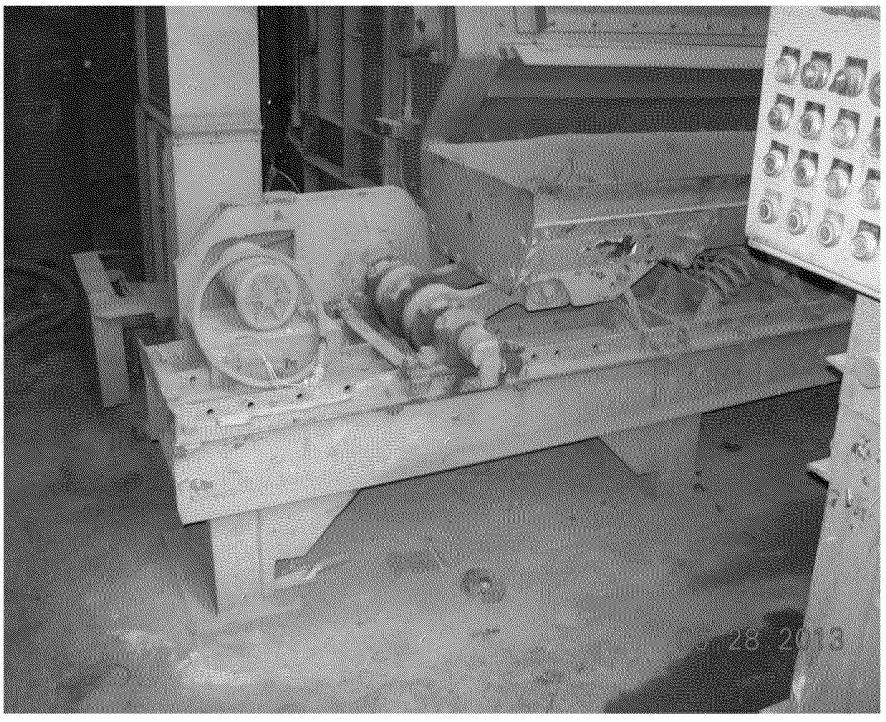
Photo No. 123

Reading # 8 – dust on floor behind blast unit - left side (See Photo No. 123)

Chromium – 39,372 ppm

Lead – 514 ppm

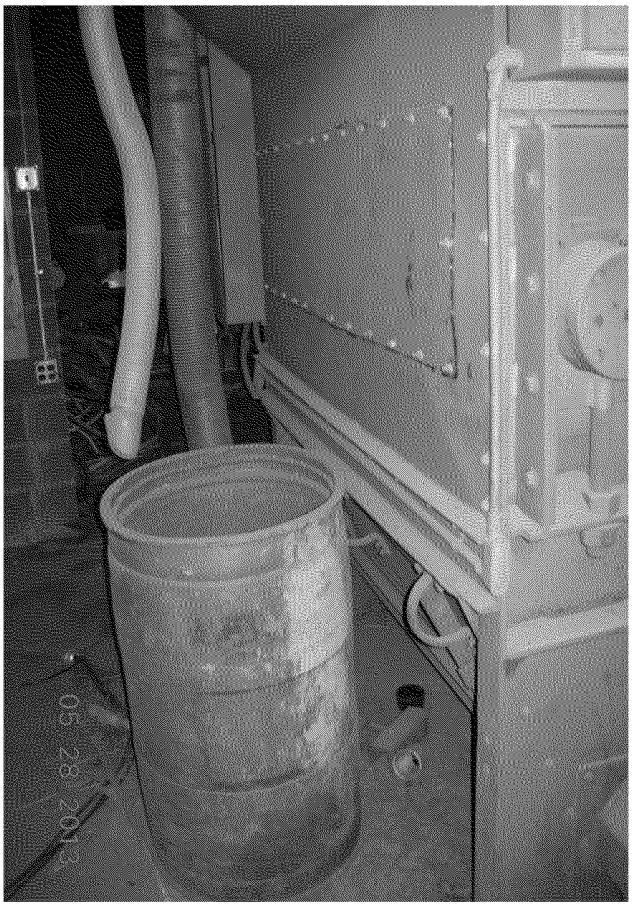
Photo No. 124

Reading # 5 – dust on floor in front of blast unit - left side (Photo No. 124)

Chromium – 39,977 ppm

Lead – 775 ppm
