Illicit Discharge Investigation Report

Case Number: 100330
Complaint: Routine monthly facility inspection
Location: 1711 1st St., SW (Super Salvage, Inc.)
Date Incident Reported: March 30, 2010
Date of Investigation: March 30, 2010
Name of Inspector(s): Ibrahim Famuditimi and Jacob Zangrilli

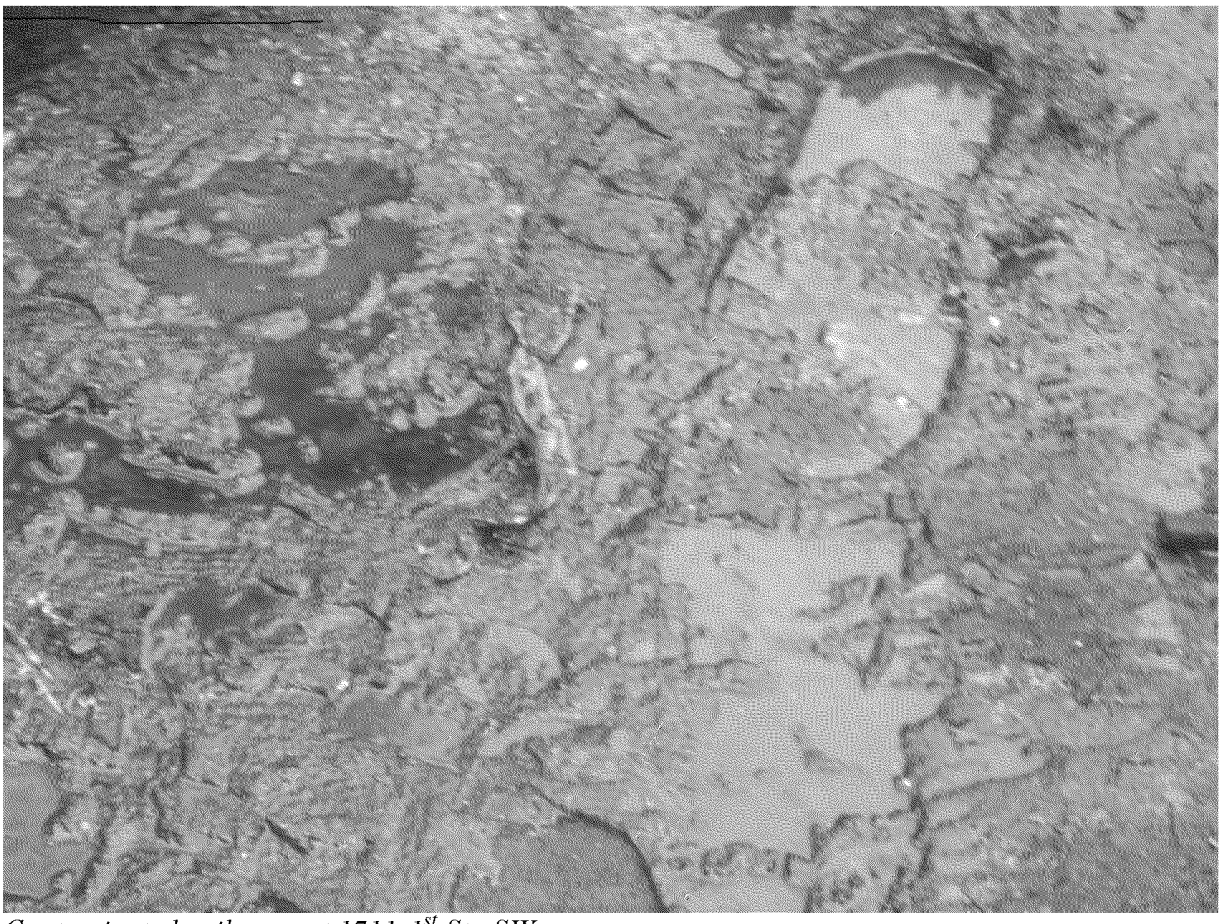
Inspectors noticed various types of fluids leaking from storage boxes left on the grounds of the property, automotive parts, and also from buildings on the property. Upon asking why fluids were coming out of the buildings, inspectors were told that they had a malfunction with the hydraulic equipment the day prior, and they are working on fixing that problem. During the time of inspection, the hydraulic equipment was turned off. Inspectors also noticed what seemed to be a concrete hole in the ground. Mr. Bullock told inspectors it was used for collecting runoff fluids on the property. Mr. Bullock stated that this "runoff collection unit" is later pumped into the pond of the back of the building. An employee on site disagreed with Mr. Bullock and said that contractors came to pump liquids from the concrete hole, and that it was a closed catchment system. When asked to see documentation that such fluids are been picked up, Super Salvage was unable to locate the paper work.

Equipment building with fluids coming out it at 1711 1st St., SW
