UNITED STATES ENVIRONMENTAL PROTECTION AGENCY 9/9/2004

RCRA Corrective Action Order Compliance Report

Facility Name:	Former Rhone Poulenc Facility
Facility EPA ID#:	WAD 009282 2302
Facility Location:	9229 East Marginal Way Seattle, WA
Facility Representatives:	John Ambrose, RCI Environmental Tasha Grey, Geomatrix Sarah Ruston, Geomatrix
Date of Inspection:	August 17, 2004
Date of Report:	September 9, 2004
Report Prepared by:	Shawn Blocker, SBlocker 9/9/04
Inspector(s):	Shawn Blocker, Environmental Scientist US Environmental Protection Agency 1200 Sixth Avenue, WCM-126 Seattle, WA 98101

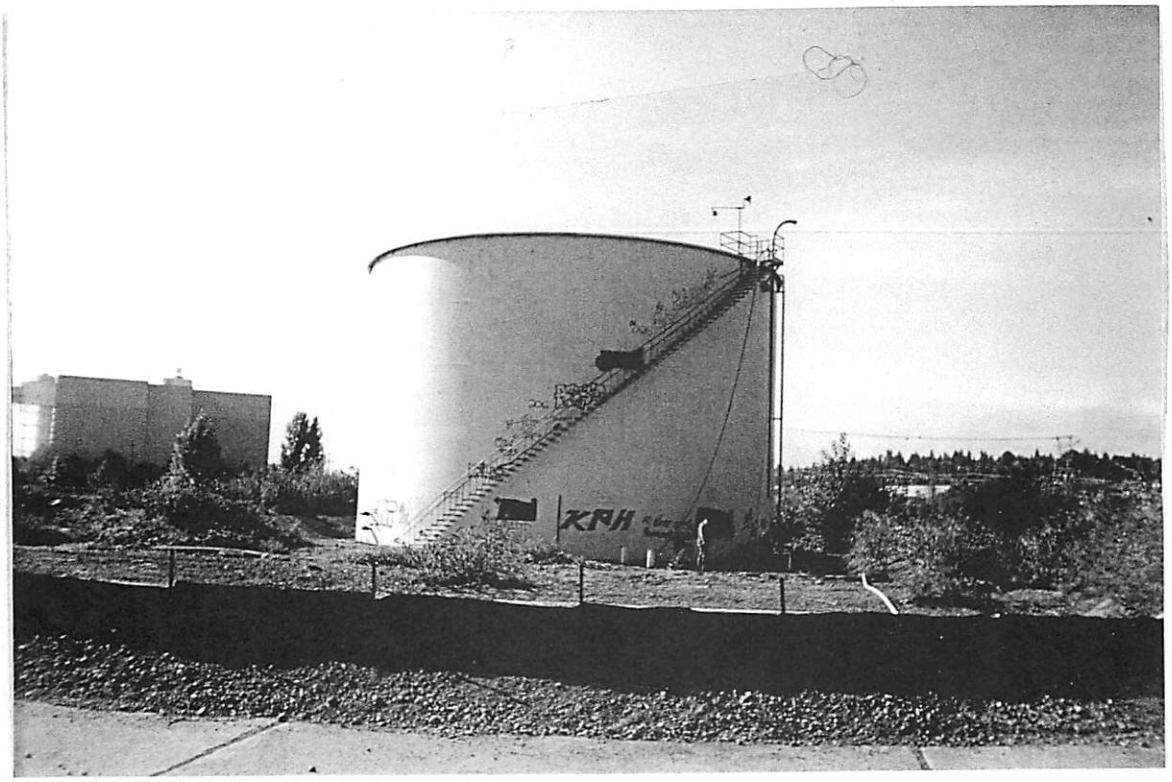
At this time I noticed 4 inch PVC piping on the ground near the large above ground storage tank located on site (photo 1). Upon further inspection, I found two different PVC lines originating from the tank. One line ("Line 1") was connected to a flex hose that went up the side of the tank completely to the top (photo 2 through 4). Line 1 proceeded from the tank in a northwestern direction across a containment berm, at which time it angled 45 degrees and ran directly east into the King County Sewer Lift Station (photo 5 and 6). I observed another portion of missing fence adjacent the lift station (photo 13). The other line ("Line 2") proceeded from near the bottom the tank directly north then turned 90 degrees terminating near the berm. After inspecting Line 2, I proceeded up the stairwell of the tank to the top. At the top, I observed that the flex line associated with Line 1 proceeded down into the tank and into several feet of liquid contained within the tank (photo 7 through 9). The hose was hooked to a submersible pump (photo 9). After observing this I proceeded down the stairs toward the access gate adjacent the Duwamish waterway.

1. Above ground storage tank.

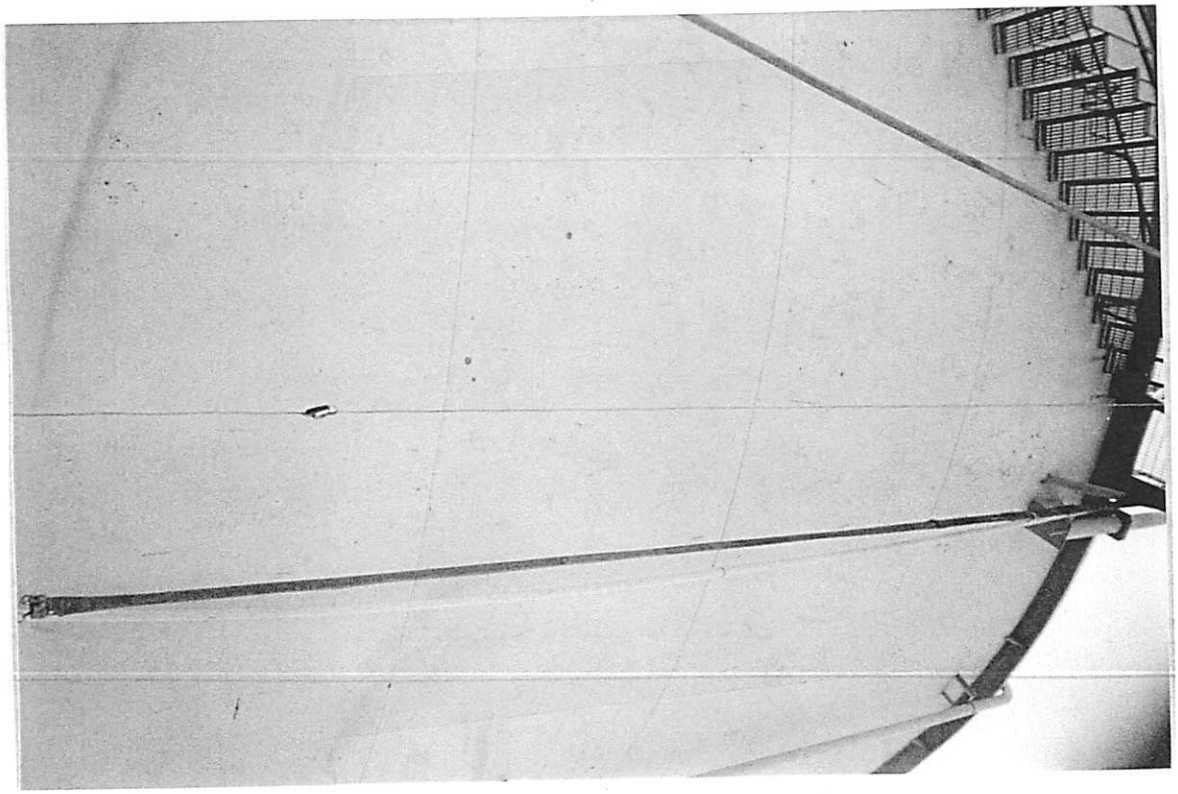
Photo 2. Flexhouse going up and into above ground storage tank.
Photo taken by Shawn Blocker, U.S. EPA
8/17/2004

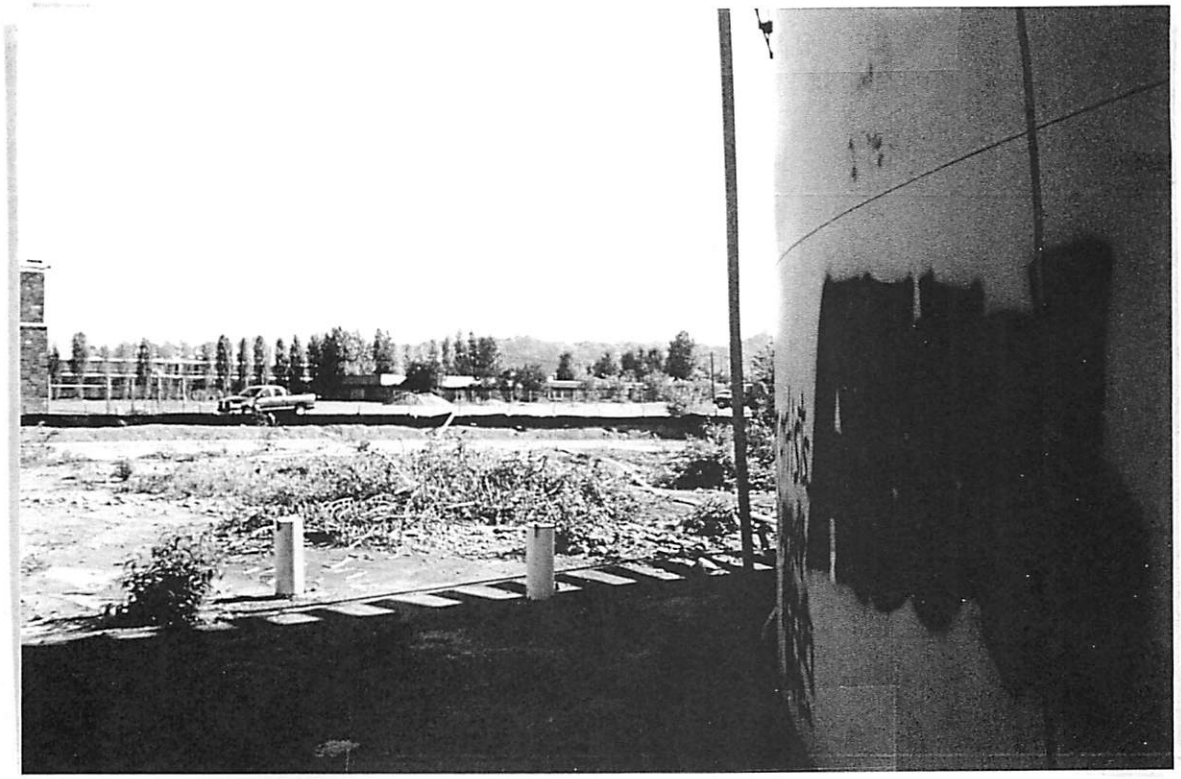
3. Flexhouse going up and into above ground storage tank.

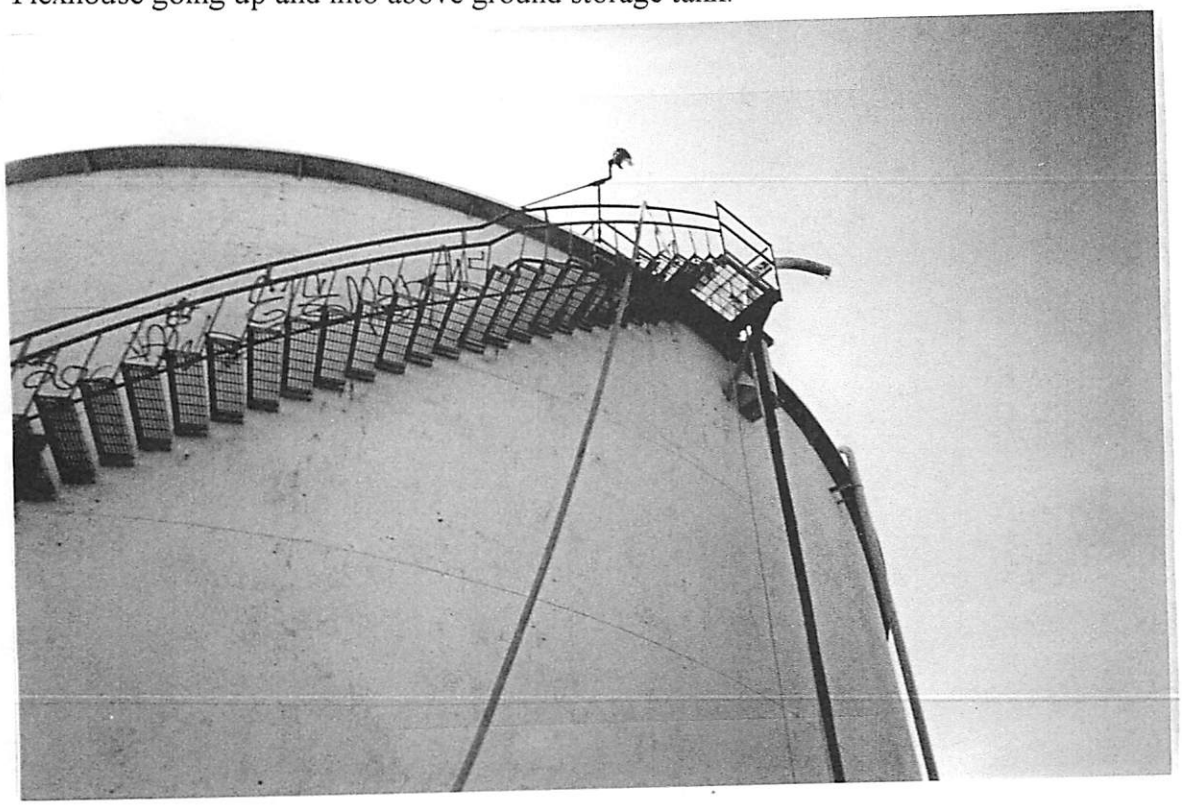
Photo 4. Flexhouse going up and into above ground storage tank.
Photo taken by Shawn Blocker, U.S. EPA
8/17/2004

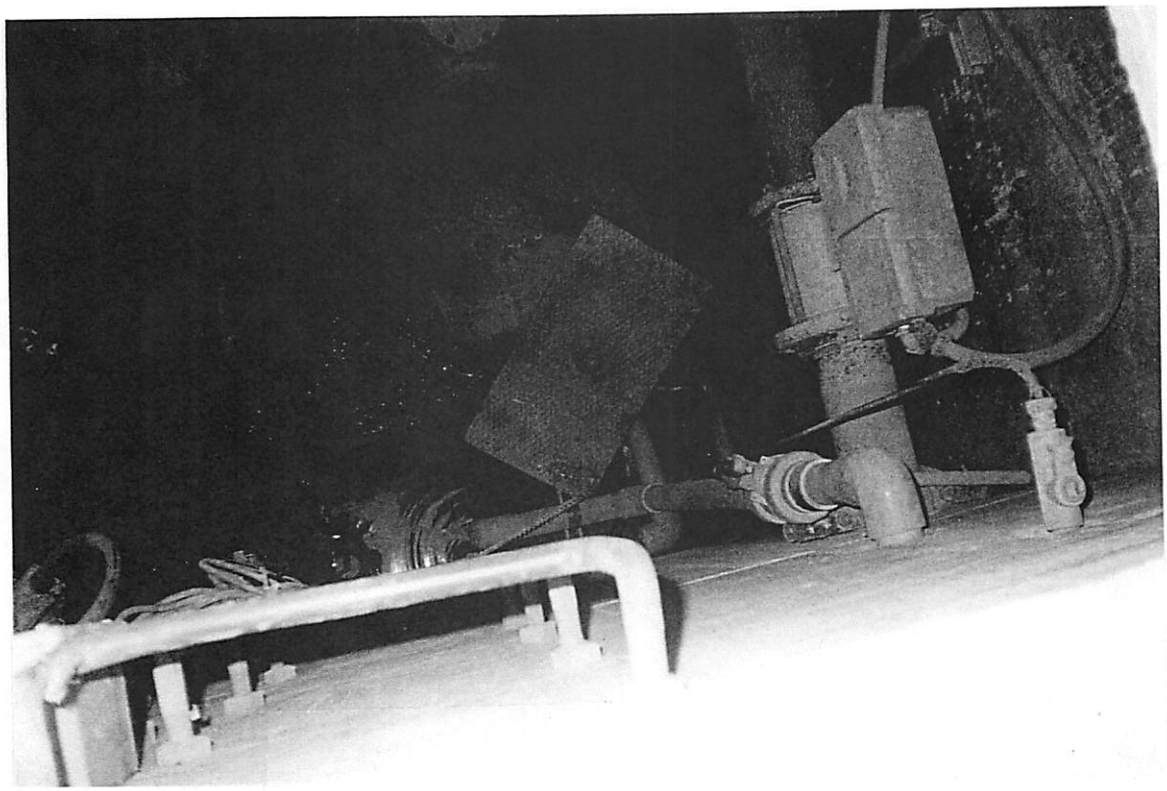
5. Photo inside King County Sewer Lift Station.

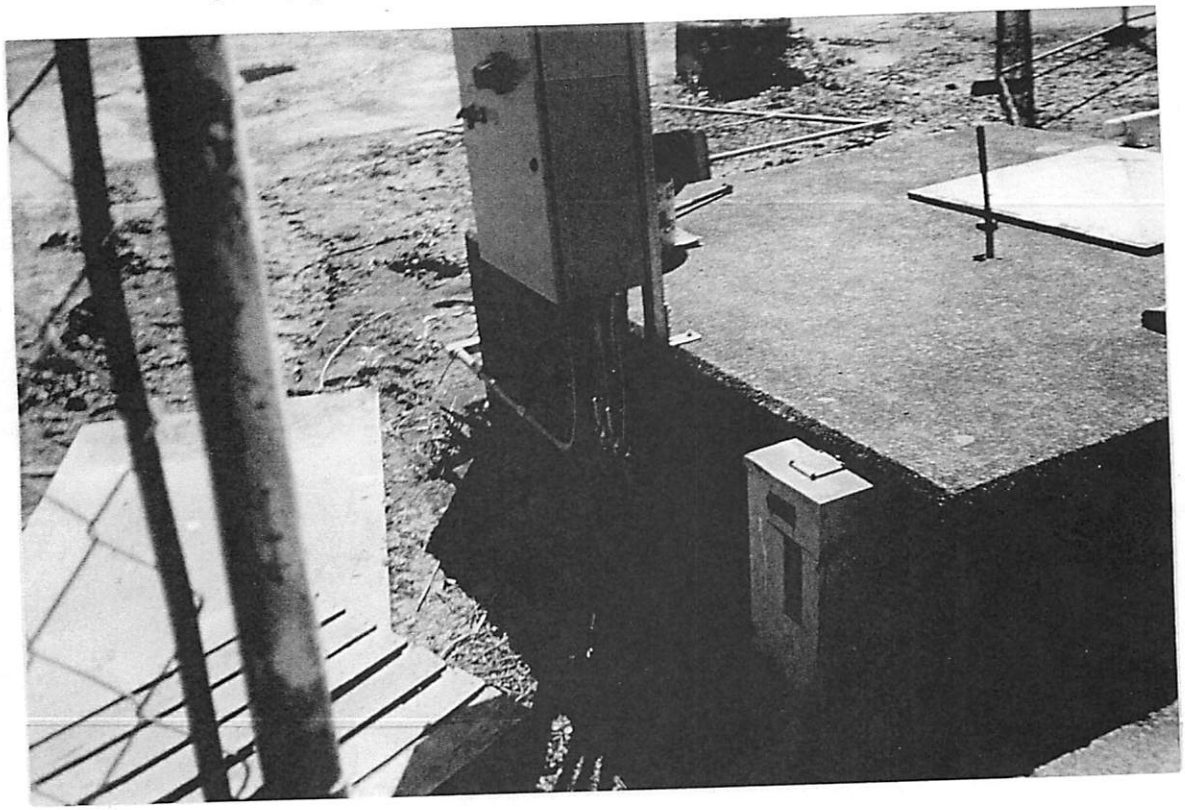
Photo 6. Photo of King County Sewer Lift Station.
Photo taken by Shawn Blocker, U.S. EPA
8/17/2004

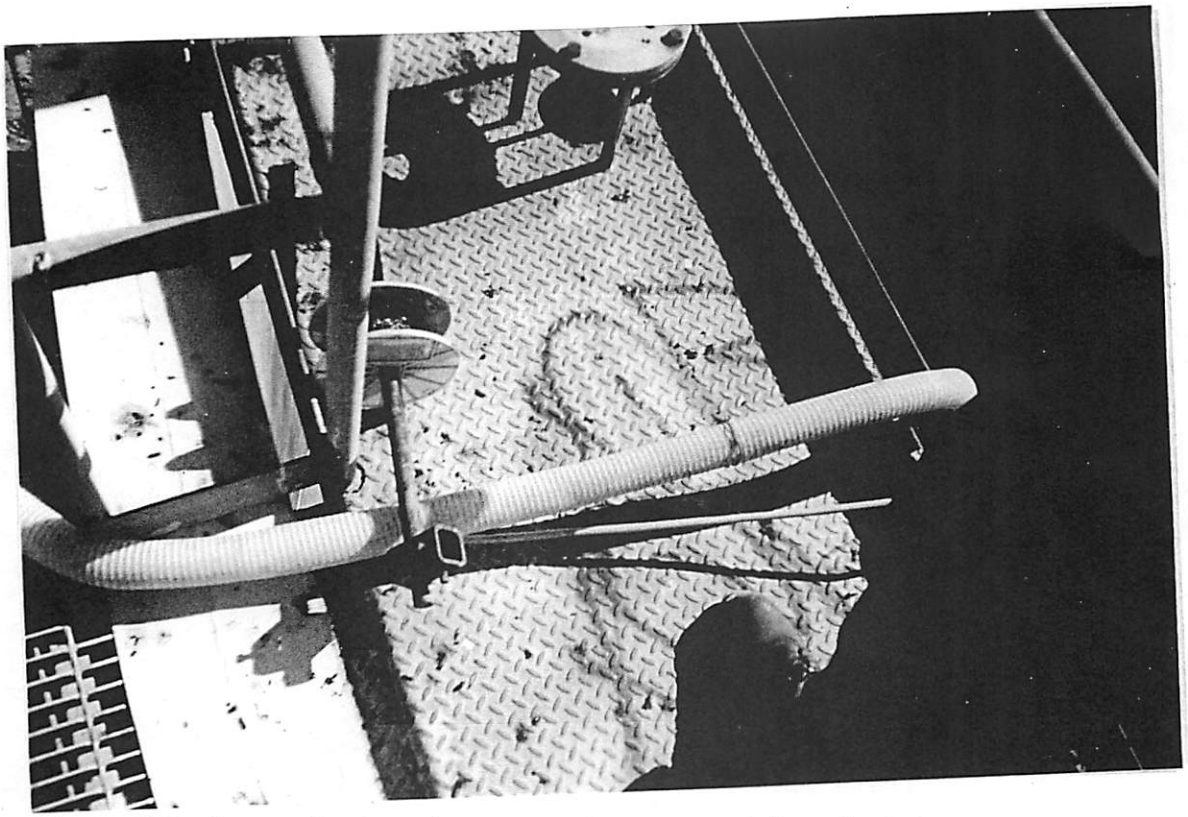
7. Photo of flex hose going into above ground storage tank from the top.

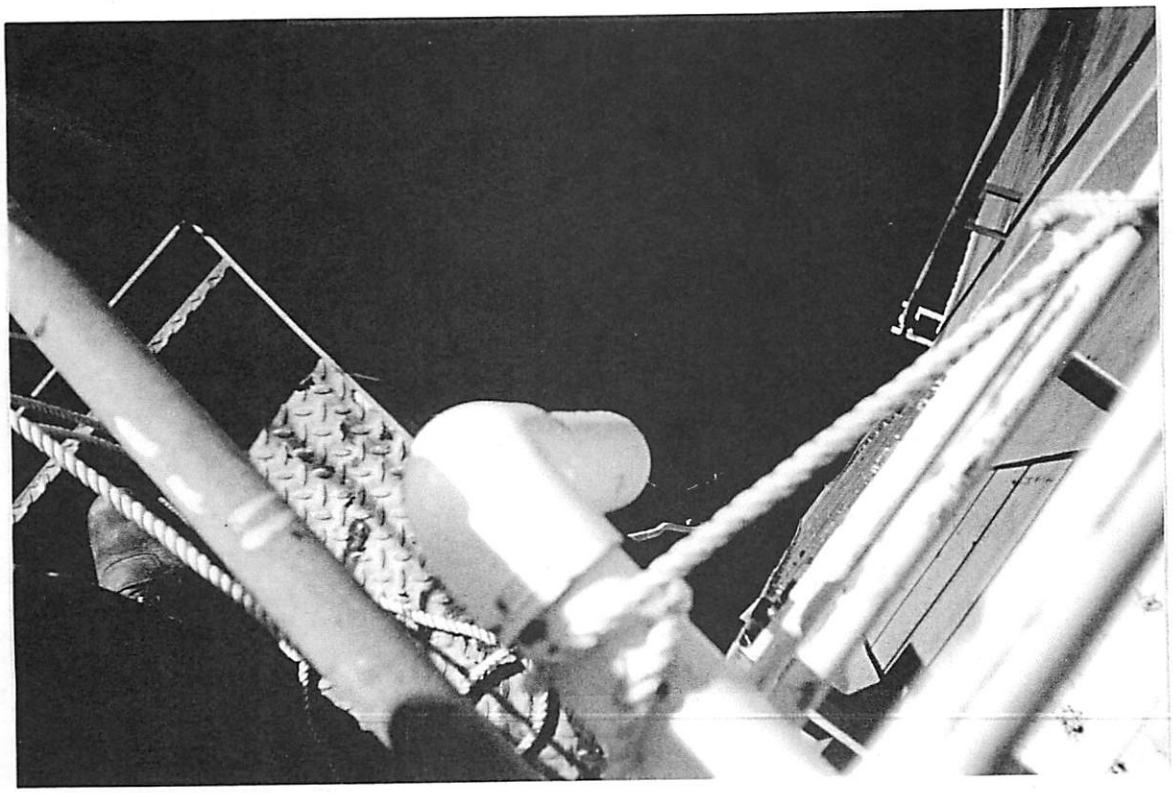
Photo 8. Photo of flex hose going into above ground storage tank from the top..
Photo taken by Shawn Blocker, U.S. EPA
8/17/2004

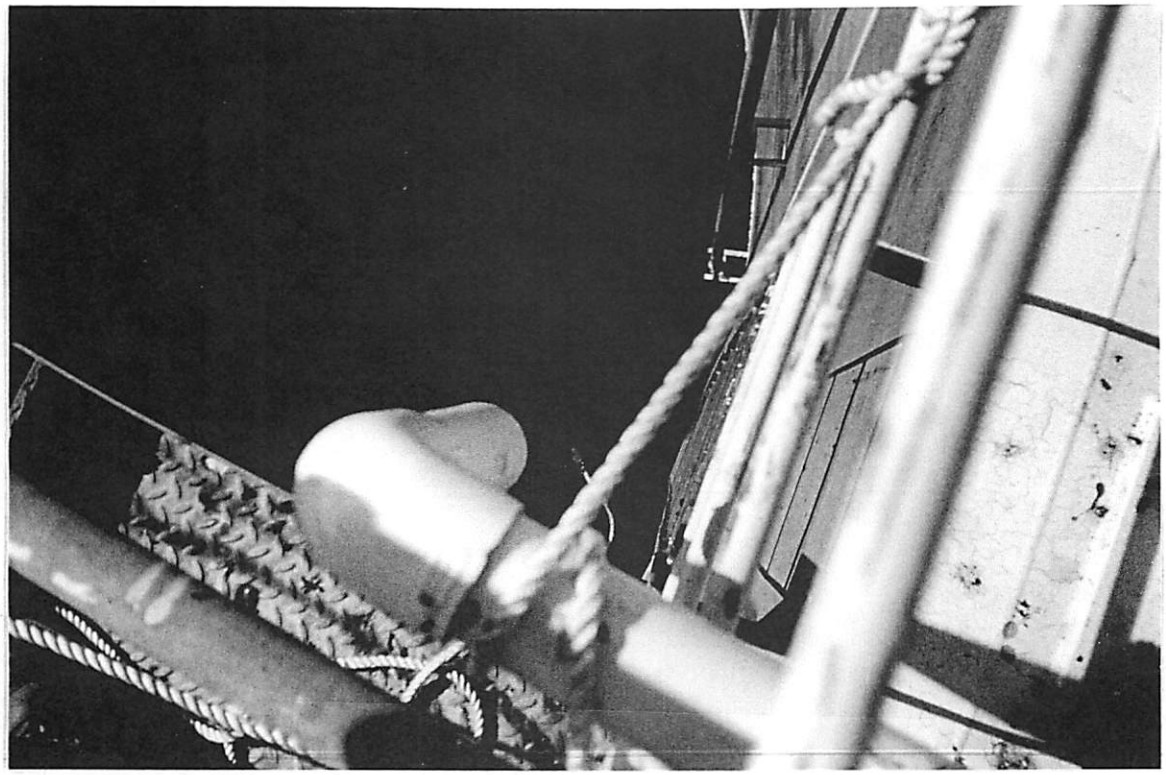
9. Photo of hose going into above ground storage tank from the top.

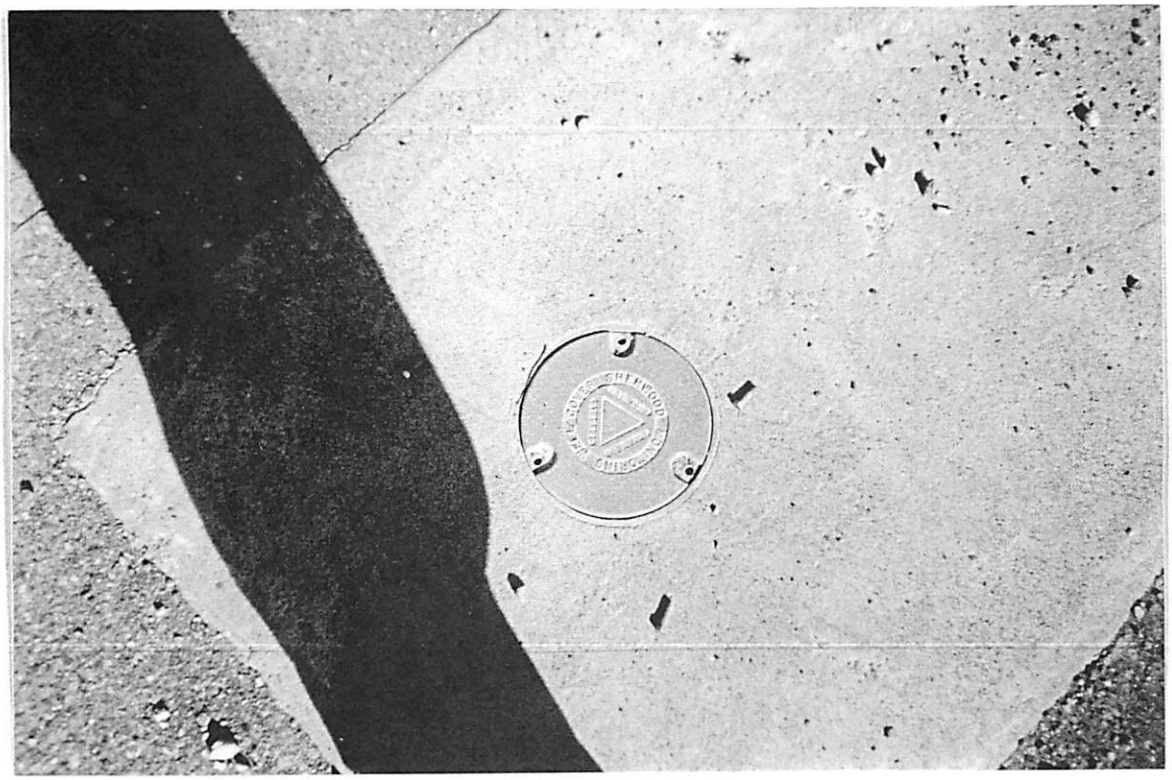
Photo 10. Photo of well cover not properly bolted down.
Photo taken by Shawn Blocker, U.S. EPA
8/17/2004

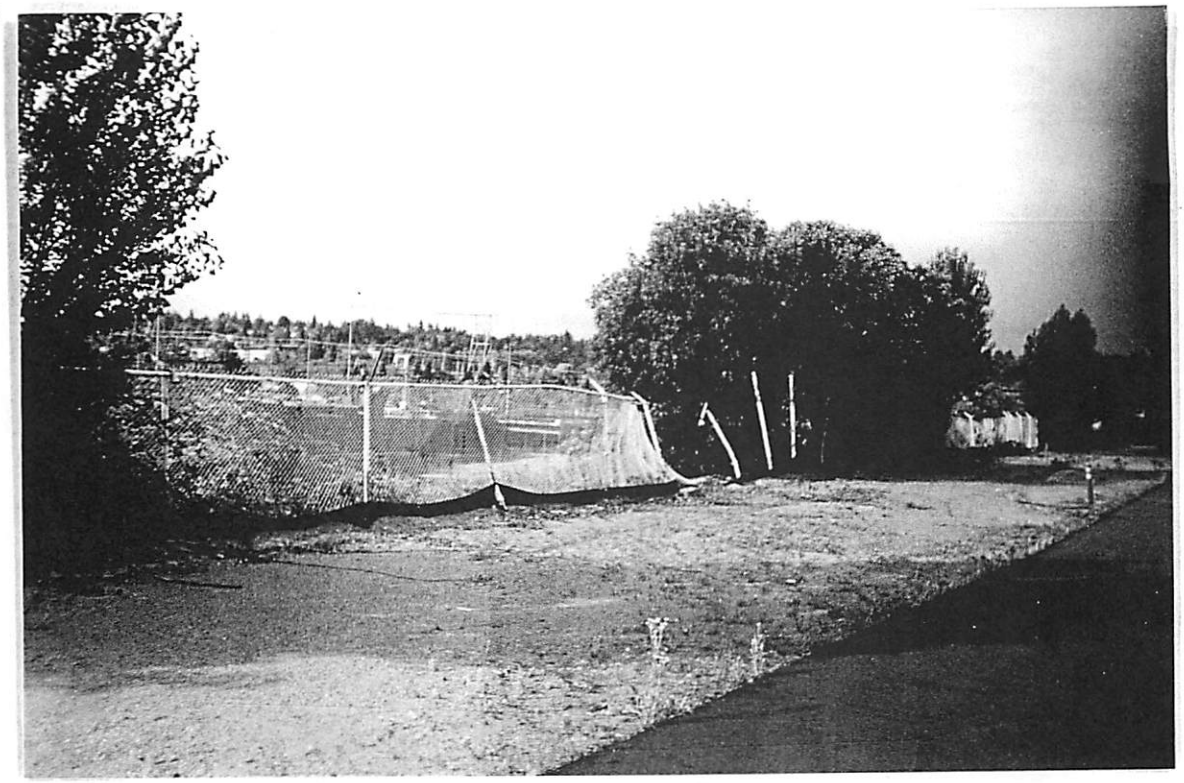
11. Missing fence along slip 6.

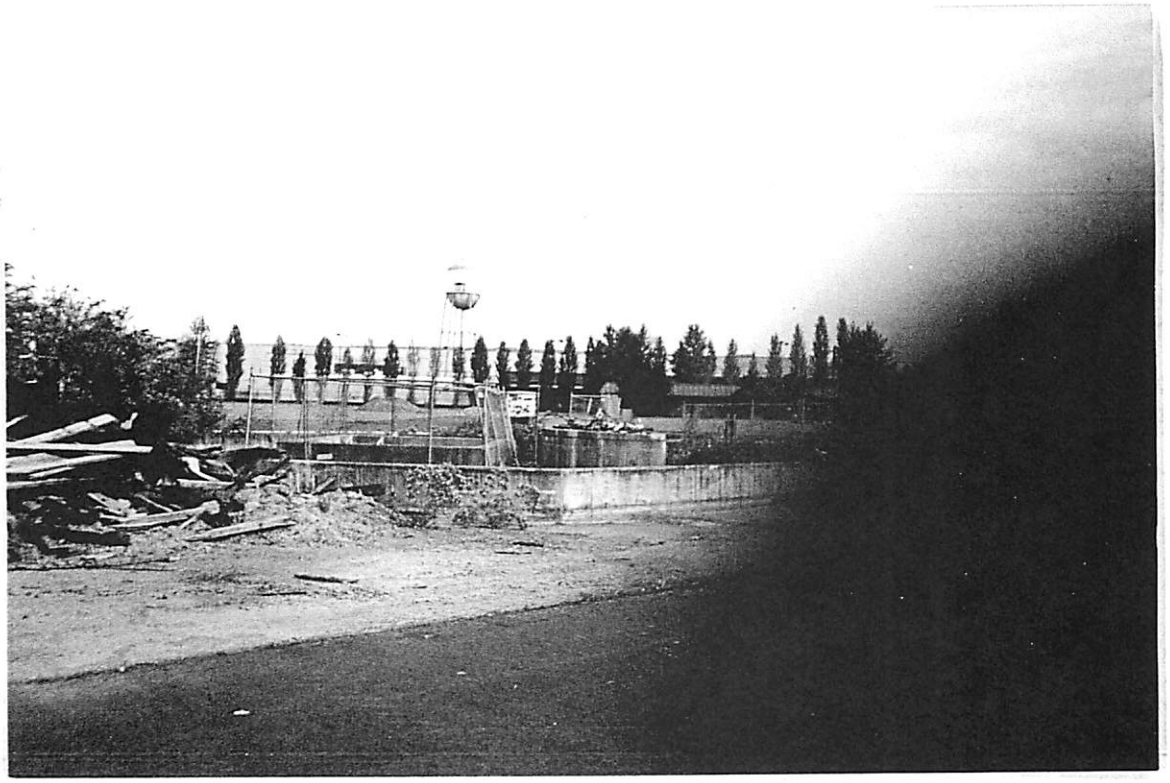
Photo 13. Missing fence near lift station.
Photo taken by Shawn Blocker, U.S. EPA
8/17/2004
