2.1 Mid Atlantic Environmental, Inc. conducted an inspection on Tank #8 at the Red Hill Underground Storage Facility, Pearl Harbor, Hawaii. This inspection was conducted in accordance with the scope of work identified by Contract Number N00604-97-R-0013, PRL 96-21, titled "Emergency Repair for Red Hill Tanks."

RED HILL TANK NO. 7
PRODUCT: DFM

Drawing Title:
Bottom Layout with Pit Indications

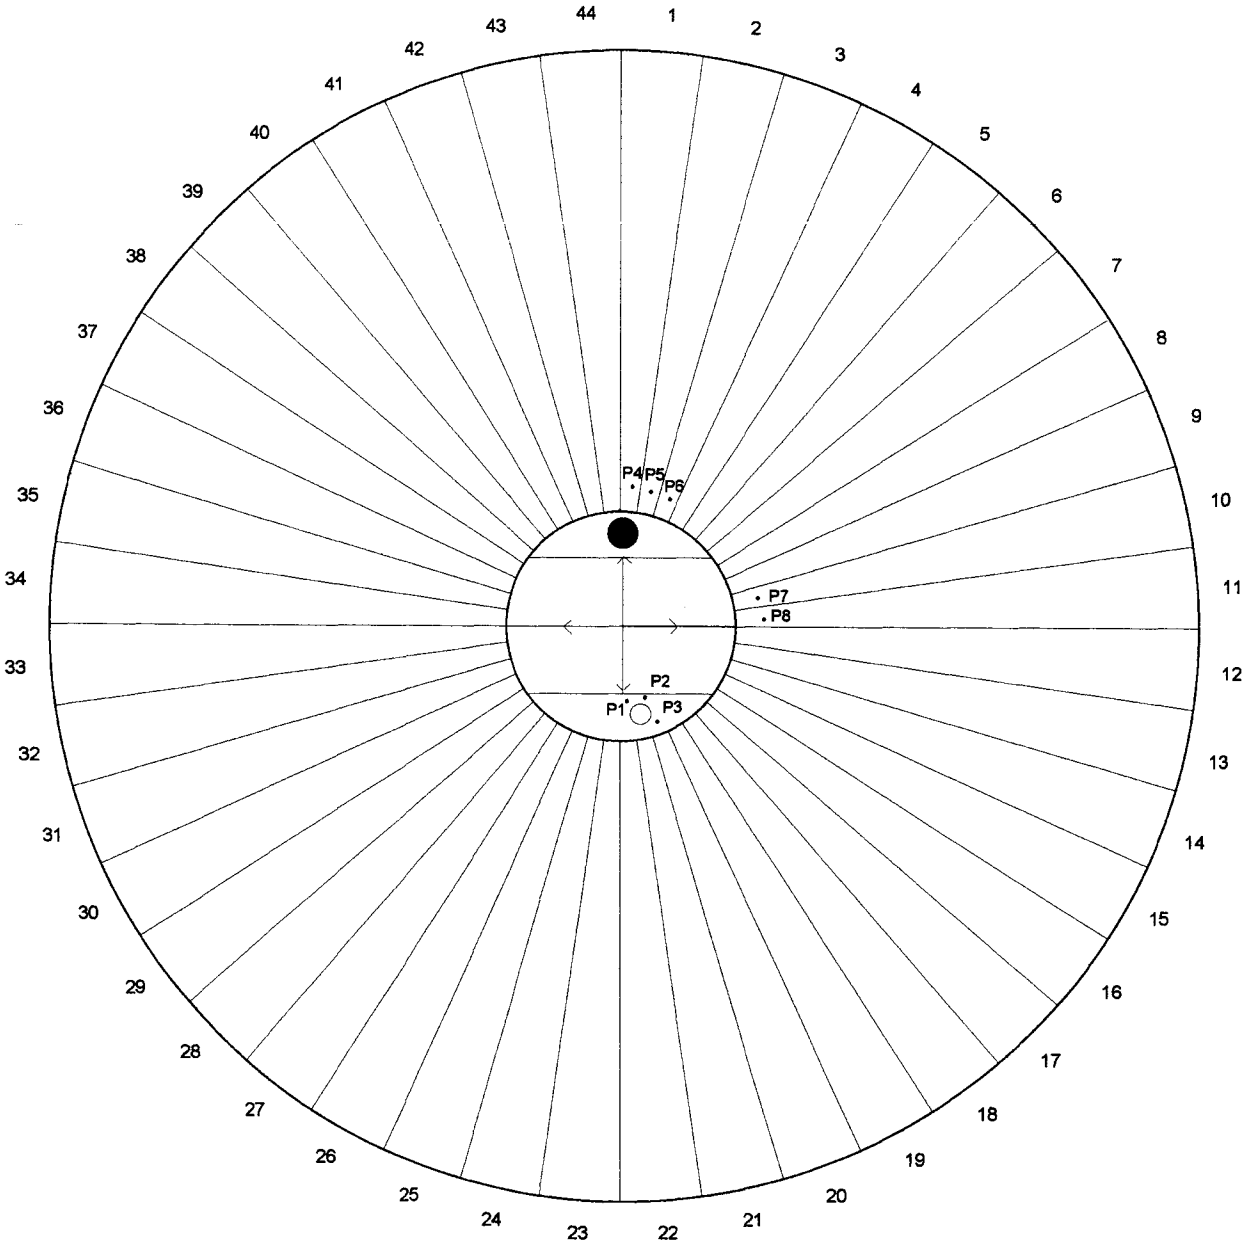
7.2.1 The original bottom thickness was determined to be 0.500 inches and the first ascending plate to be 0.250 inches. The ultrasonic thickness measurements taken determined that backside corrosion in this area is not a problem. Pitting is not a problem since the remaining metal thickness is well within the 0.10 inches of metal required by API Standard 653 by the next inspection. Also the coating to be applied to the tank bottom should prevent any increase in pit depth. Although pitting is not a problem with regard to structural integrity, it did present a problem regarding the coating to be applied. Pictures of this pitting are included with this report. The surface contamination test results yielded 0% ferrous salts, 32 ppm Nacl and a ph level of 7. These results are within the limits set forth in the KTA SCAN Kit tecnical data and the NACE tecnical committee report on Surface Preparation of Contaminated Steel Surfaces. The Caustic Soda test of the tank bottom indicated that all Flame Sprayed Aluminum had been removed. By visual inspection, scattered pitting was observed on the tank bottom and first ascending plates. The deeper pits were measured and recorded on the Bottom Layout With Pit Indications drawing.

P1 = 0.120
P2 = 0.160
P3 = 0.120
P4 = 0.119
P5 = 0.075
P6 = 0.071
P7 = 0.090
P8 = 0.125
