OVERFLOW NO. 020
CLIFTON ST. @ QUINNIPIAC AVE
NEW HAVEN, CONNECTICUT

3600 Site Report

Project/Phase: New Haven, CT CSO Date: 8/28/97 Name: MPN

Address/Location: Quinnipiac Ave And Clifton St.

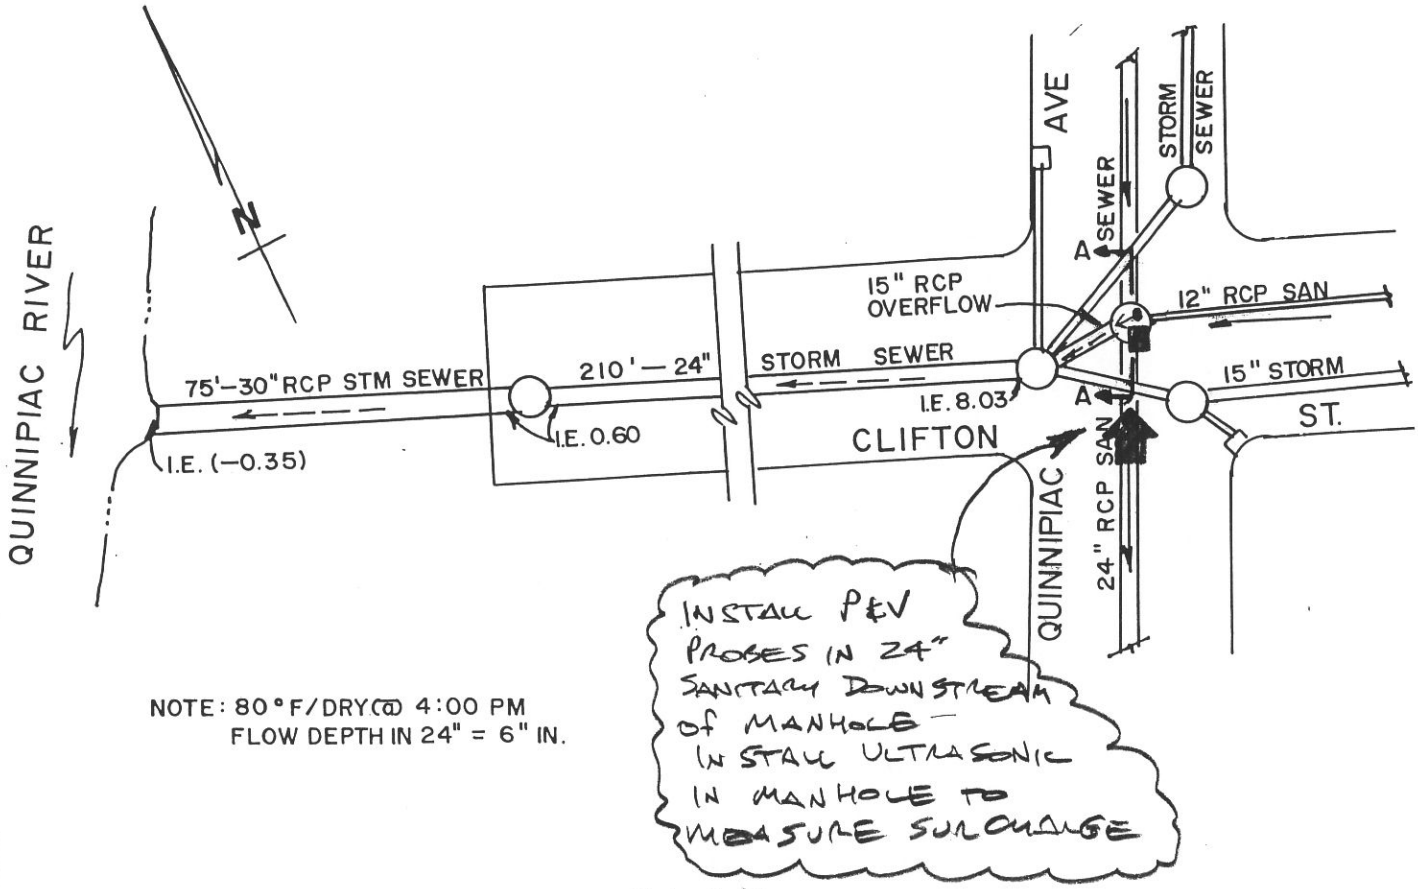
PLAN

NOTE: 80°F/DRY @ 4:00 PM
FLOW DEPTH IN 24" = 6" IN.

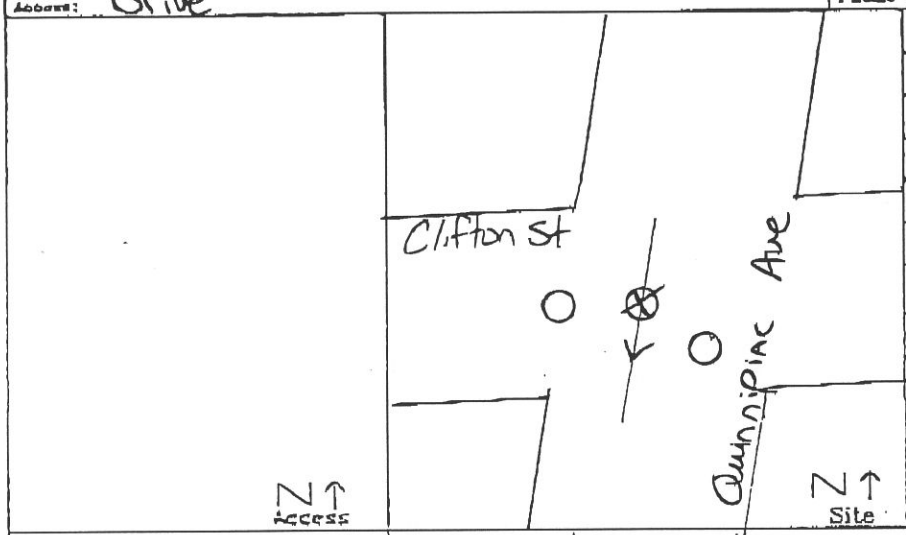
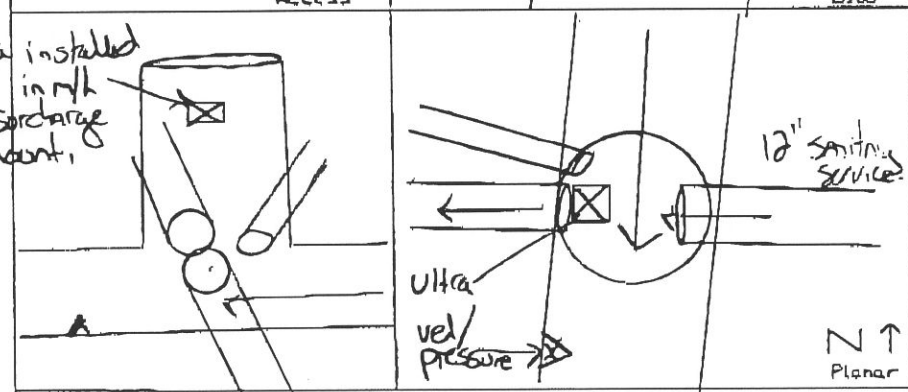
Ring and crank assembly w/ vel and pressure installed downstream of manhole. Ultrasonics installed on surcharge mount in manhole.

Manhole Condition: Good

Hydraulics: Good Laminar Flow; 12" Sanitary Connection not providing enough turbulence to effect flowmeter installed d/s.

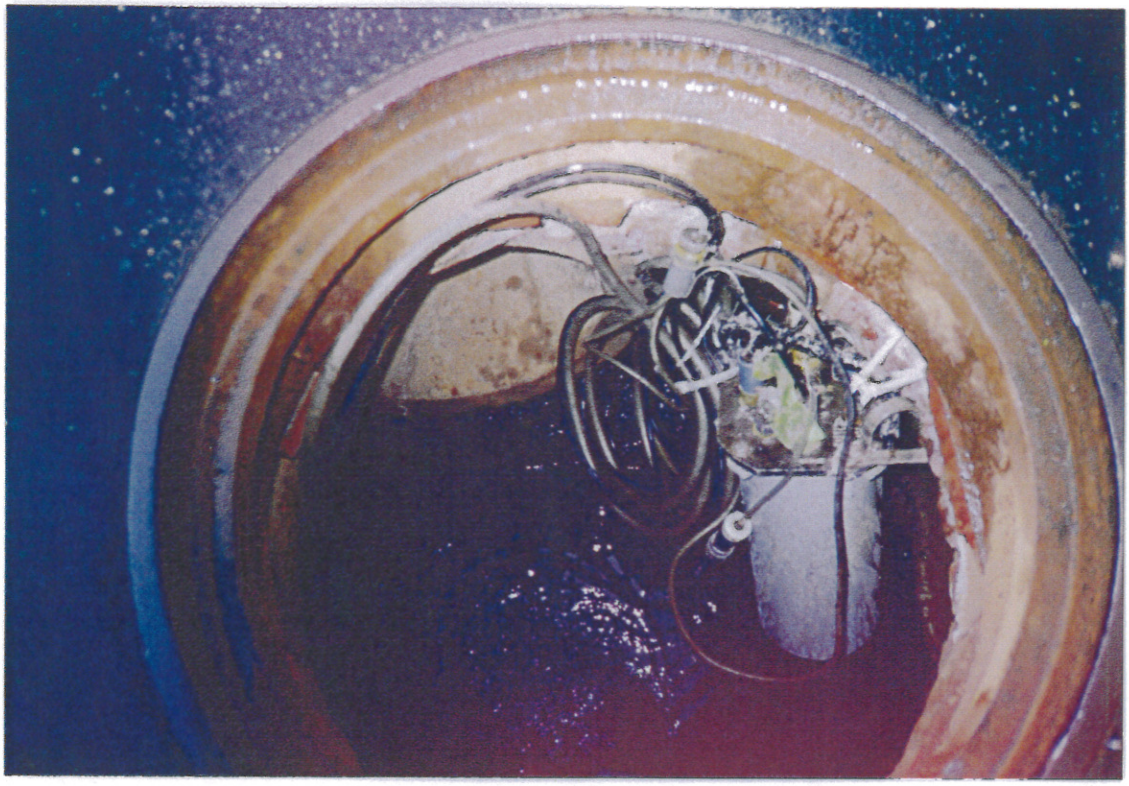
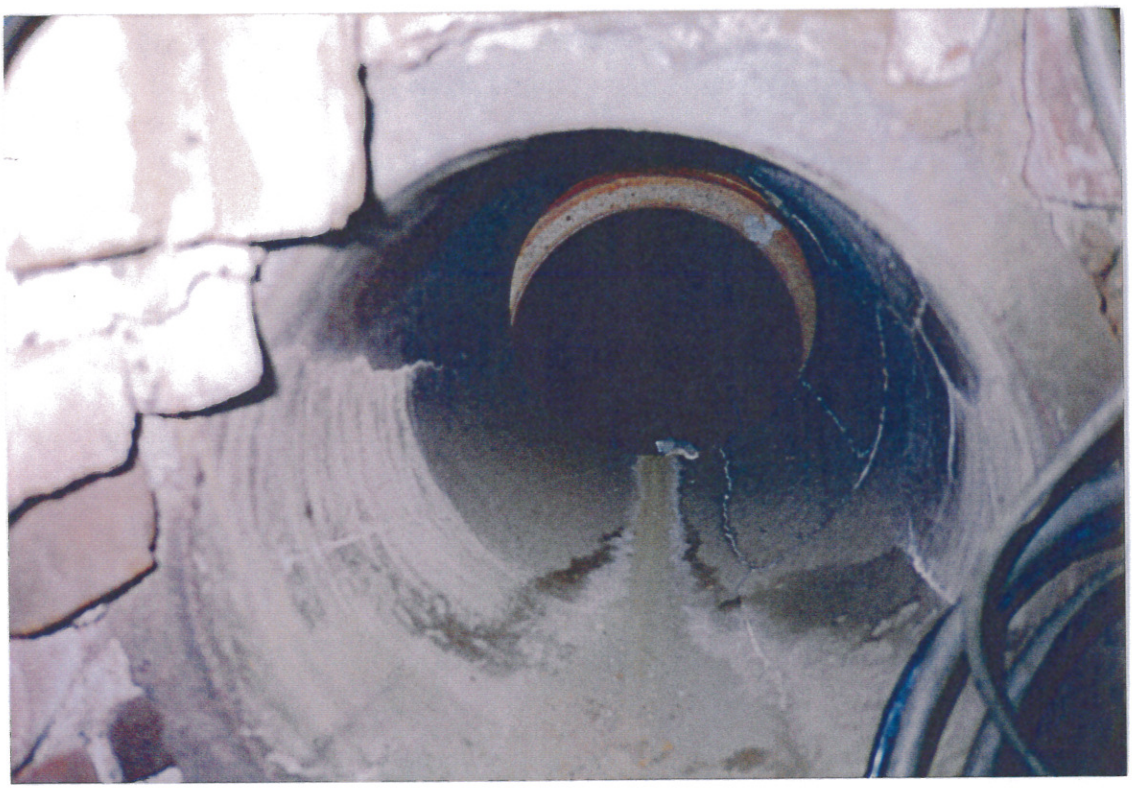
Good 1500 monitoring site

Upstream Manhole: Does not Isolate
