ABANDONED OR INACTIVE URANIUM MINES IN NEW MEXICO

A report of investigation carried out between August 1979 and May 1980 under contract with the New Mexico Energy and Minerals Department.

New Mexico Bureau of Mines and Mineral Resources
Open-File Report 148

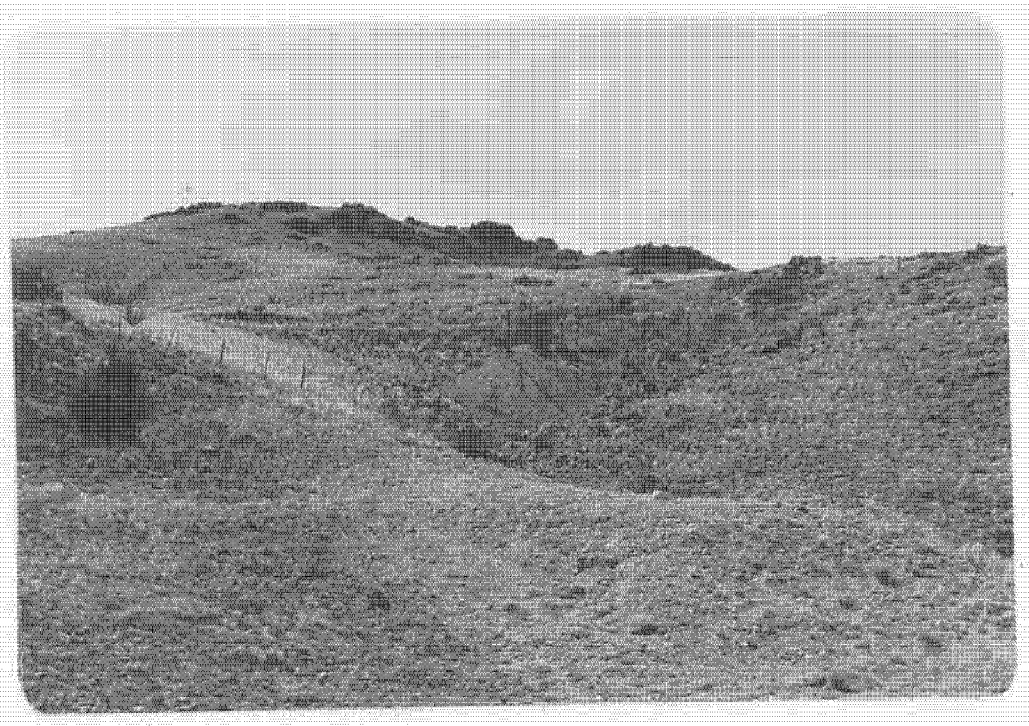
(photo a) Looking southwest toward the Junio mine area; note conical mine dump at center photo crossed by barbed wire fence.

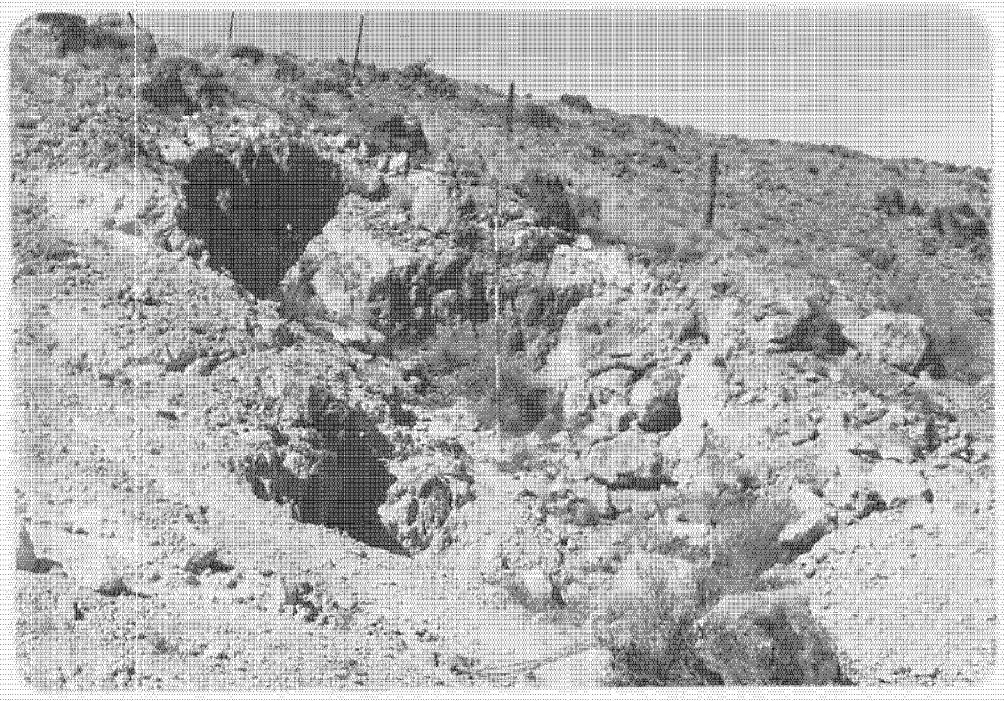
(photo b) Looking northwest at open pit up slope from decline entrance; note range pole for scale.

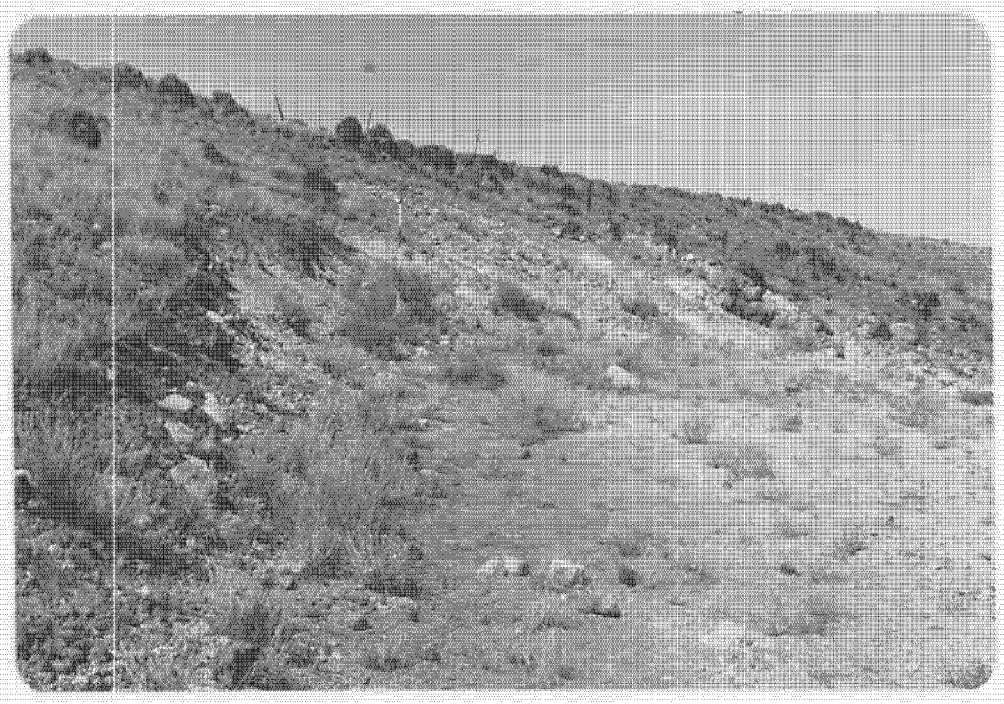
(photo c) Bench cut immediately S of open pit; looking north. Note range pole for scale.

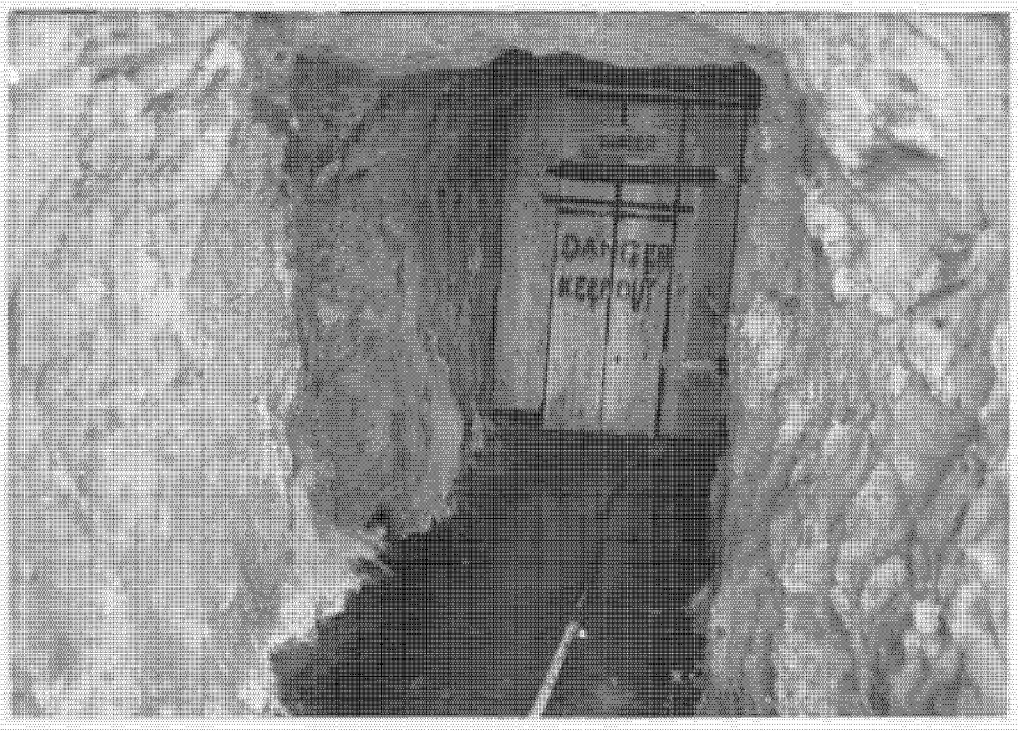
View inside lower (larger) adit of Baby Mine

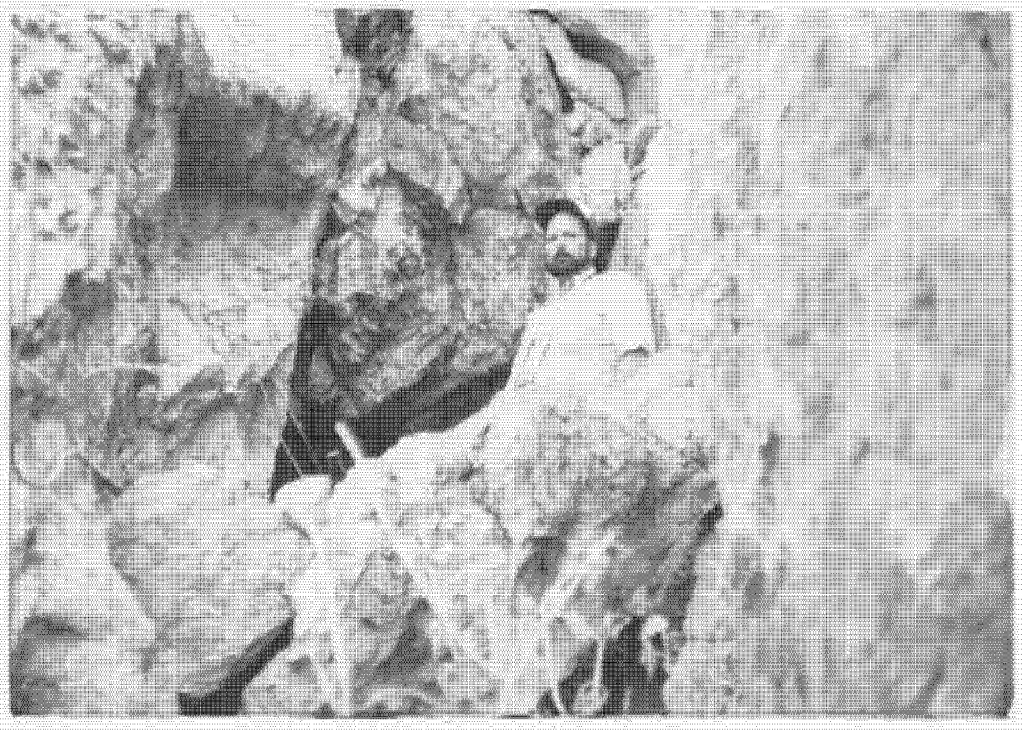
Entrance to upper level (smaller) adit of Baby Mine

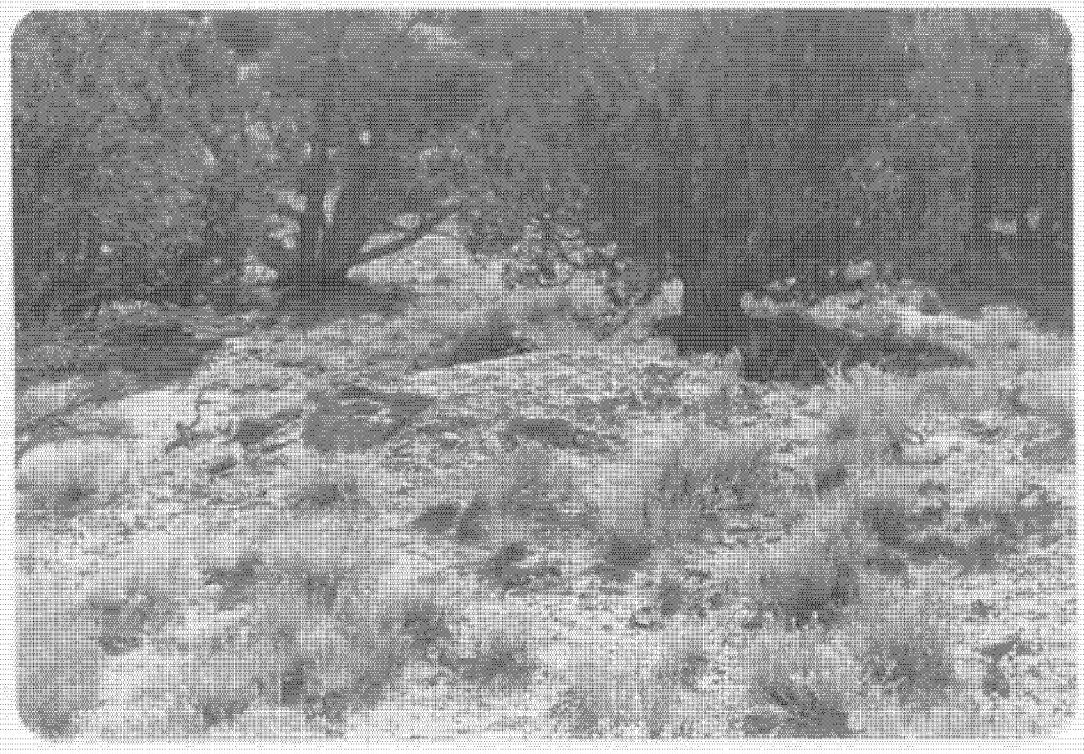
Photo (a) Looking east at the small dump on the Section 21 (Varnum) Prospect.

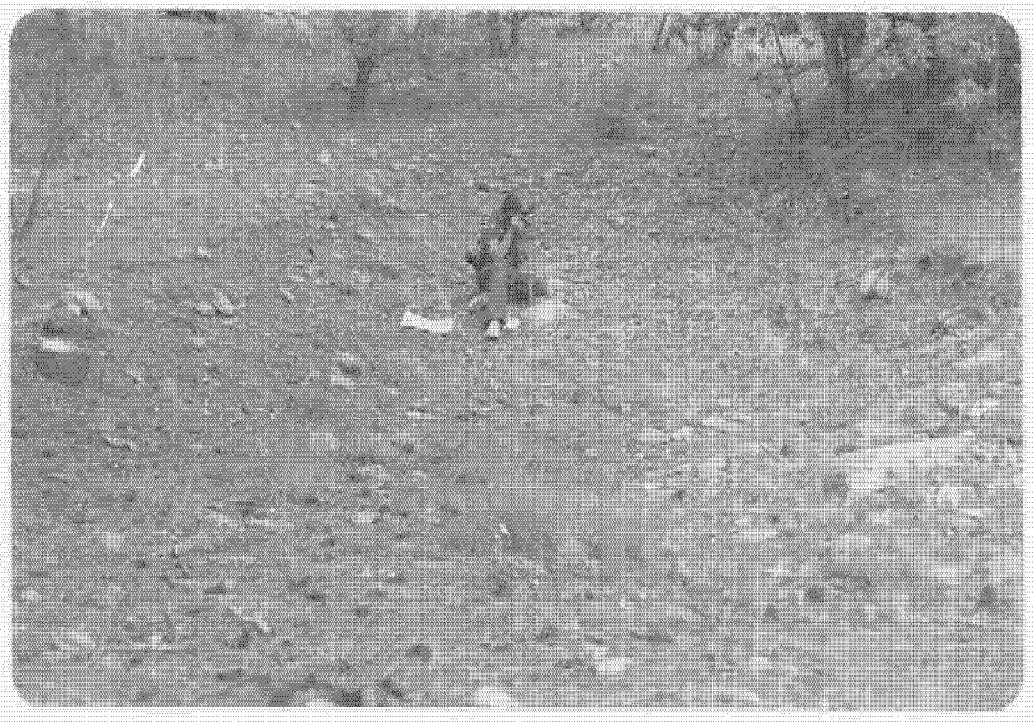
Photo (a) Looking east at small pit on the Quary Prospect.

Photo (b) Looking west at Quary Pit and Dump.

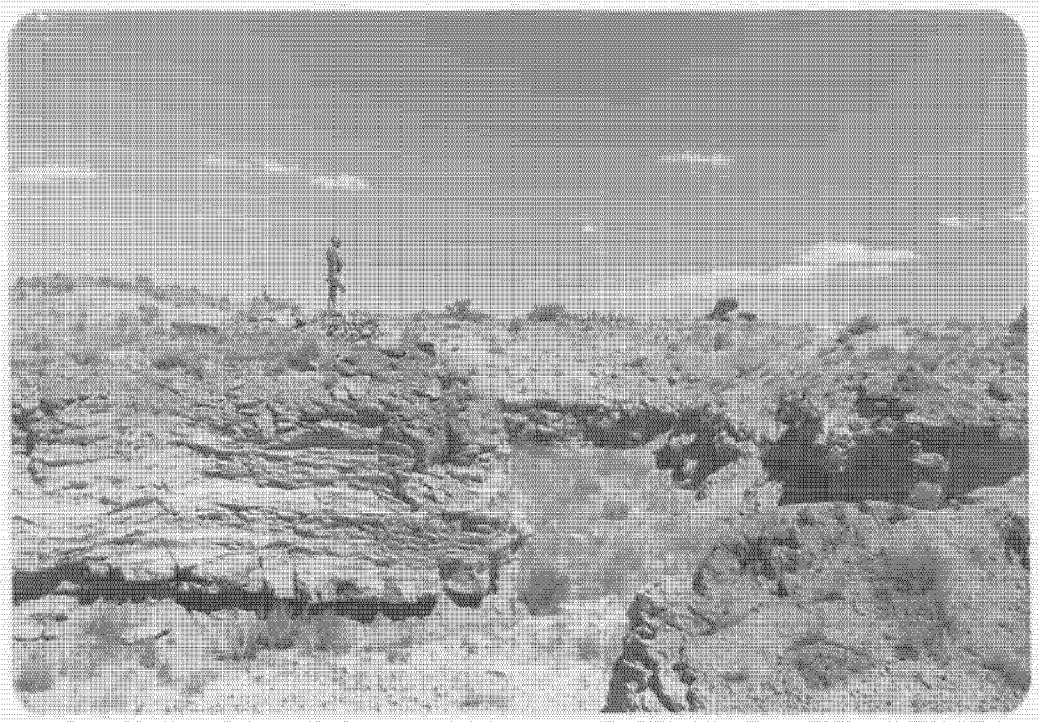
Photo (a) Looking E at the Midnight #2 open pit.

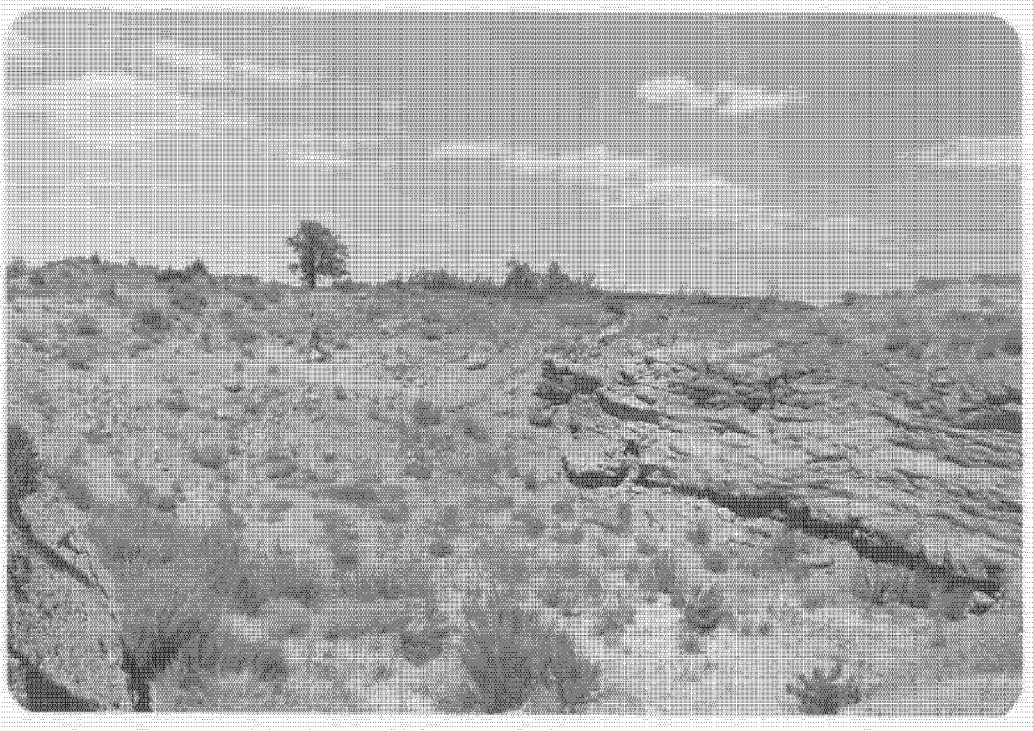
Photo (b) Looking N at entrance to Midnight #2 open pit.

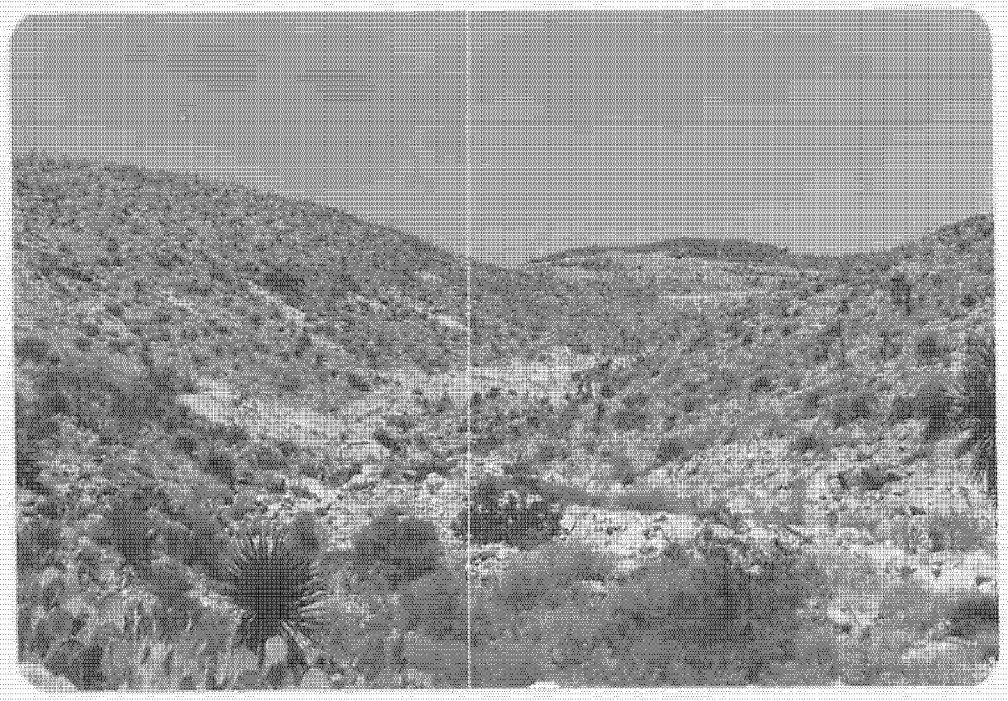
Photo A - looking N at Blue Star fault valley, adits to left.

Photo B - first adit; Blue Star.

Photo C - Second adit; Blue Star.

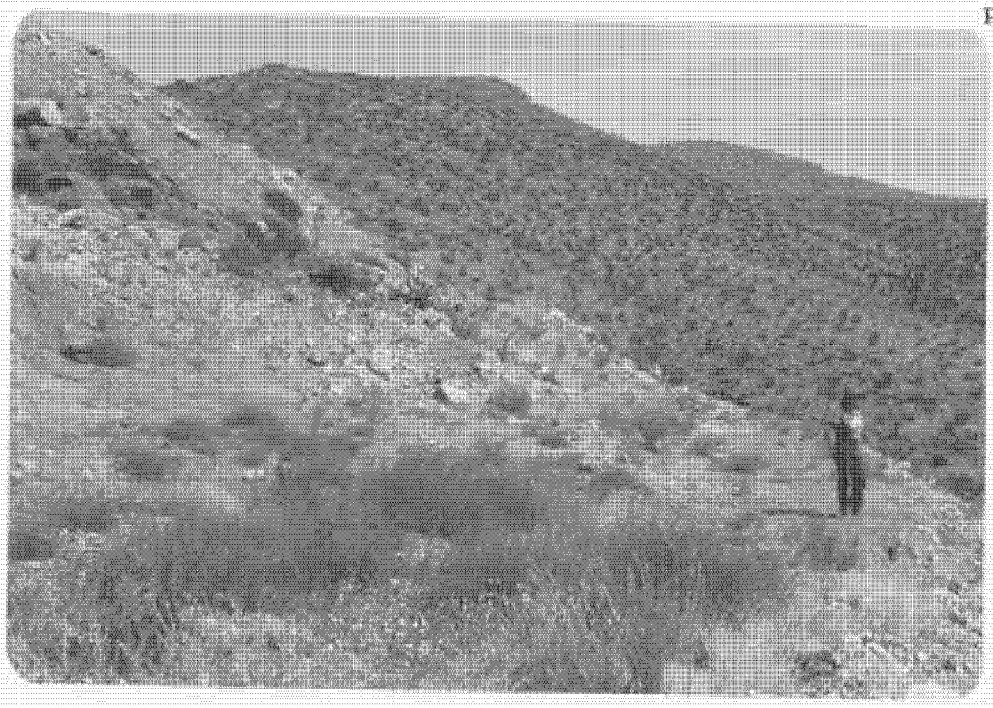
Photo D - Drill road at Blue Star.

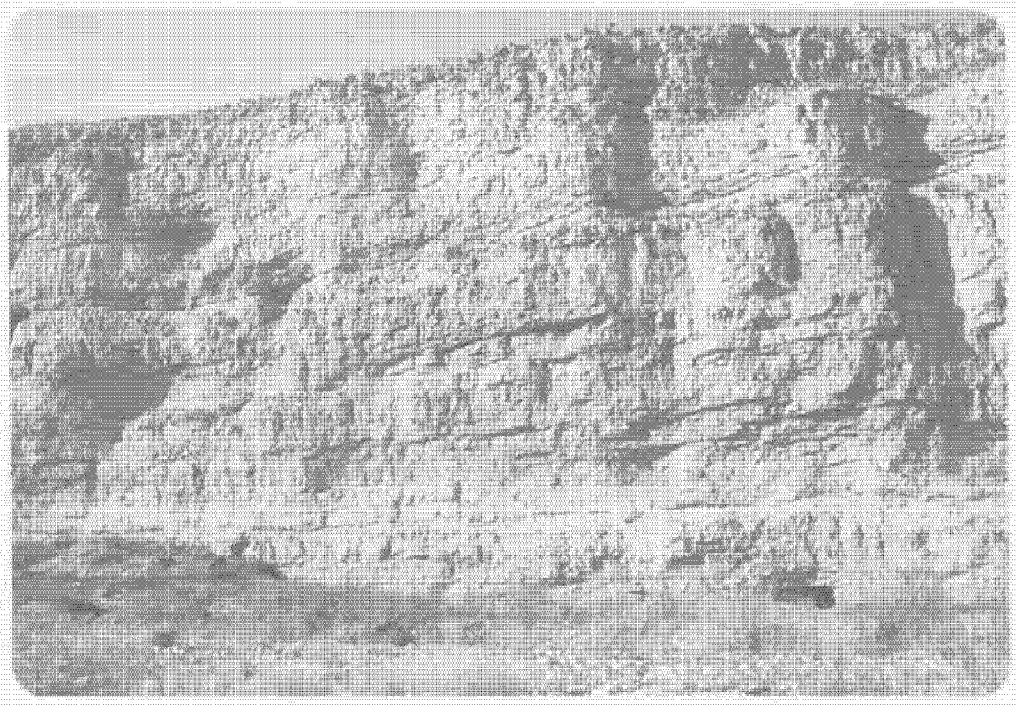
Photo (a) Looking northwest at cliff face of Yates dolomite, with 6' x 6' portal of Teepee adit shown at lower right.

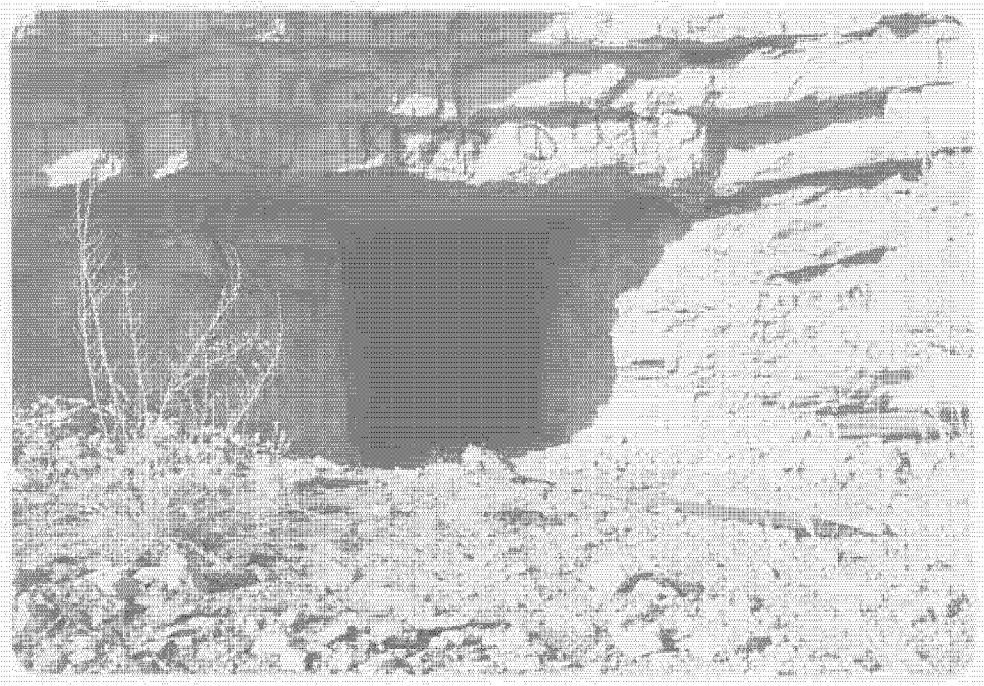
Photo (c) Portal of Teepee adit, about 6' x 6'.

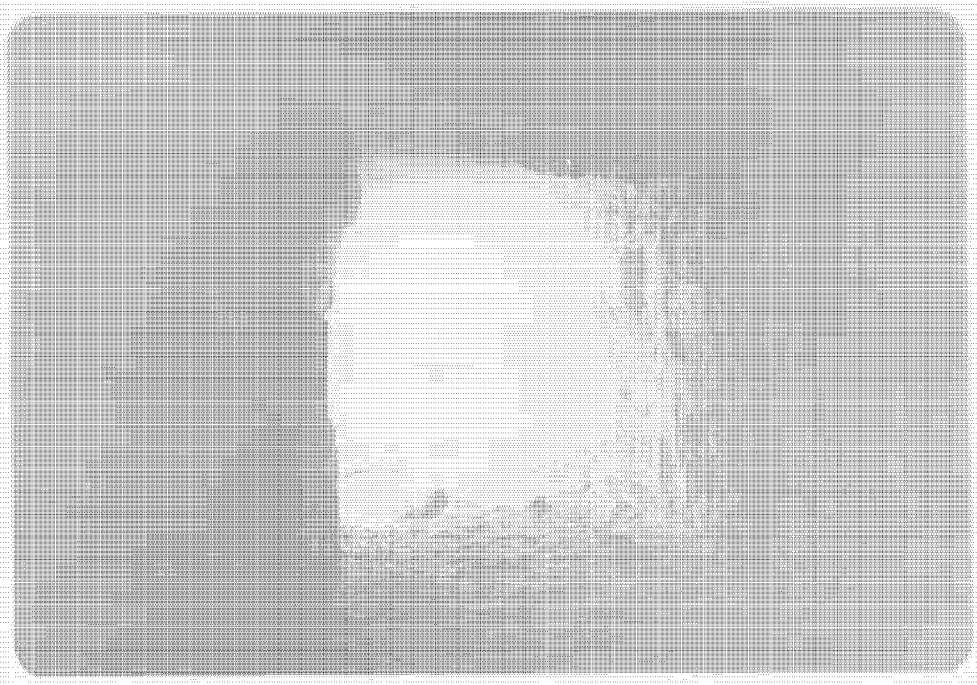
Photo (d) View from just inside portal looking out, showing "clean" face, roof, and floor of adit.

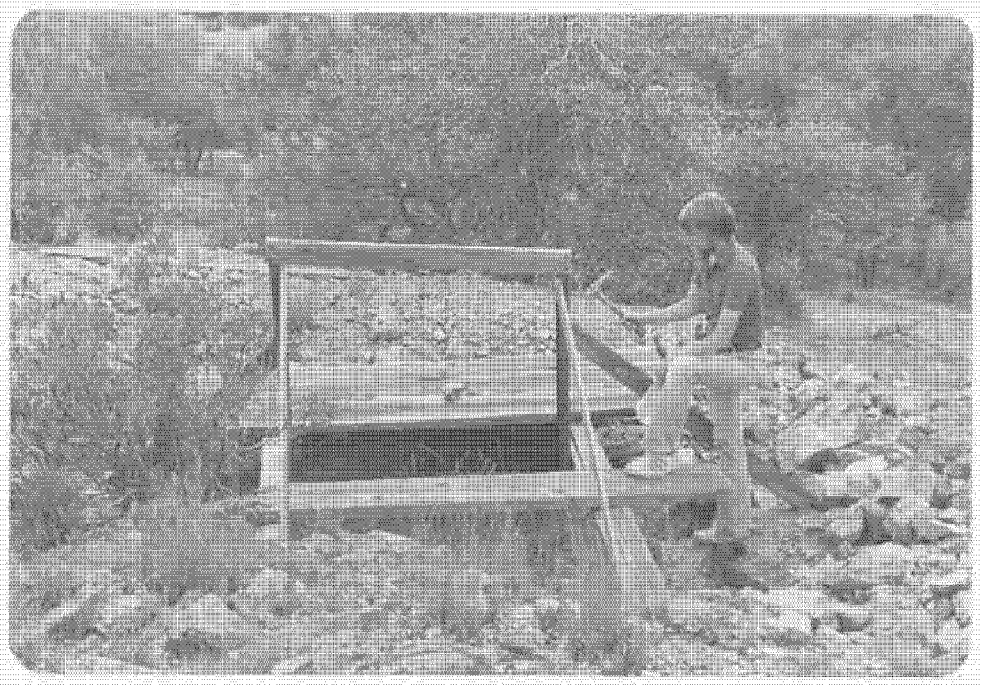
During the present investigation one small vertical shaft with a collar dimension about 4' x 6' was found. At a depth of 10' water was standing, so total depth unknown (see photos a & b). A deteriorating wooden bailing or hoisting platform remains over the shaft.

Photo (a) Looking south showing small hoisting platform, underlying shaft, and small tailings pile, at Alhambra-Bluebelle No. 2.

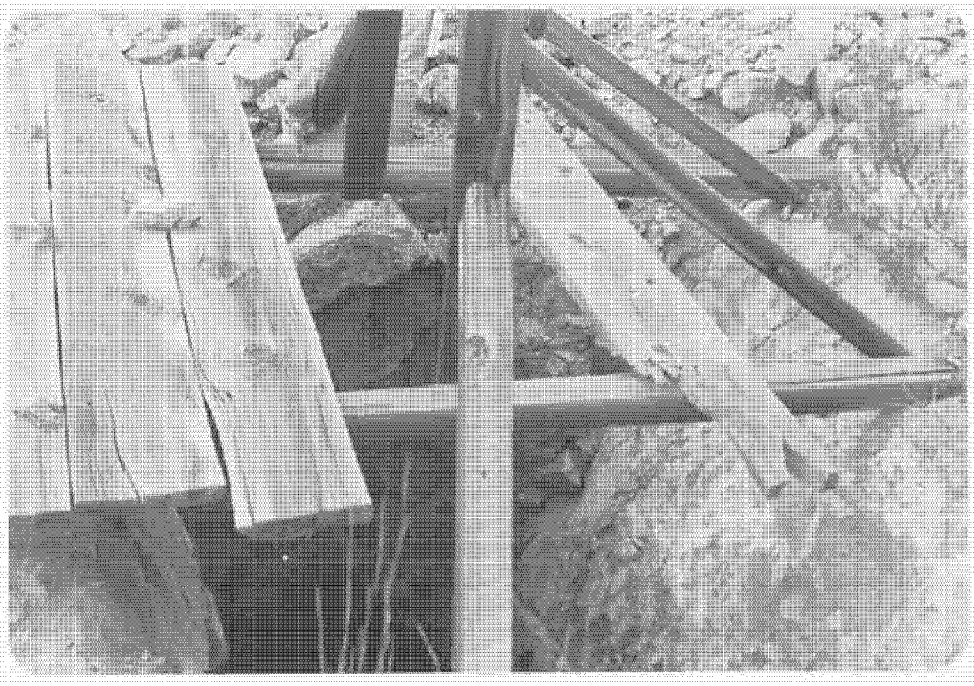
Photo (b) Close up of Alhambra-Bluebelle No. 2 shaft. Depth to water was 10 feet.

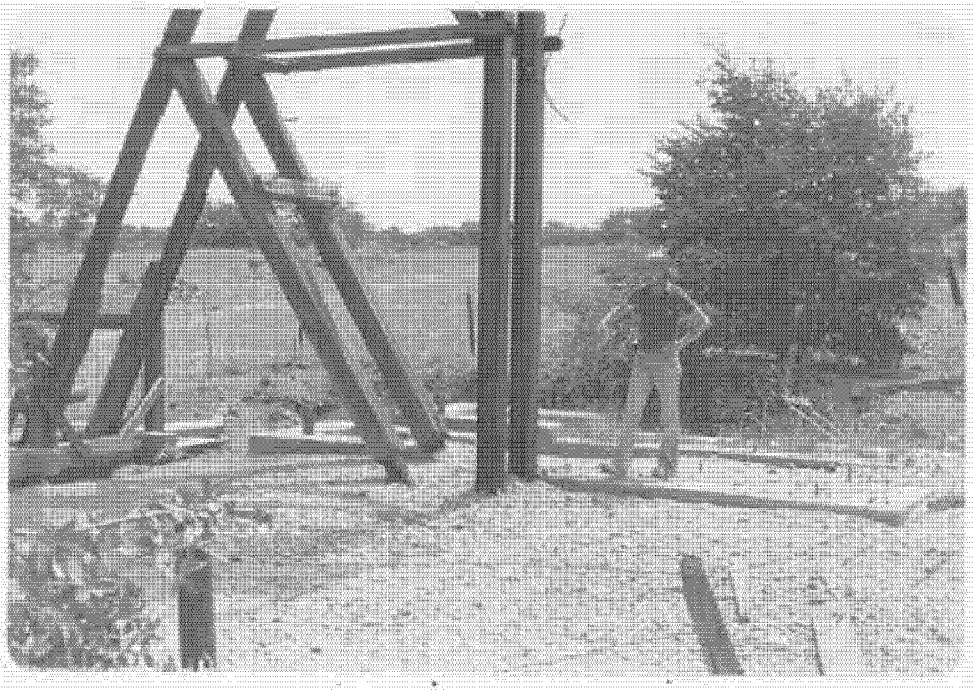
Photo (b) Head frame at Floyd Collins Mine, looking south-southeast.

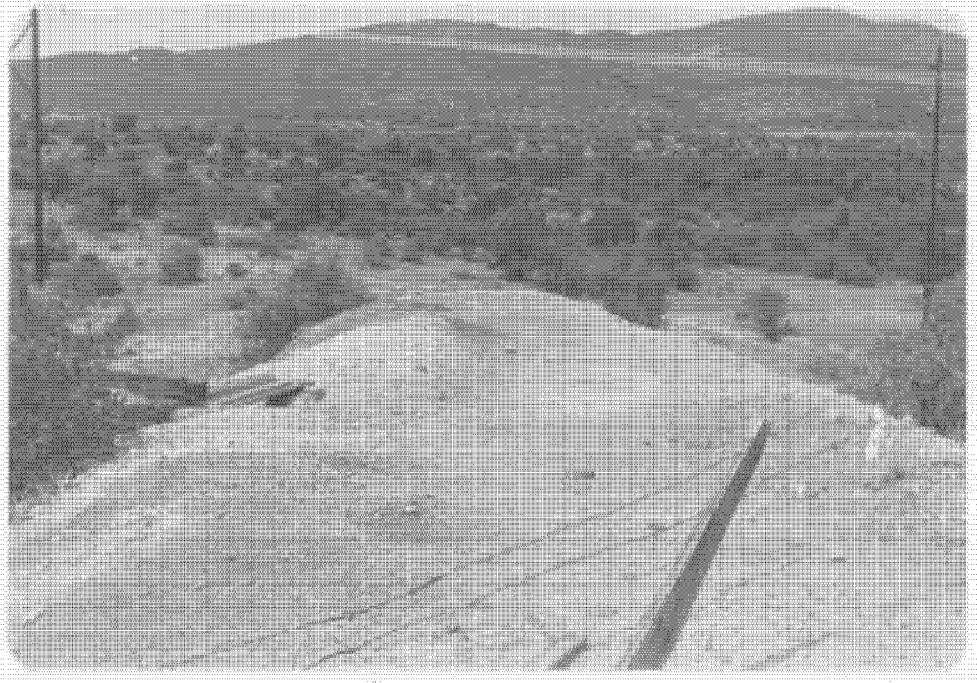
Photo (c) Tailings dump extending west from Floyd Collins Mine shaft. Dump is 10' high, 80' long.

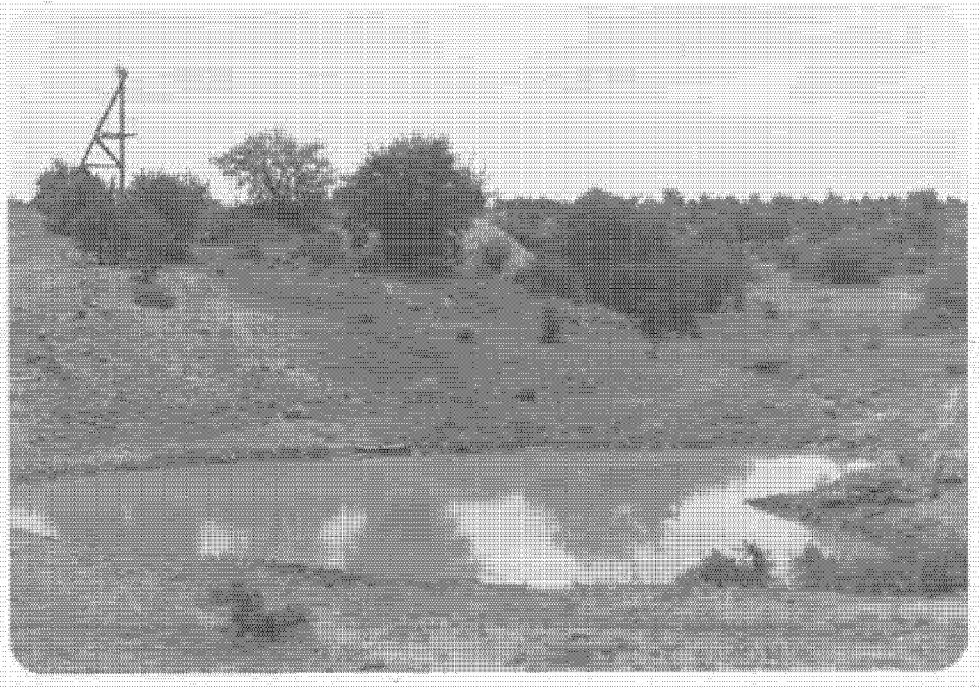
Photo (d) Looking southeast at head frame and tailings dump (through trees) that extends down to small drainage line.

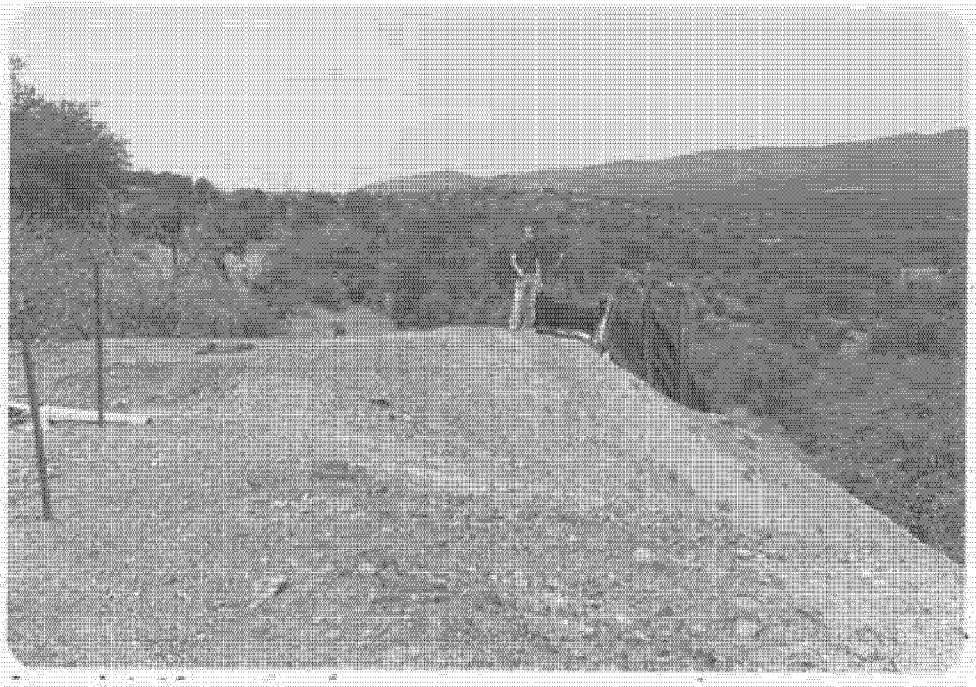
Photo (b) Tailings dump and ore chute just west of shaft, looking west.

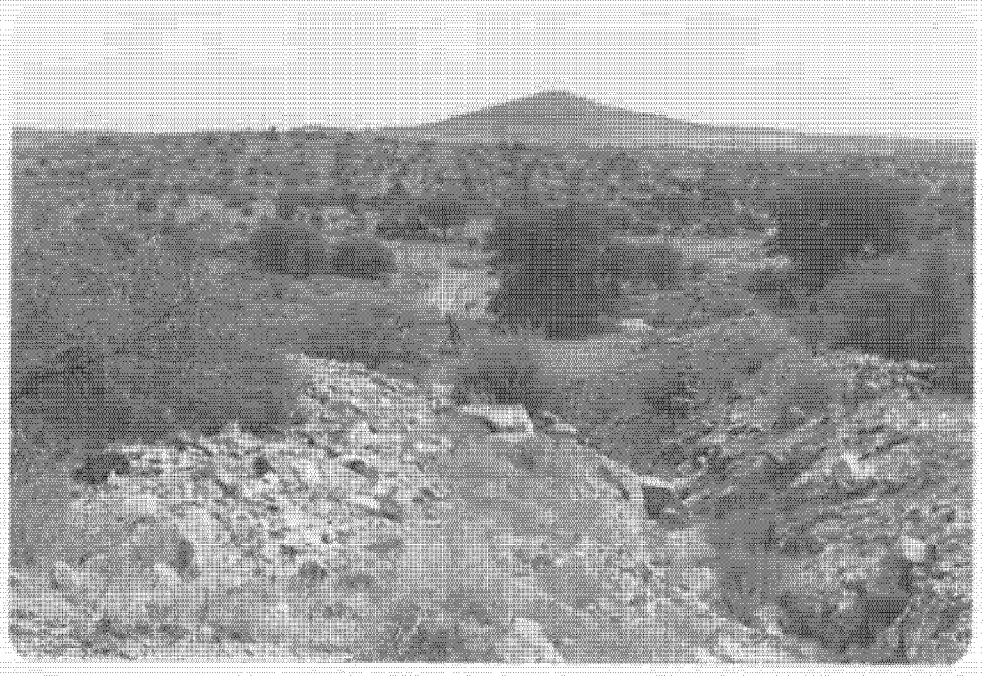
Photo (c) Trenching just southwest of Merry Widow shaft exploring mineralization along east trending fault where it cuts and displaces a diabase dike.

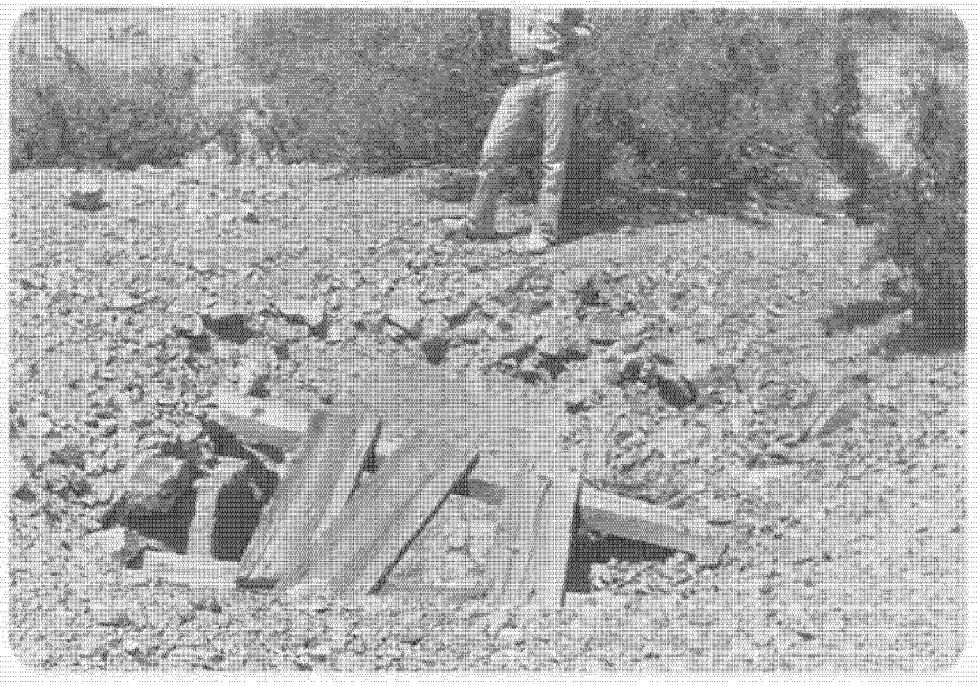
Photo (a) Looking west at Shamrock shaft; collar dimension is 4' x 6'.

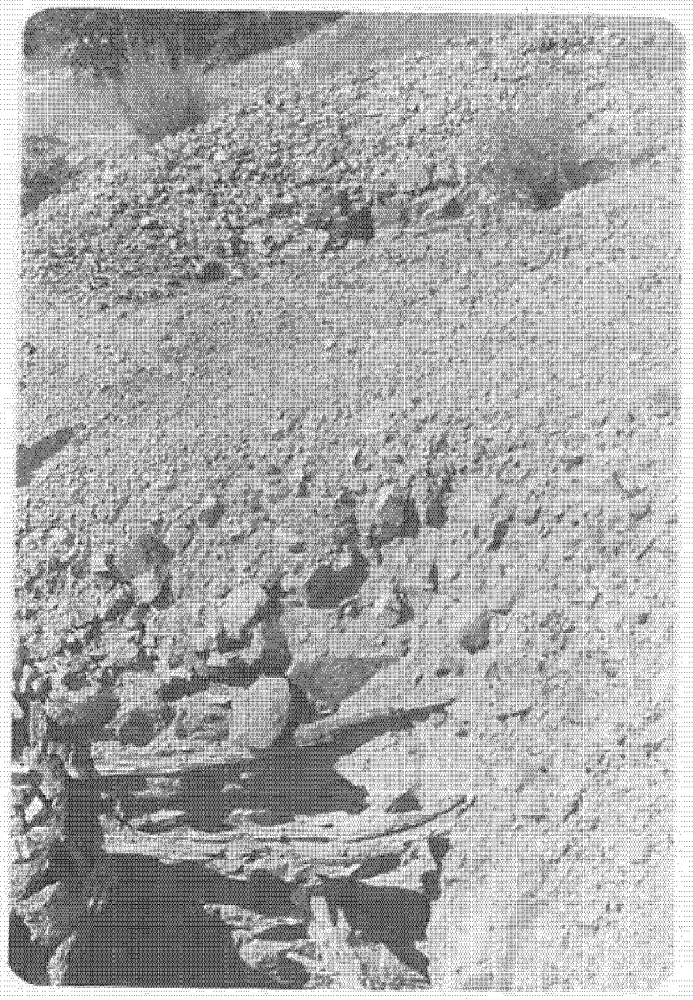
Photo (a) Looking westward at two shafts, 25' apart, on the Calamity Claim. Shaft in background is just barely visible behind hammer placed for scale.

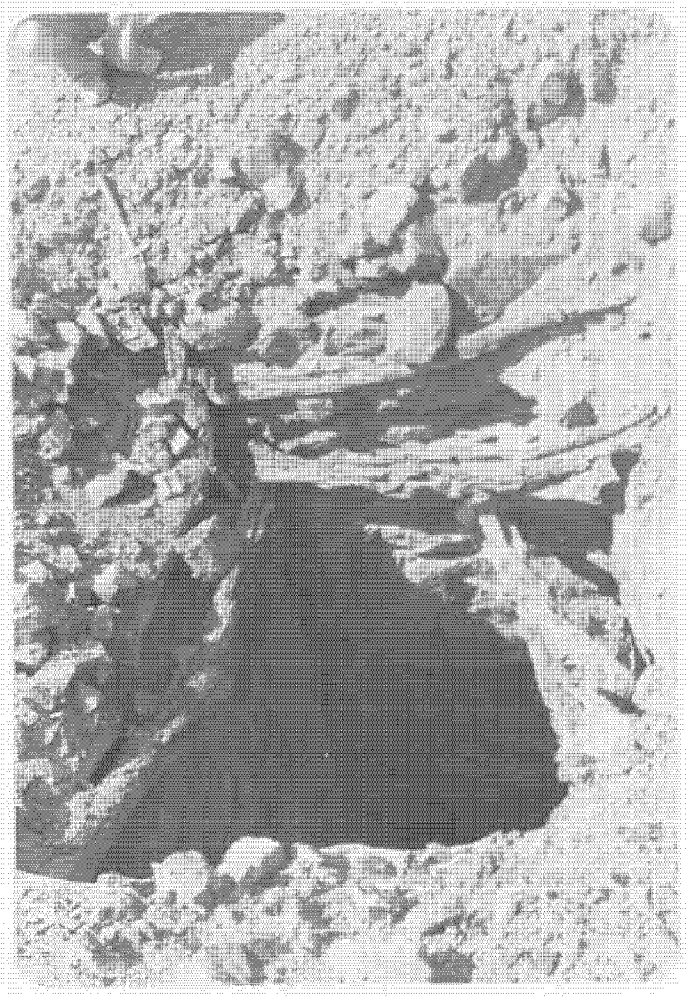
Photo (b) Easternmost shaft, 4' x 6', with water standing at the 60' level.

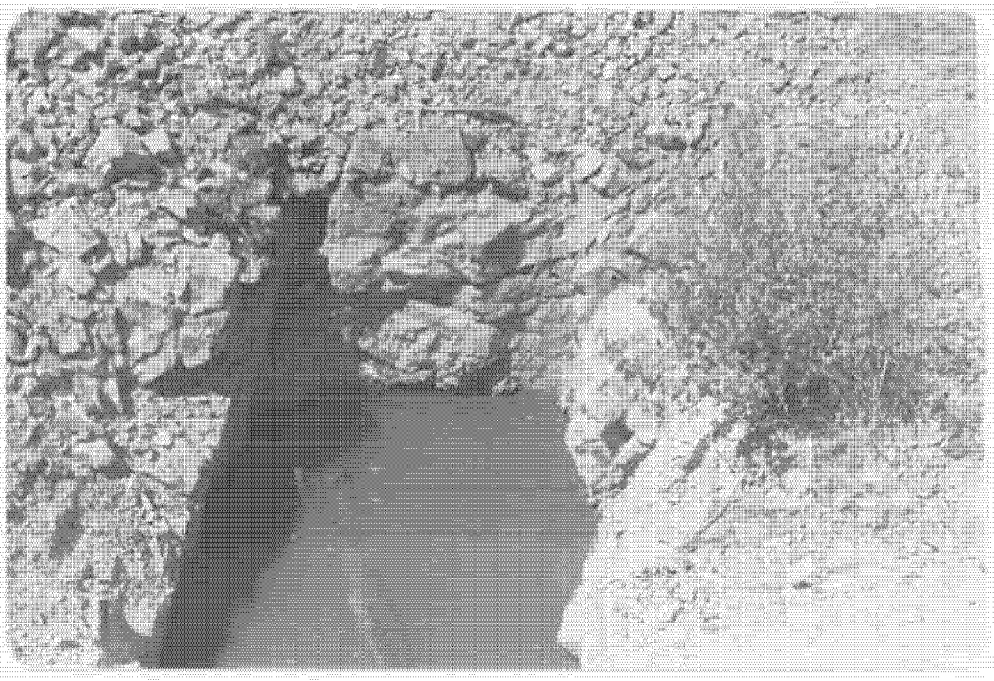
Photo (c) Westernmost shaft (in background in photo (a)), standing full of water, note hammer at upper center for scale.

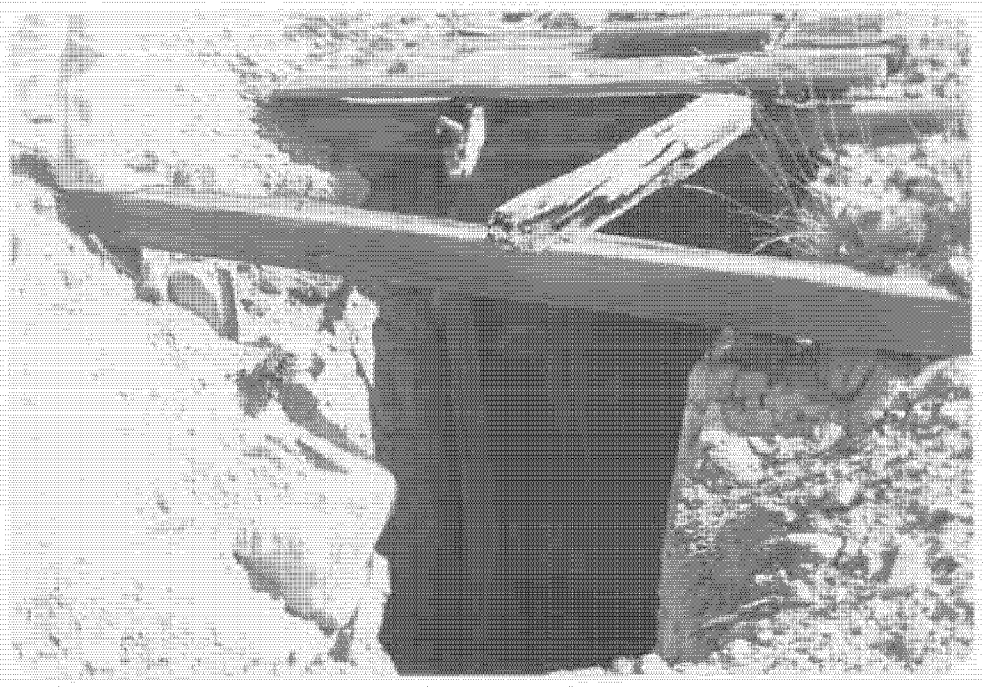
Photo (a) Looking north into covered inclined shaft thought to be on Blue Jay Claims.

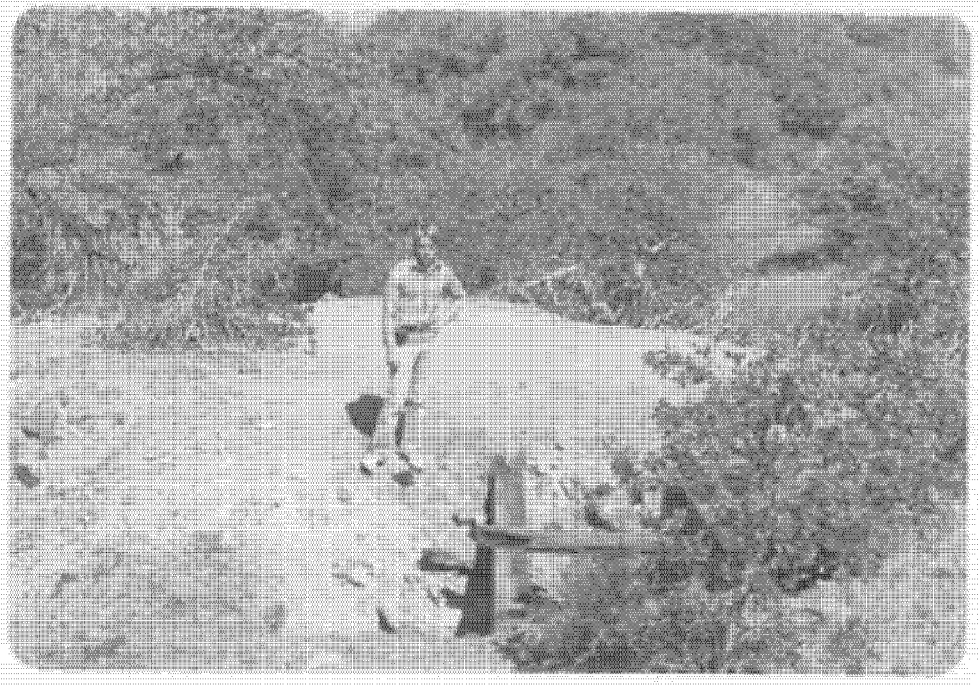
Photo (b) View to the west showing portion of timbering over shaft and tailings dump extending to south and west.

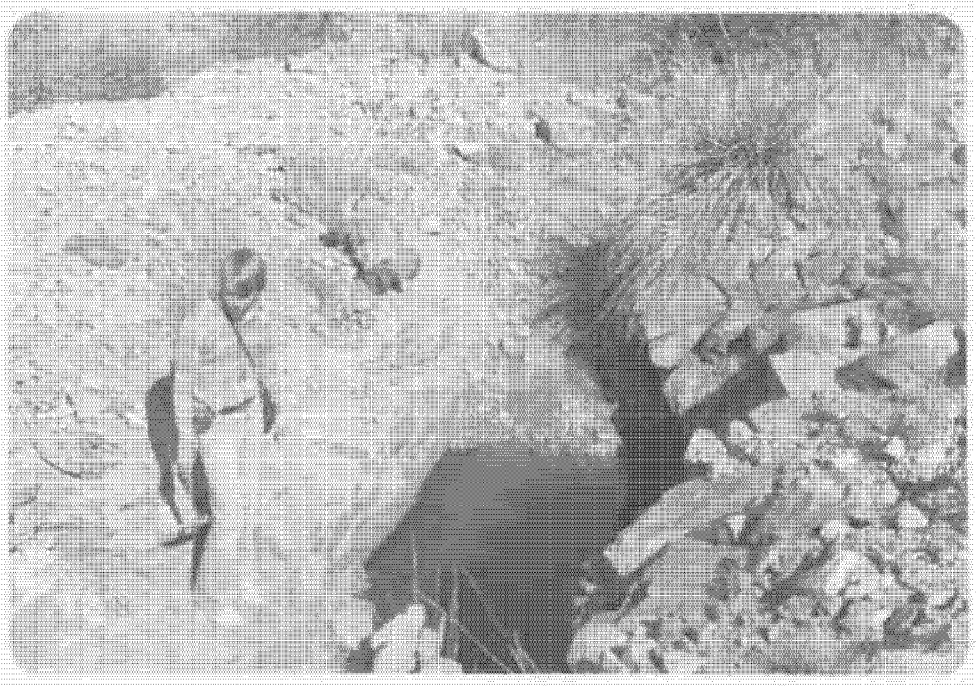
Photo (a) Looking westward at water filled Eugenie shaft; collar dimensions about 4' x 8'.

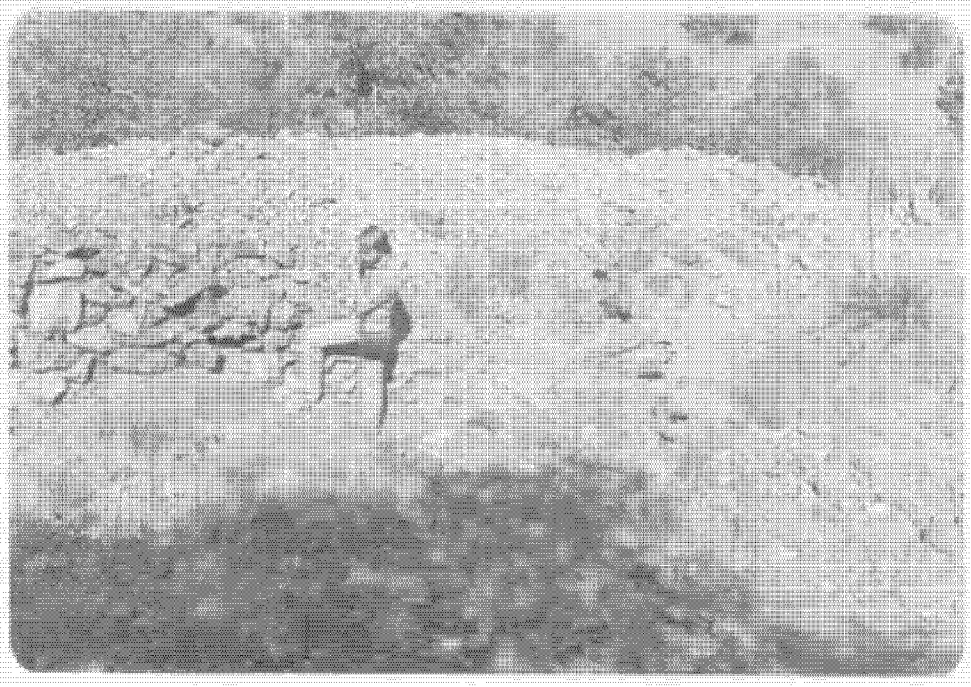
Photo (b) Looking southward at shaft site (immediately in front of persons in photo) and tailings pile in back.

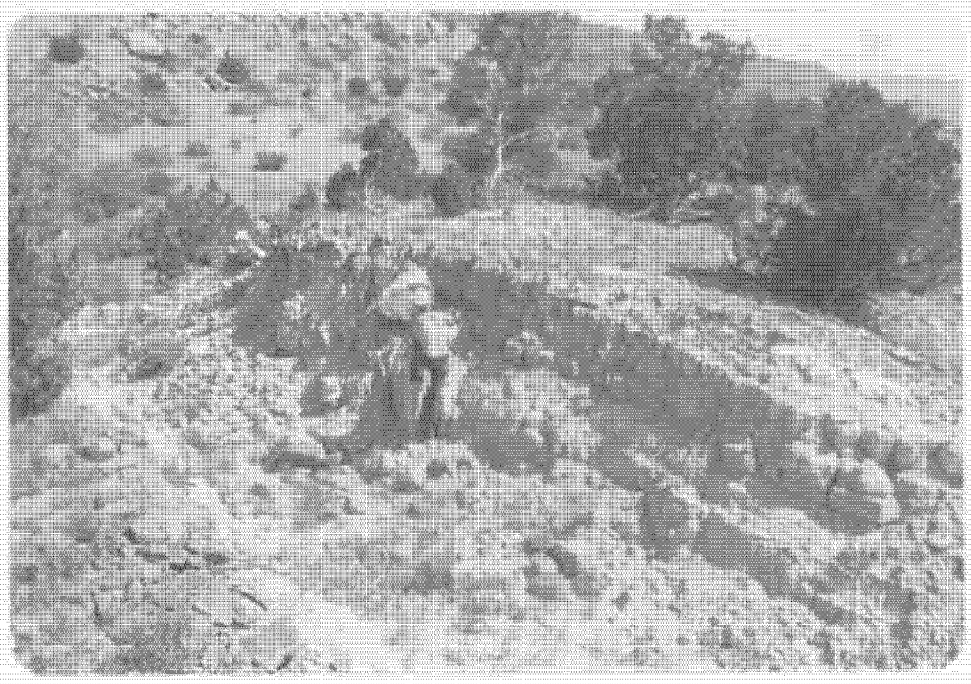
Photo A - open cut at Polita.

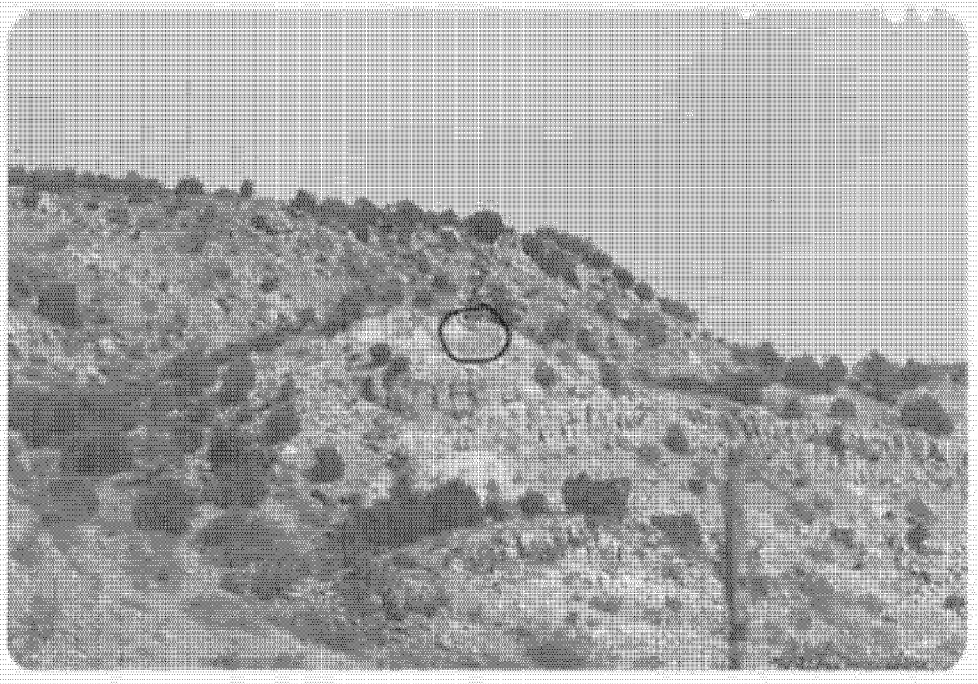
Photo B - Polita open cut.

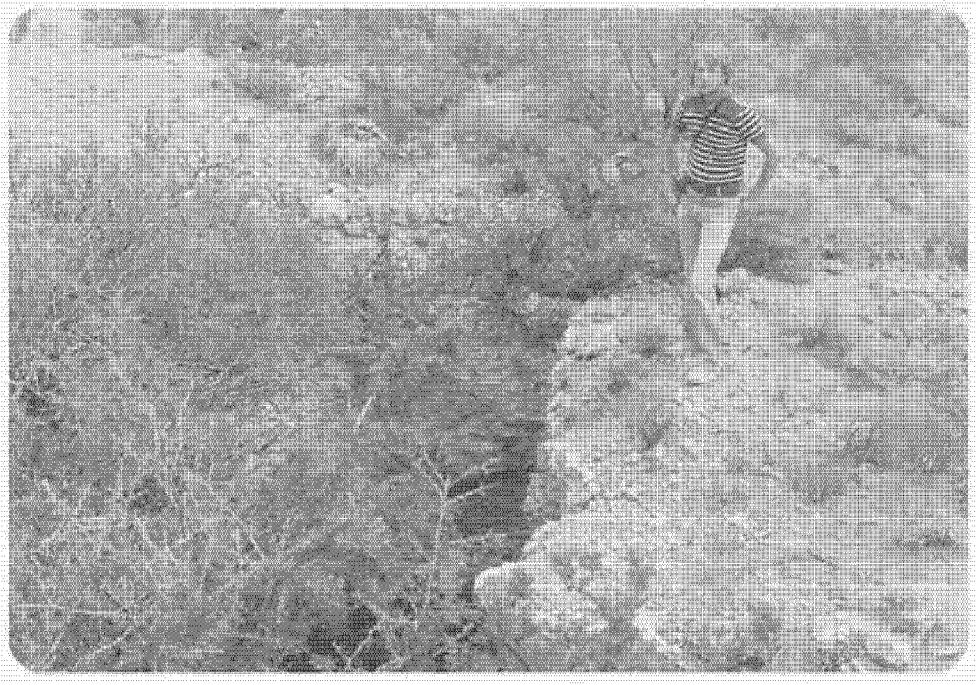
Photo (a) Looking northward at incline shaft 250' to west of access road in SE¼ sec. 25 as mining district is approached; site is nearby an abandoned trailer house. Sign on approach advertises the Cruz Blanca Mining Co.

Photo (b) Vertical shaft, 4' x 6', 50' deep; in cluster of workings east of abandoned trailer house near the International Boundary, in SE¼ sec. 25.
