ABANDONED OR INACTIVE URANIUM MINES IN NEW MEXICO

A report of investigation carried out between August 1979 and May 1980 under contract with the New Mexico Energy and Minerals Department.

New Mexico Bureau of Mines and Mineral Resources
Open-File Report 148

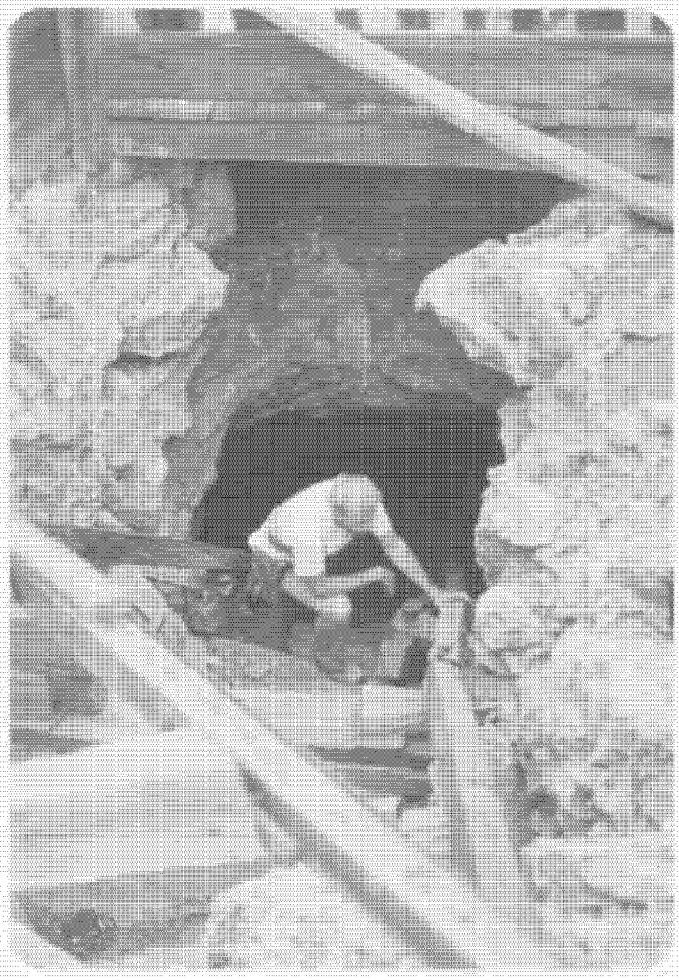
Photo (c) Entrance to 30° decline with a due east heading; workings are 100' west of shaft shown in photo (b).

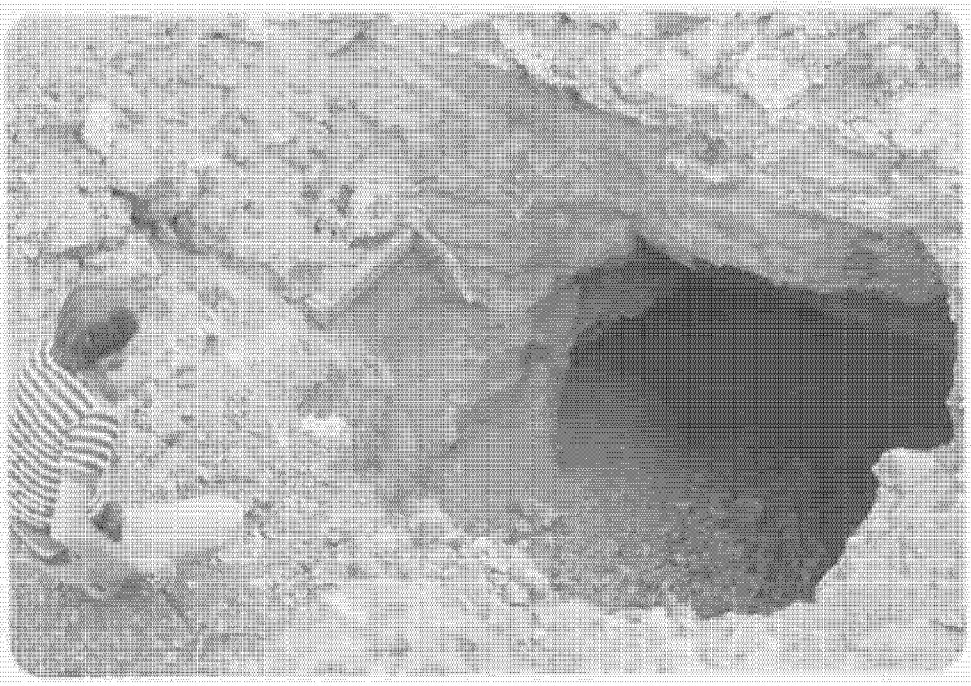
Photo (d) In 8' x 12' open pit with small decline at east face; underground workings only 10' - 12' long. Area is immediately south of decline shown in photo.

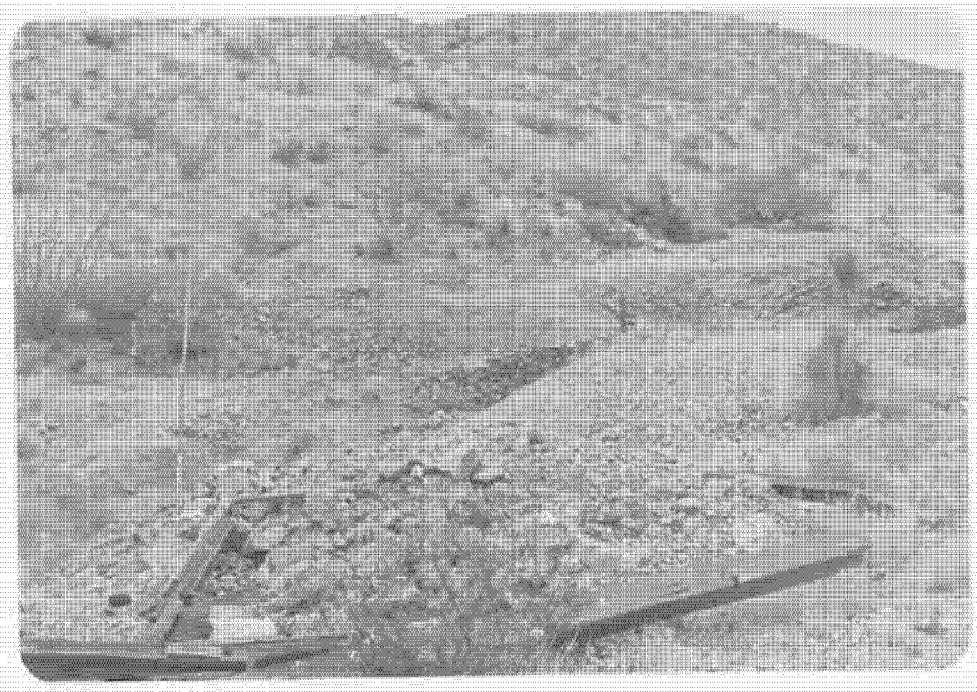
Photo (e) Tailings dump from workings shown in photos (c) and (d).

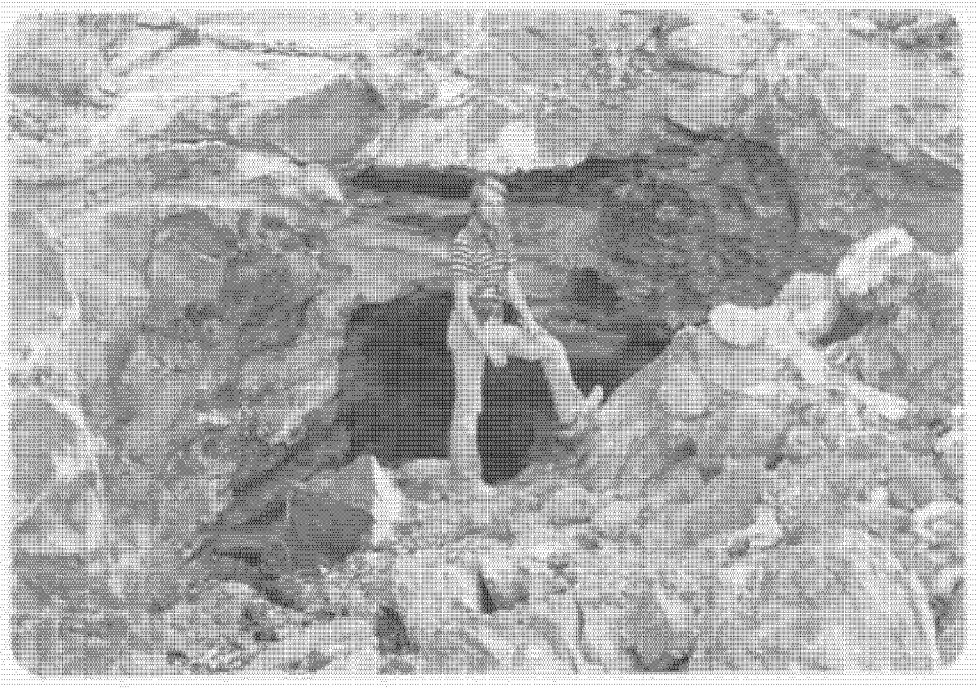
Photo (f) Small inclined shaft, 5' x 6', in E½ SE¼, sec. 25.

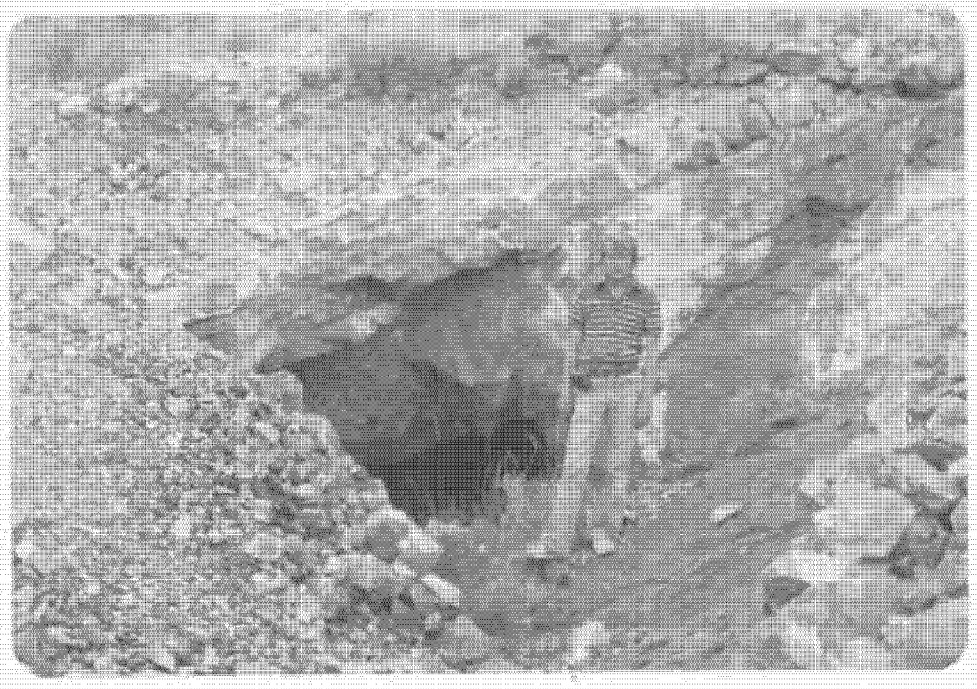
Photo (g) Adit 4' high, 5' wide, 25' long in E½ SW¼ sec. 25; negative slope at entrance is causing adit to backfill.

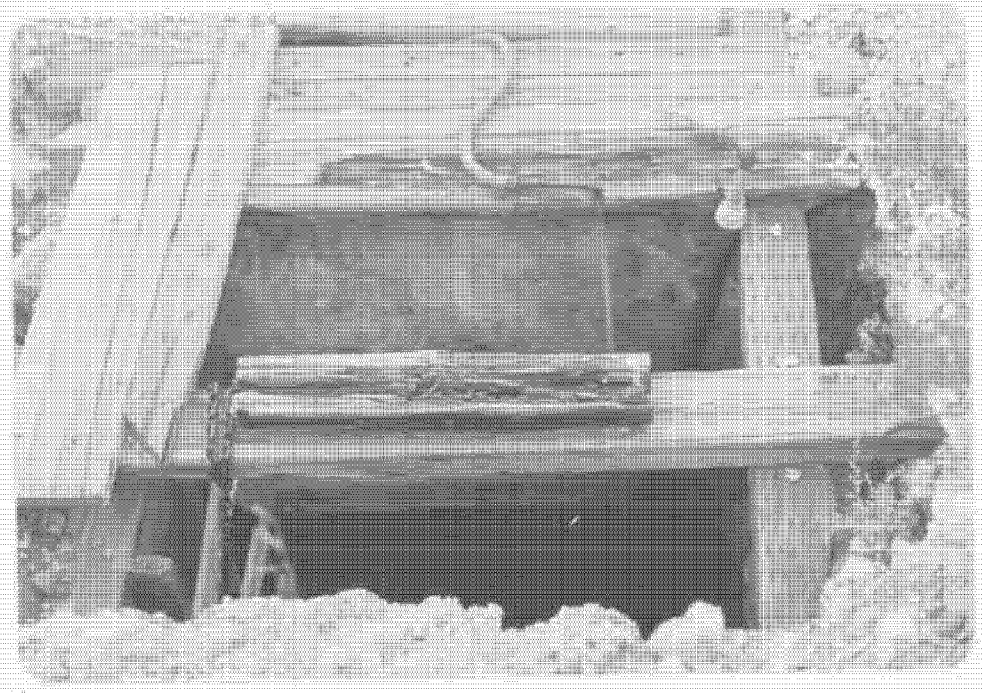
Photo (h) Vertical shaft, 6' x 6', 50' deep, with some "plumbing" left in place; note log chain at left for scale. In SE¼, sec. 25.

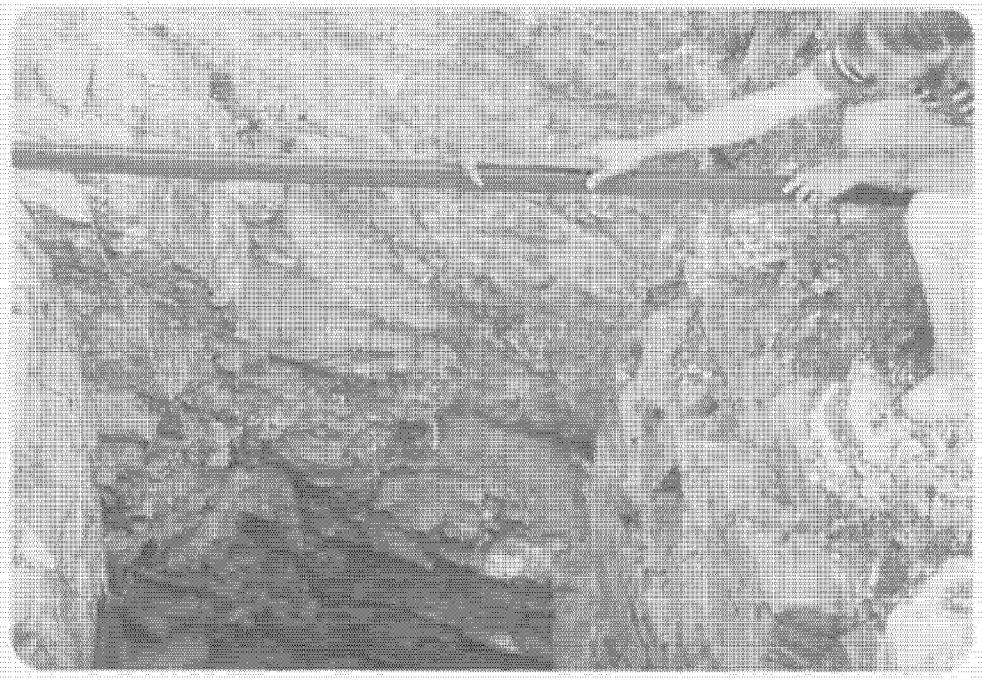
Photo (i) Vertical shaft, 6' x 6', at least 50' deep, in E½ SW¼, sec. 25.

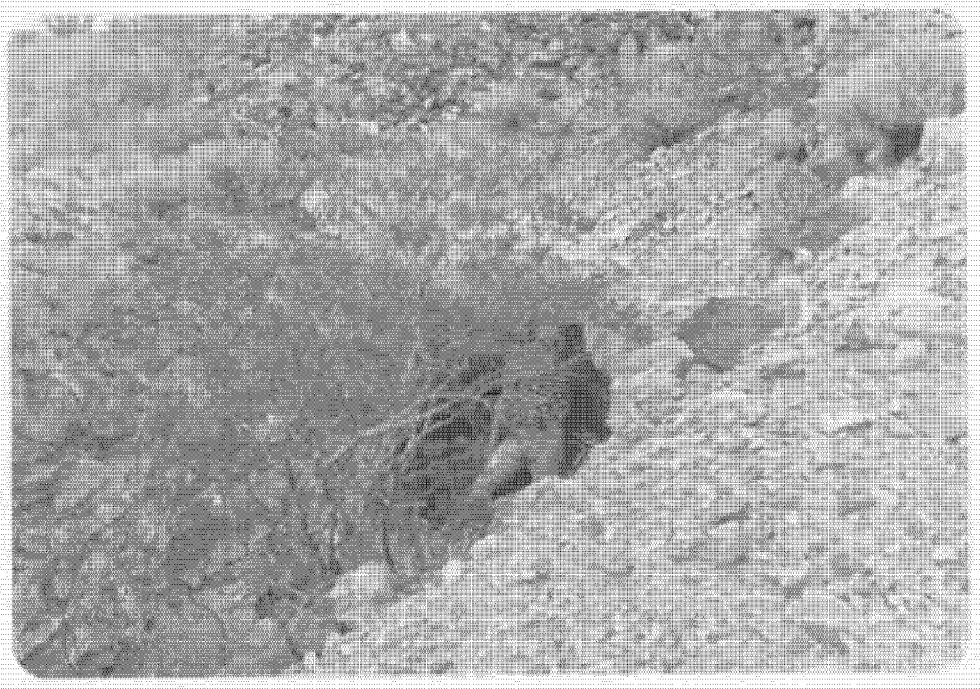
Photo (j) Small adit with a heading of 335°, portal 5' high, 6' wide, in E½ SW¼, sec. 25. Ore in tailings pile is iron rich.

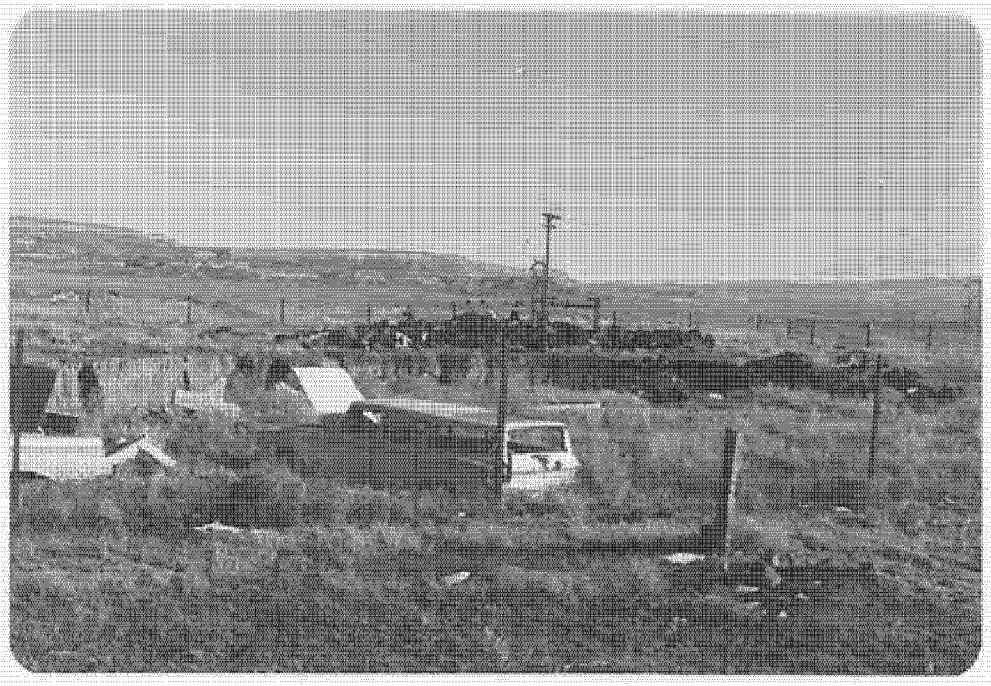
The shaft has subsequently caved leaving a 75' diameter funnel shaped hole perhaps 75' deep or deeper (see photos a & b). A close up of the lower portion of the hole is shown in photo (c). The shaft site is enclosed with a 6' high wire mesh fence that is nearly 250' long on each side; however, a section along the south side has been damaged and this allows access to the mine shaft. Scintillometer readings around the shaft site range from 400-600 cps; one area along the north fence line up to 1,200 cps. The mine dump extends mainly eastward from the shaft; it is composed of very low, 3'-4' high, scattered conical piles and ridges that extend 600' east of the shaft. Scintillometer readings were in the 600-1500 cps. range in the dump area (see photos d & e). A small powder magazine remains about 700' west of the shaft.

Photo (a) Looking eastward at caved shaft site showing fence and general debris.

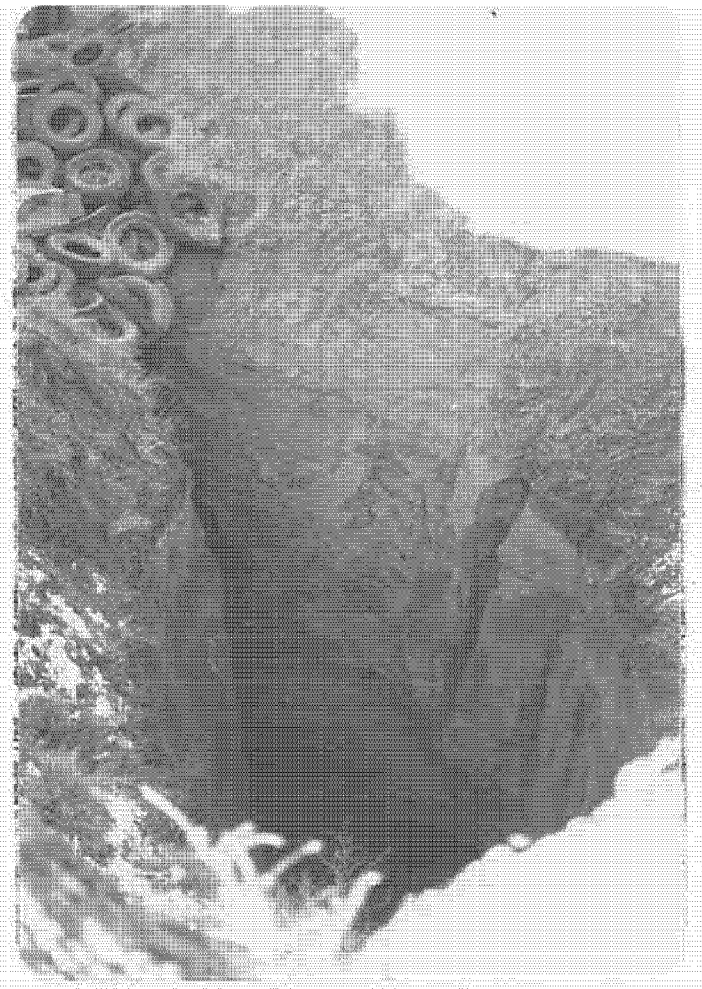
Photo (c) Close-up of lower portion of caved depression where it funnels into the old shaft.

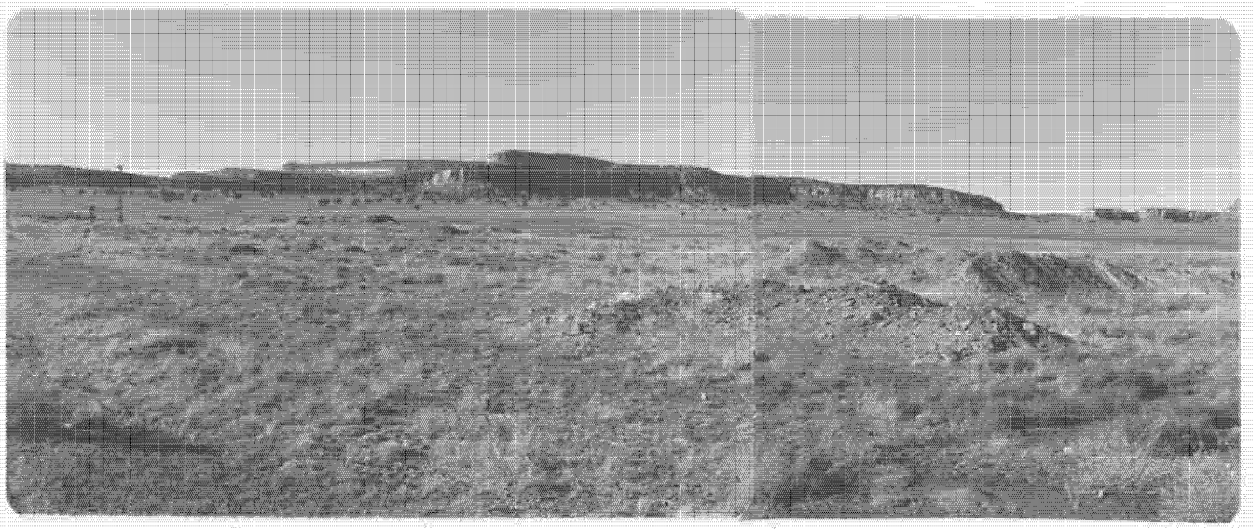
Photo (e) Looking northwest at dump (ore stockpile are?) 600' east of the mine shaft which is indicated by arrow at left. Note range pole at center for scale.

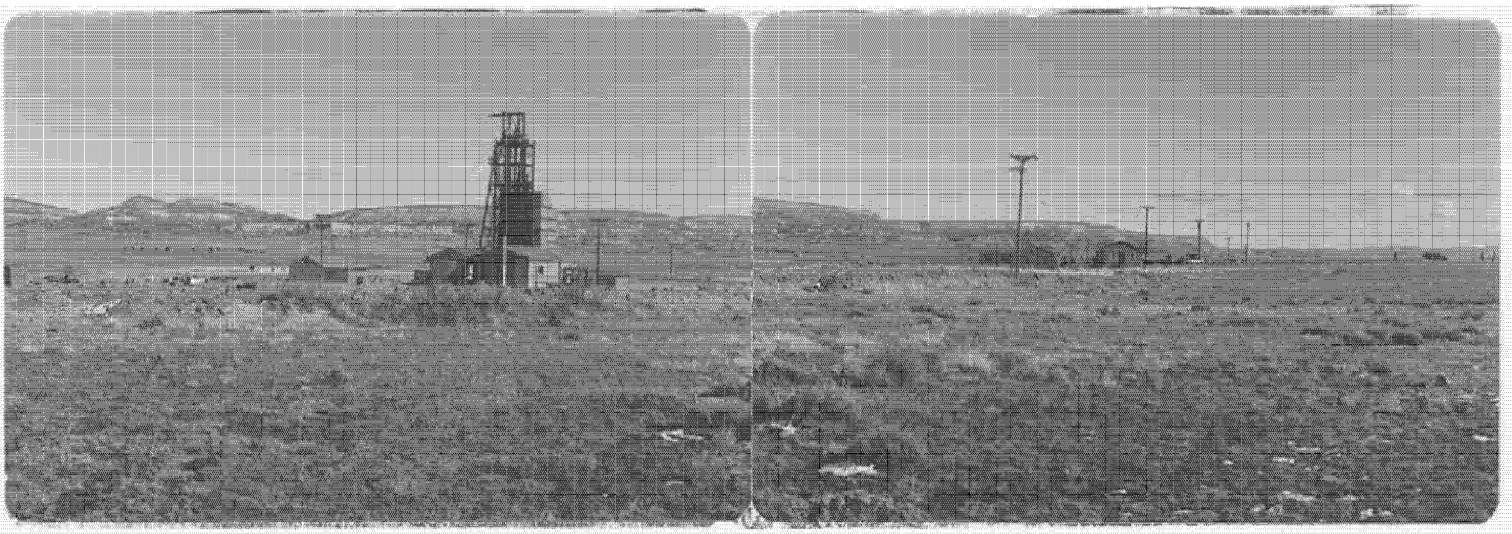
Photo (a) Looking eastward at Dysart No. 1 Mine; headframe is 40' high. House at far right is used by United Nuclear-Homestake Partner's caretaker.

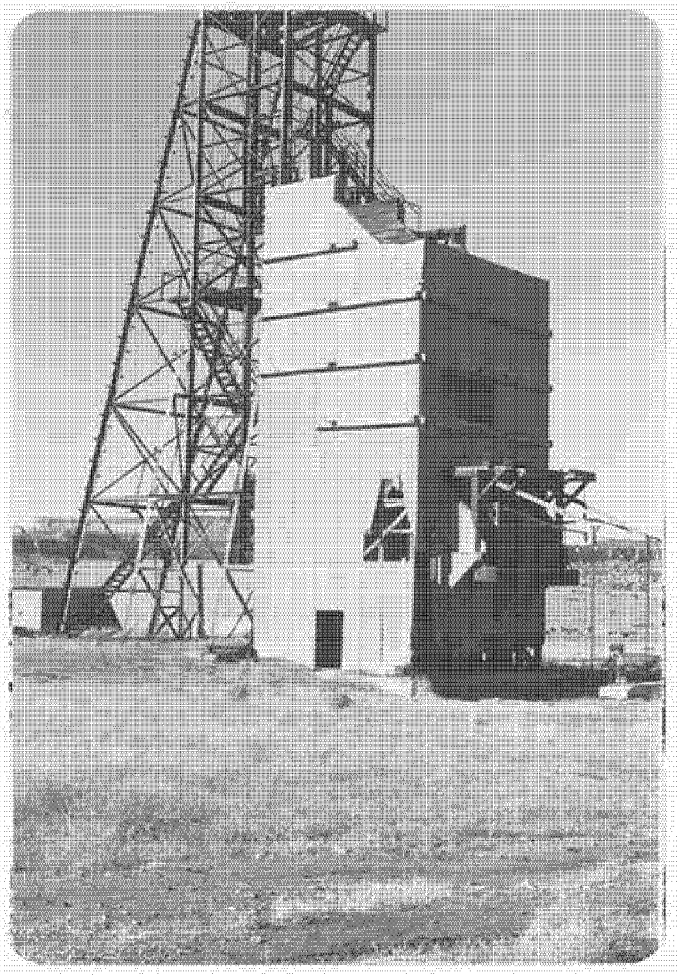
Photo (b) Close-up, looking northward at the Dysart #1 headframe and ore bin.

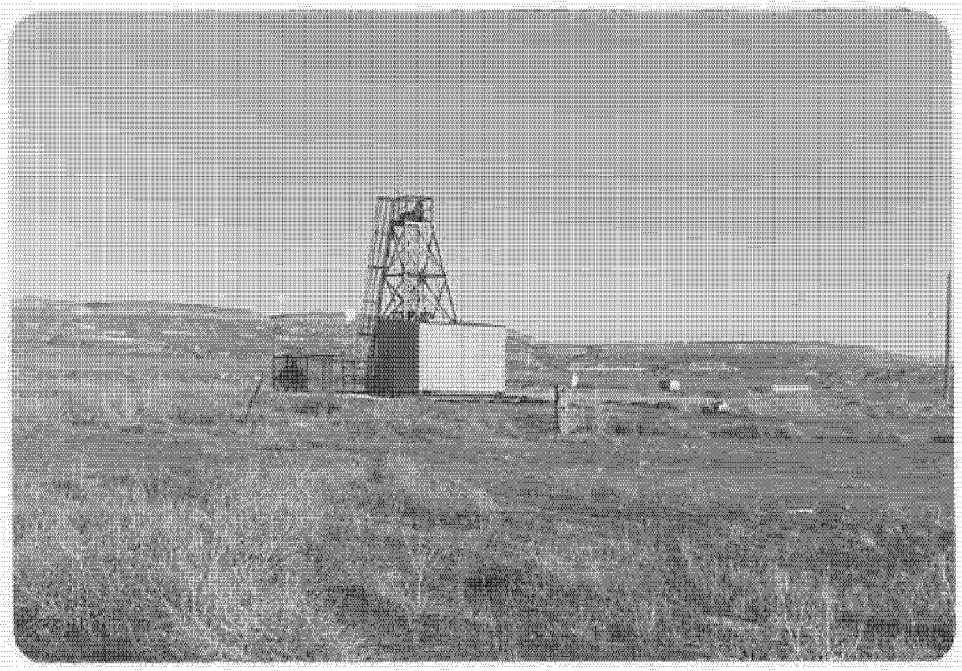
Photo (a) Dysart No. 2 headframe, approximately 30' high; shaft is used as an upcast ventillation shaft by Cobb Nuclear at the Sec. 12 Mine. Cobb equipment is visible in background.

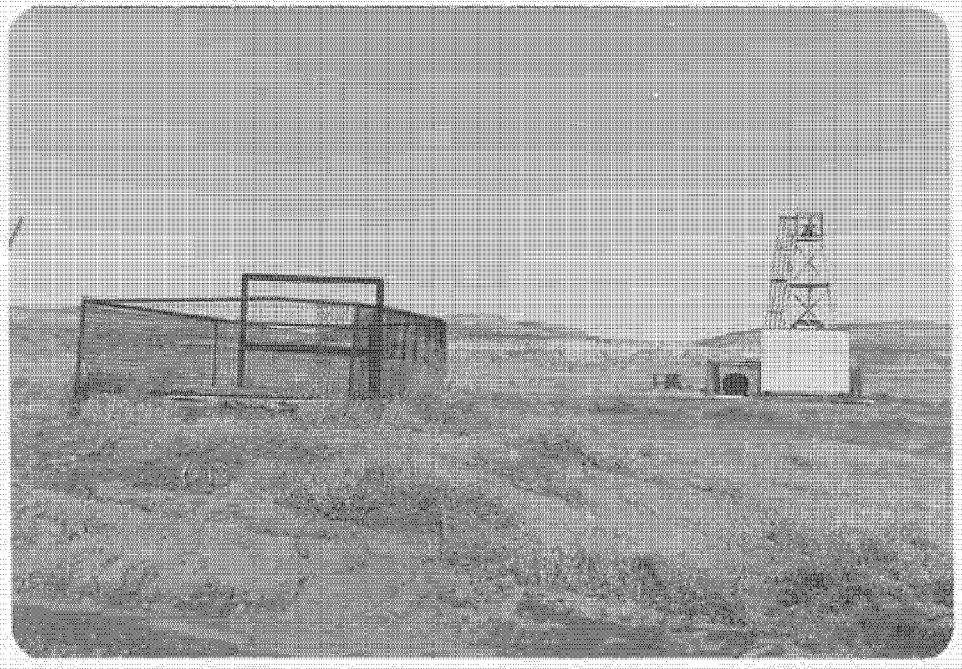
Photo (b) Dysart No. 2 ventillation shaft in foreground, and headframe 150' to east.

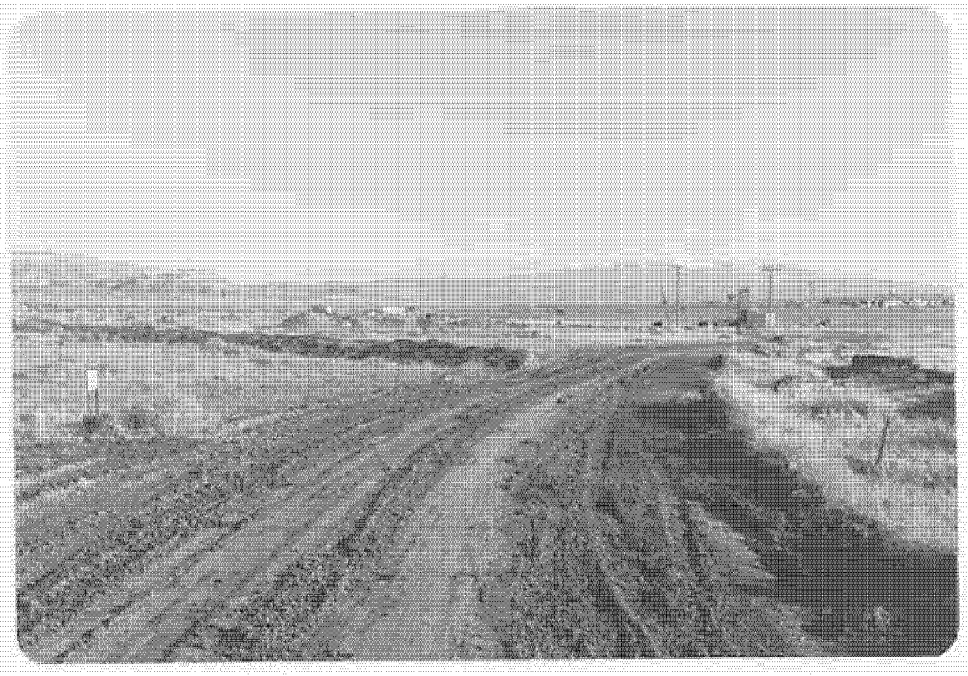
Photo (c) Looking southeastward toward the Dysart No. 3 Mine dump area; note portion of dump intersecting road at center photo. Headframe is at right with Mt. Taylor in background.

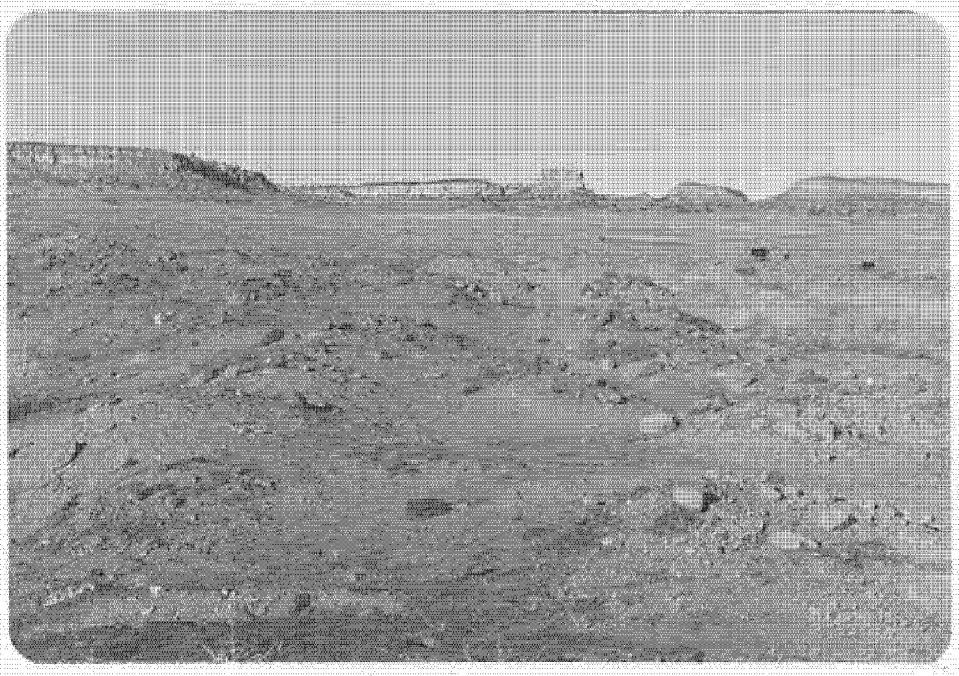
Photo (d) Compact dump area northeast of ridge shown in photo (c); note cattle grazing in background.

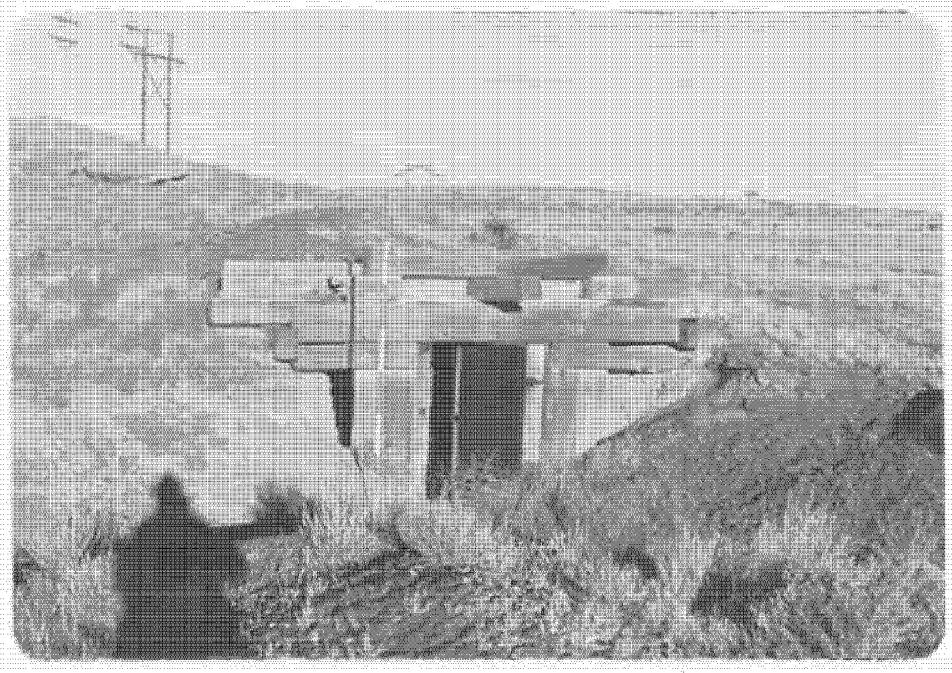
Photo (d) Looking northeast at powder magazine which is located 400' southeast of the mine shaft; note range pole for scale.

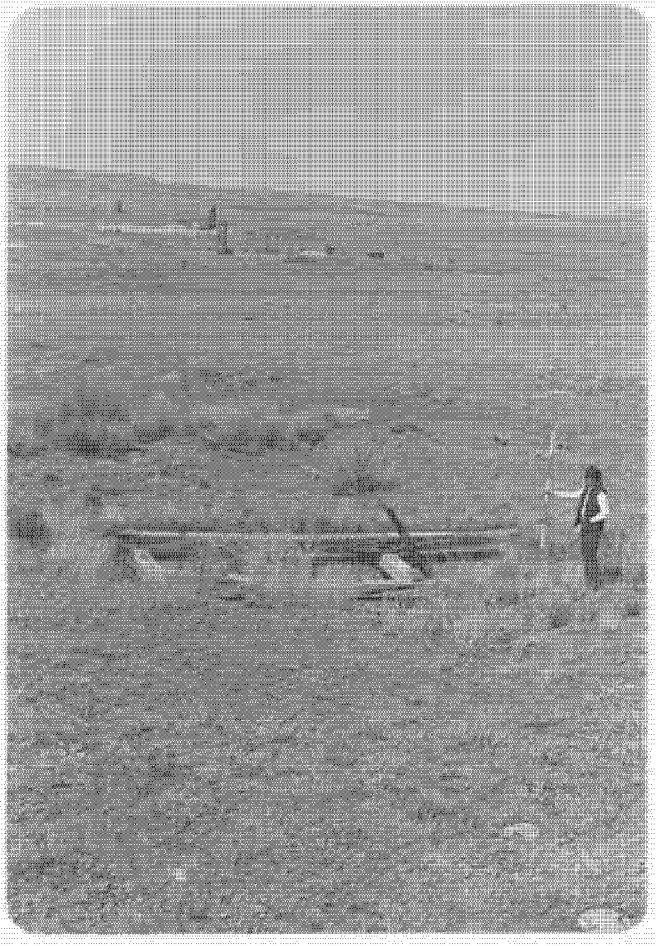
The mine workings consist only of an incompleted shaft begun and abandoned in 1957 by Rio de Oro Uranium Mines, Inc., (see photo a). It is impossible to tell whether the remaining structure constitutes the beginnings of a two compartment vertical shaft, as is indicated by the 6' x 12' collar (see photo b), or whether it was to be an inclined adit driven northward; blow sand and tumble weeds are rapidly filling in the remaining hole which is no more than 4' deep. Scintillometer readings at the site were not significantly above background.

Photo (a) Looking northwestward at the remains of the incompleted sec. 26 shaft; the headframes of the sec. 27 mines (nos. 1 and 2) and the Ann Lee Mine show in the background.

Photo (b) Close-up looking northward at the 6' x 12' collar of sec. 26 shaft, note range pole at left for scale.

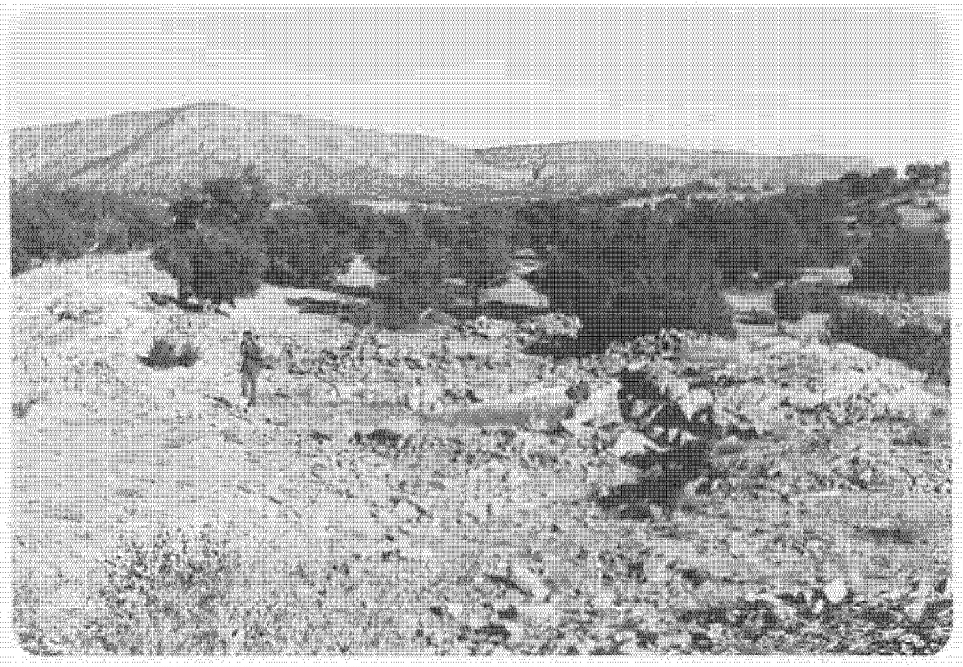
Photo (b) Looking east at group of closely spaced open pits, up to 4' deep.

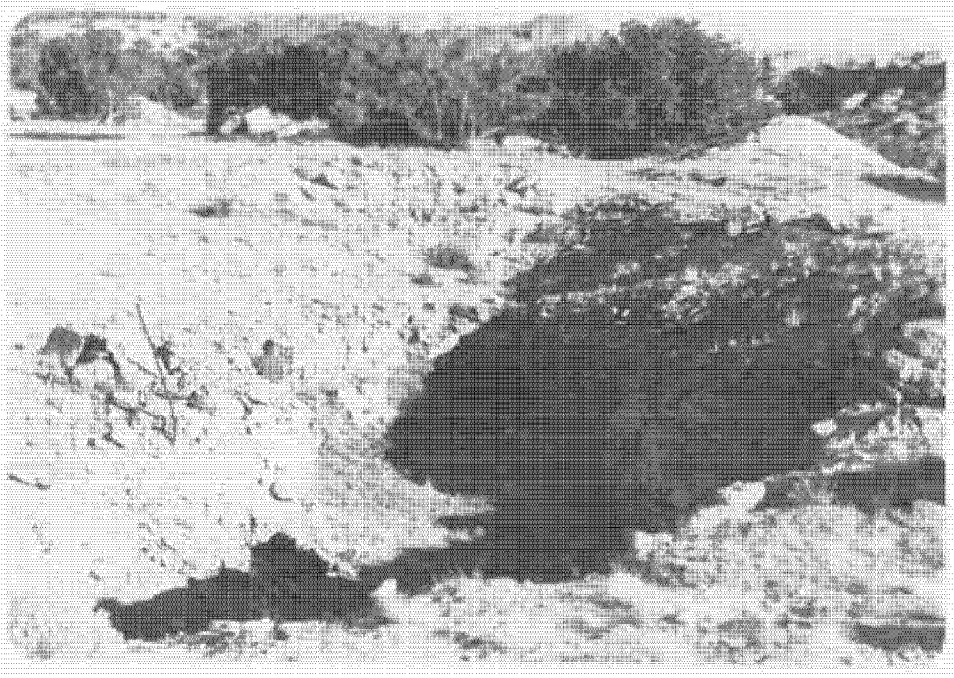
Photo (c) Looking east at deepest pit at the site slightly more than 6' deep; note range pole just left of center for scale.

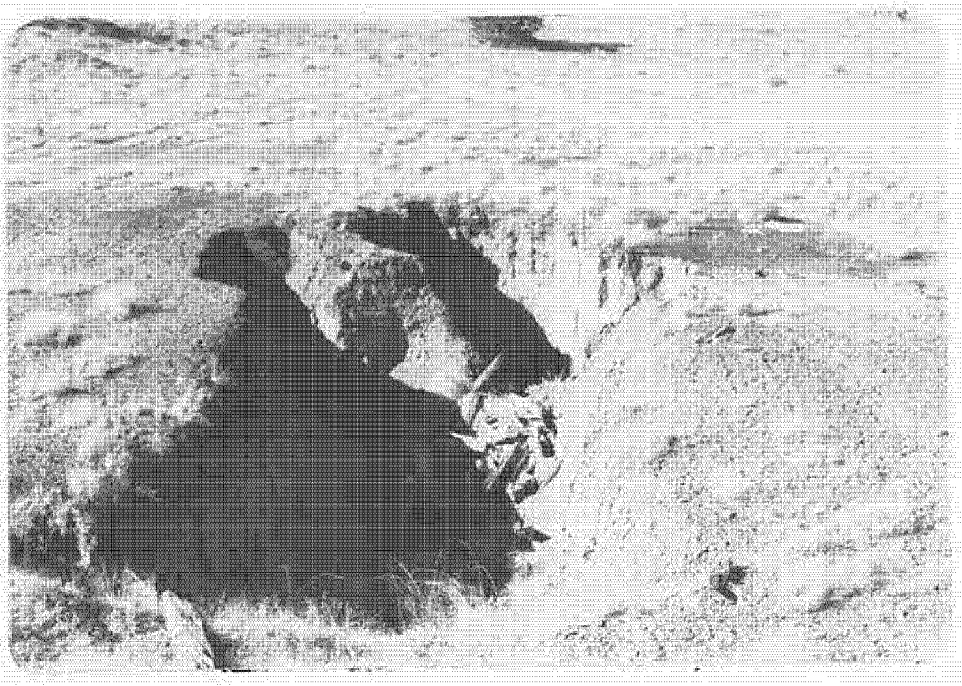
The mine consists of a shaft, a loadout facility, and a long trench with a decline driven at the end; (see Fig. 1). The shaft has caved (photo a) but a portion of the collar or timbering is still visible in the hole. Present depression is circular in plan and is about 10' deep. The shaft may have been inclined.

Photo (a) Looking north at caved shaft; note range pole at right side of shaft for scale.

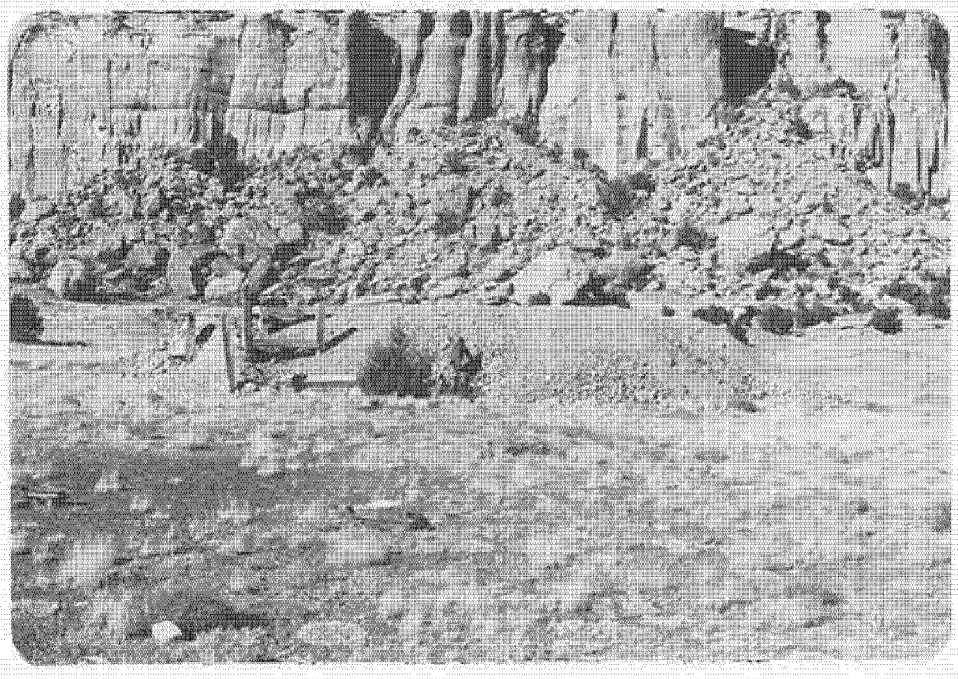
The dump, shown in photo (b), is about 60' x 40', 8'-9' high, and is immediately south of the shaft. A deteriorating wooden load out structure is at west edge of dump. A stockpile area for low grade ore lies 100' south of the mine dump, and consists of a cluster of conical piles up to 3' high spread over an area that measures 100' x 100' (see photo c). Scintillometer readings on these piles ranged up to 1,000 cps. The only building structure remaining on the site is a metal shed (photo d) which stands about 350' southwest of the shaft.

Photo (b) Looking north at mine dump and wooden load out facility at left; note person at center on toe of dump for scale.

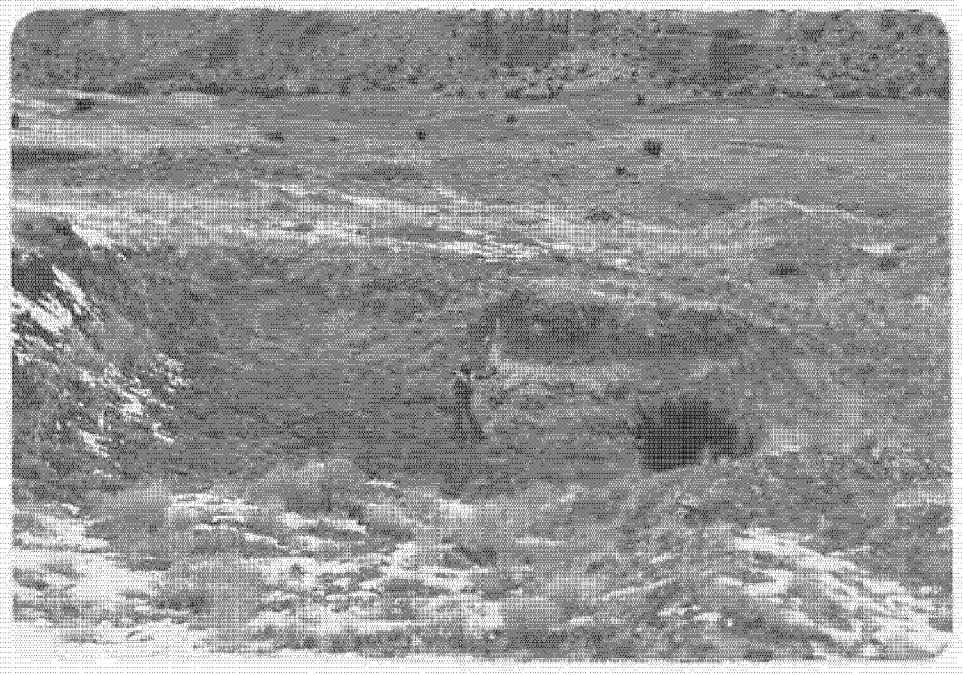
Photo (a) Looking NW into stripped area from SE edge of sec. 24 mine; note overburden piles at upper center and upper left extending for nearly 1,000' away from viewer. Mine trends NW.

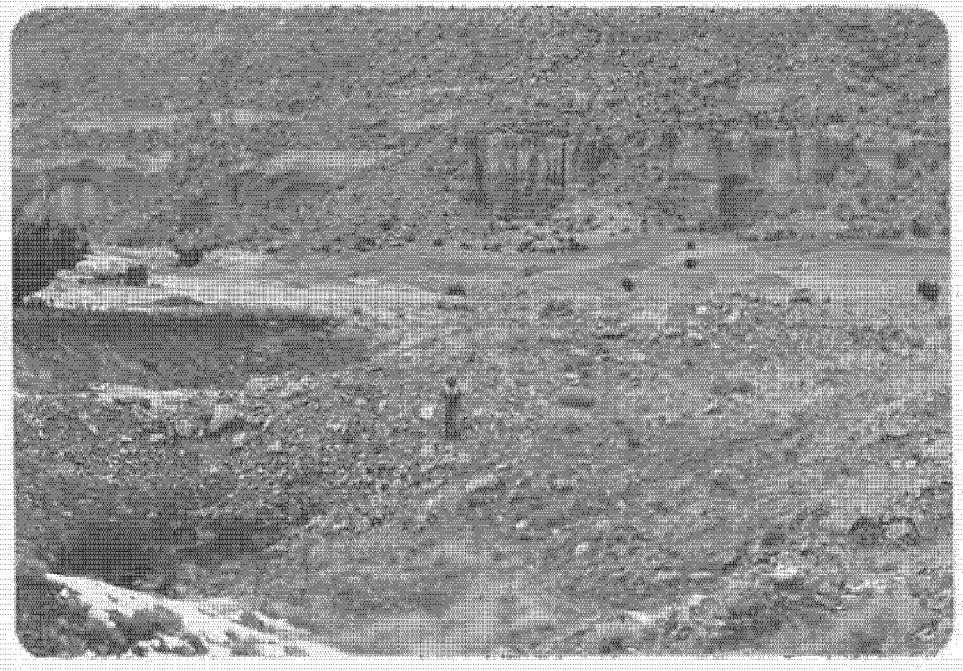
Photo (b) Looking again to NW, from within mine area, showing size and nature of individual pits; unconsolidated overburden is often more than 10' thick as seen in highwall below vehicle at left. Note large overburden and waste piles at center, middle distance.

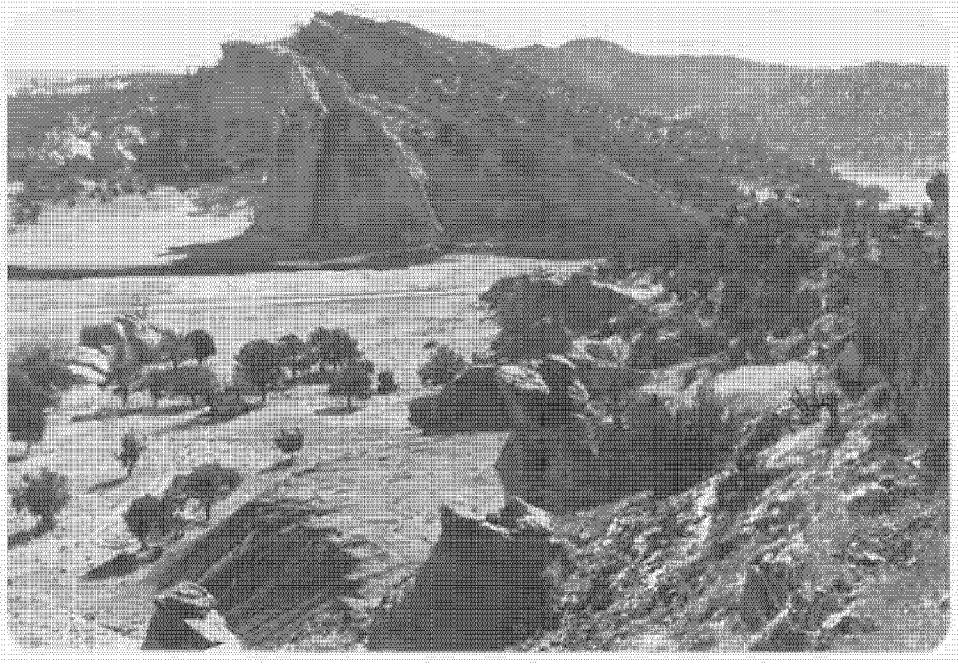
Photo (a) Looking southeast from crest of hogback above Diamond Mine showing Sundance Coal Mine road in middle distance; note mine dump at center foreground.

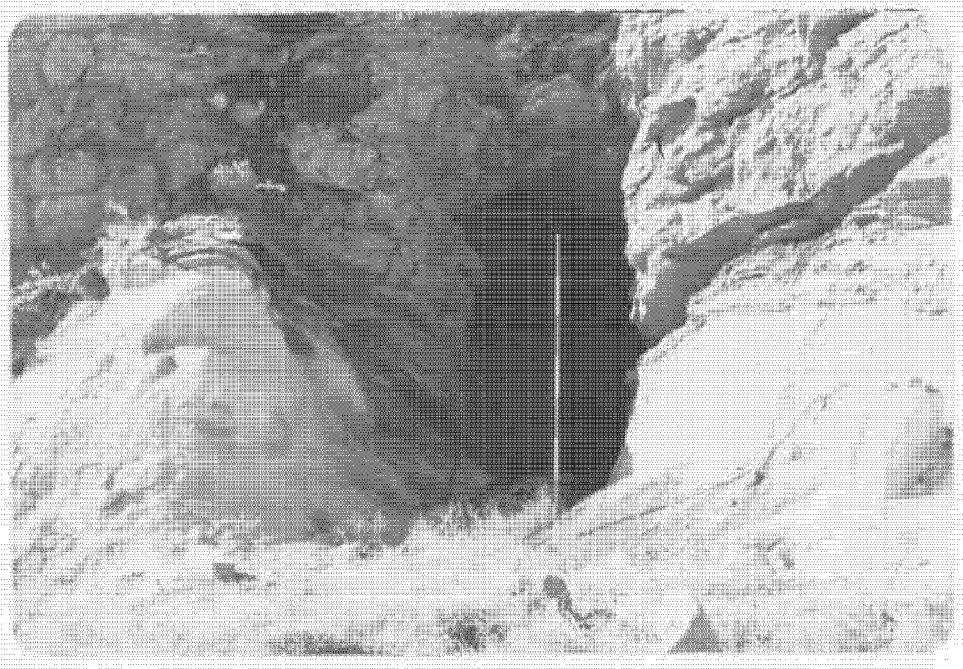
Photo (b) Looking southwest into opening of southern decline.

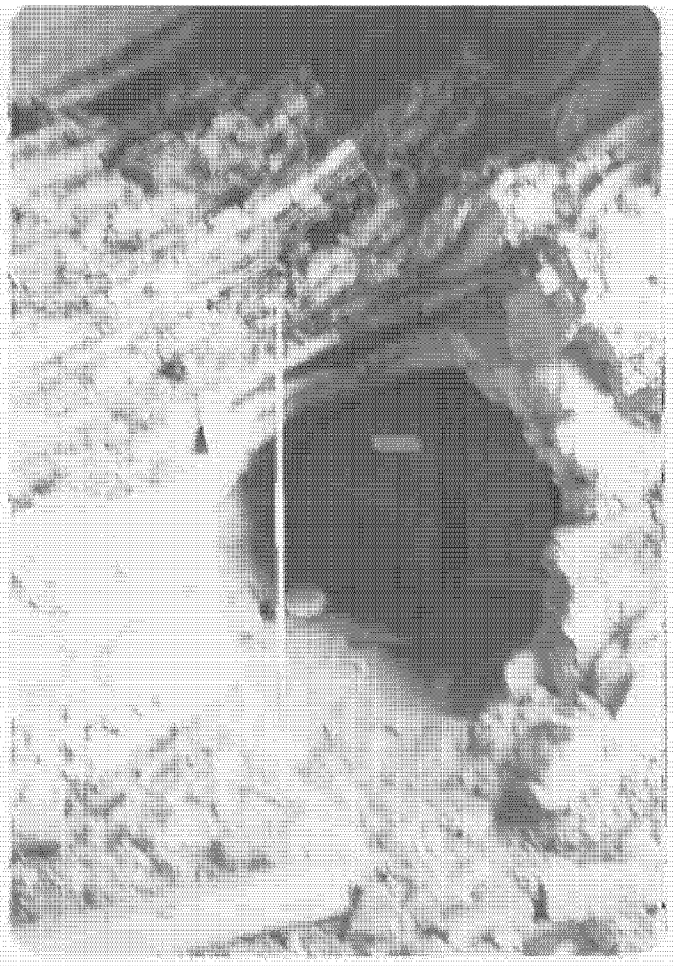
Photo (c) Looking northwest within the southern decline, into powder magazine driven off the side just below a carb. shale zone.

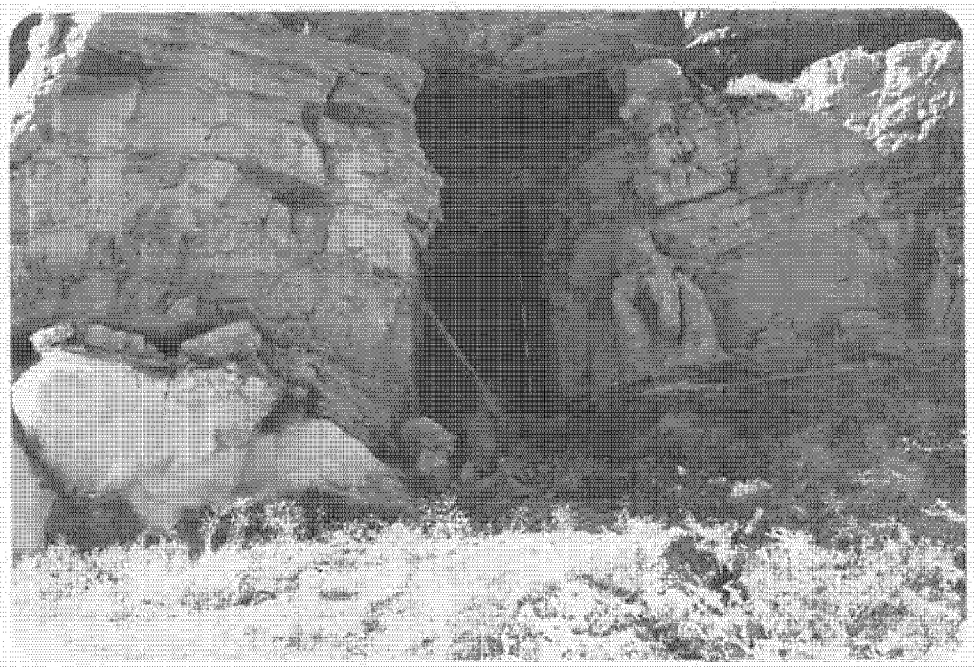
Photo (d) Looking southwest into northern decline, driven down dip just below 4' thick carb. shale zone.

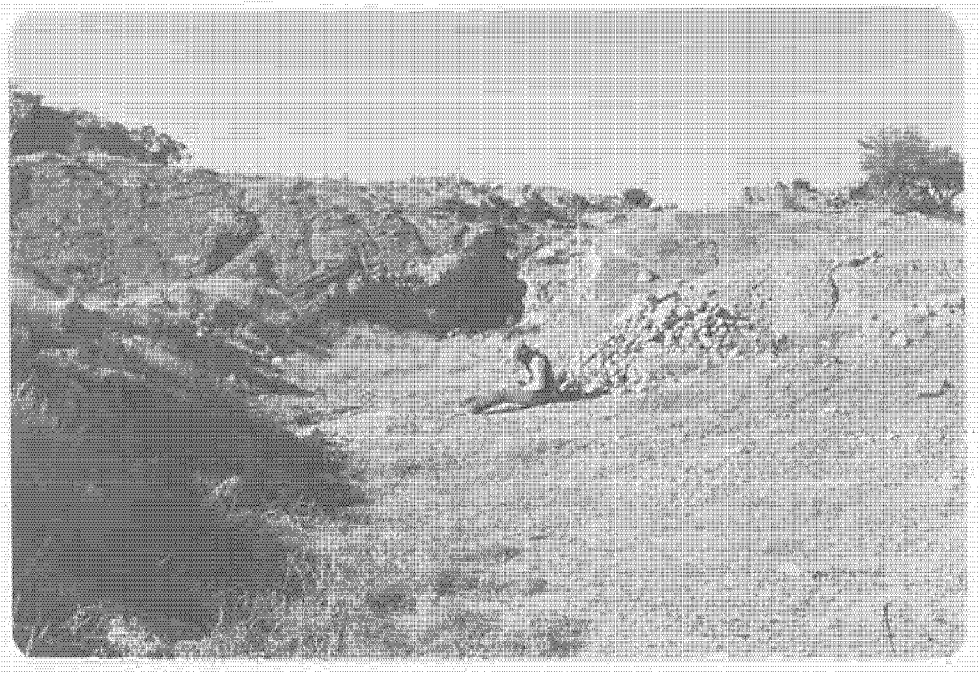
Photo (e) Looking north in main pit near crest of hogback; note small ore pile at left center.

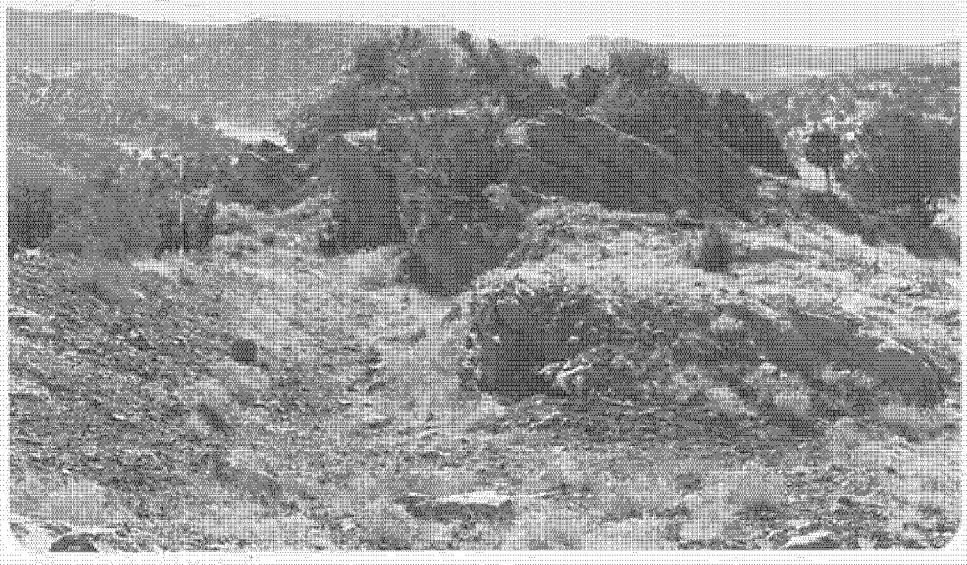
Photo (f) Looking southeast along crest of hogback showing 40' long prospected area.

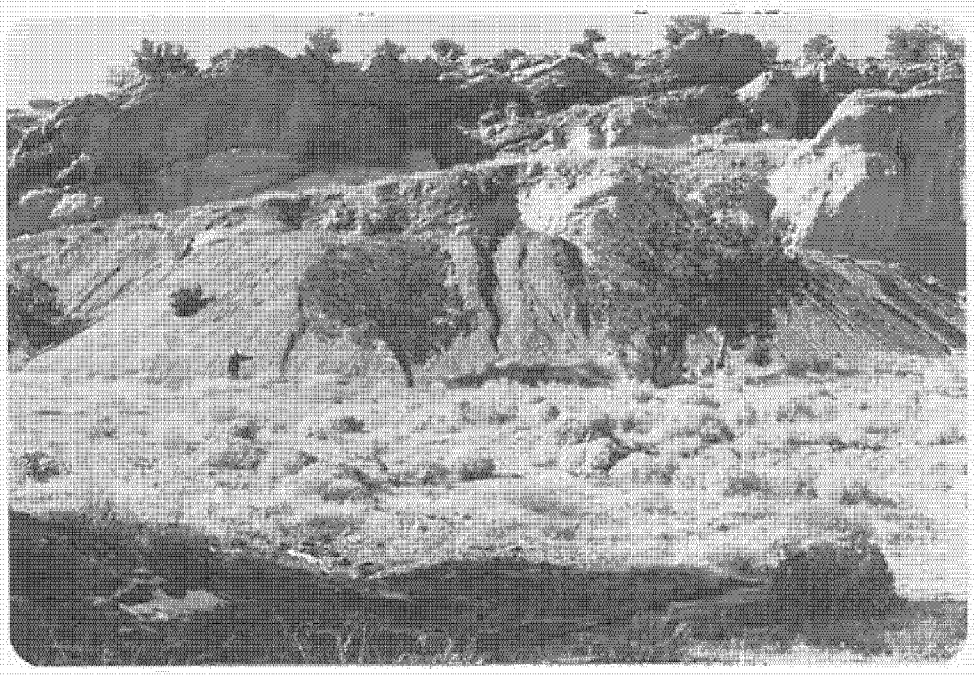
Photo (g) Looking west at mine dump; note portals of the two declines indicated by arrows, and person at lowel level for scale.
