ABANDONED OR INACTIVE URANIUM MINES IN NEW MEXICO

A report of investigation carried out between August 1979 and May 1980 under contract with the New Mexico Energy and Minerals Department.

New Mexico Bureau of Mines and Mineral Resources
Open-File Report 148

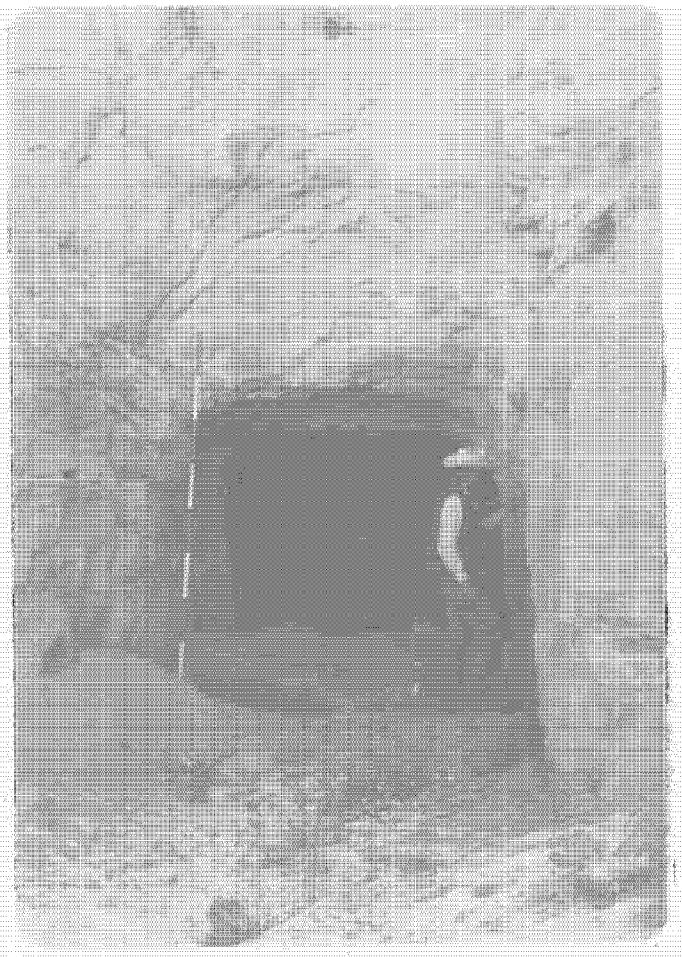
Photo (a) Foutz 3, looking southwest into eastern adit; a jog to left just inside leads to open stope. To right a drift leads to western workings.

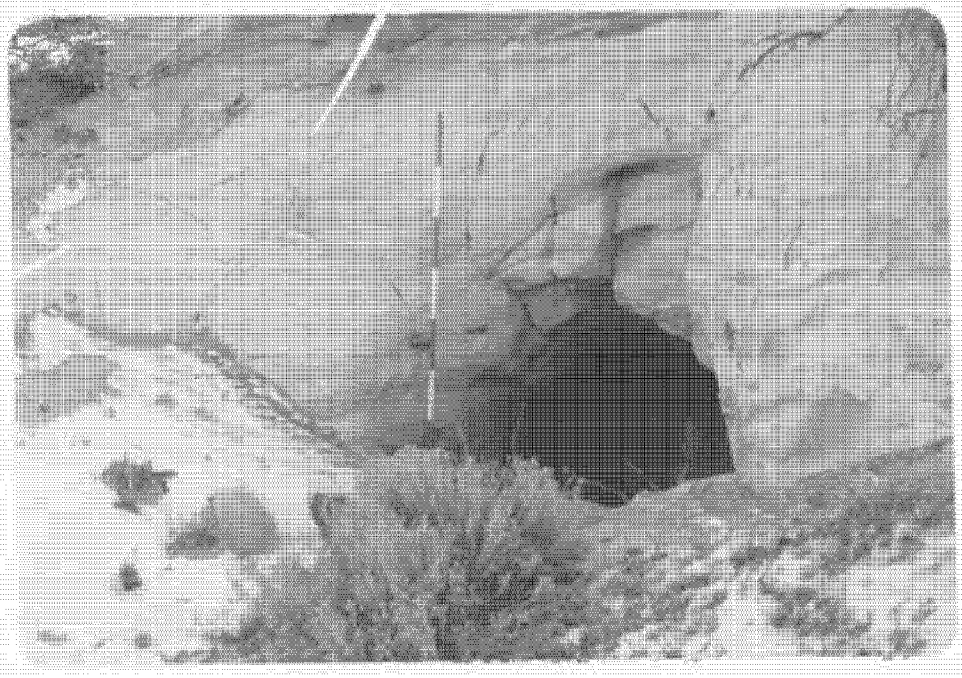
Photo (d) View eastward showing western entrance to open stope area shown in photo (c). Photo (c) was taken from a point just inside this entrance.

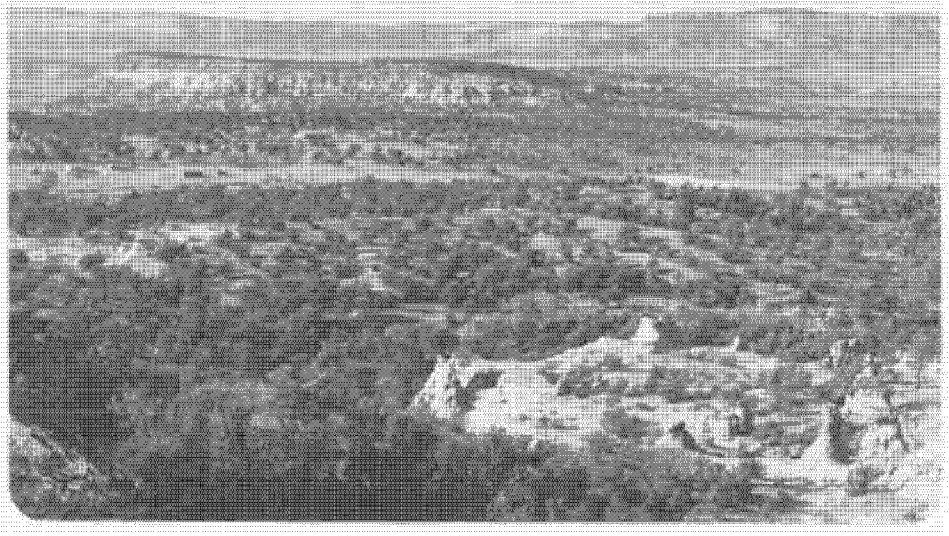
A view westward from the western workings of the mine is shown in photo (f). The numerous dwellings shown in the valley below are about ½ mile away.

Photo (f) View westward from mine showing local topography and proximity of dwellings just visible at left center in middle distance.

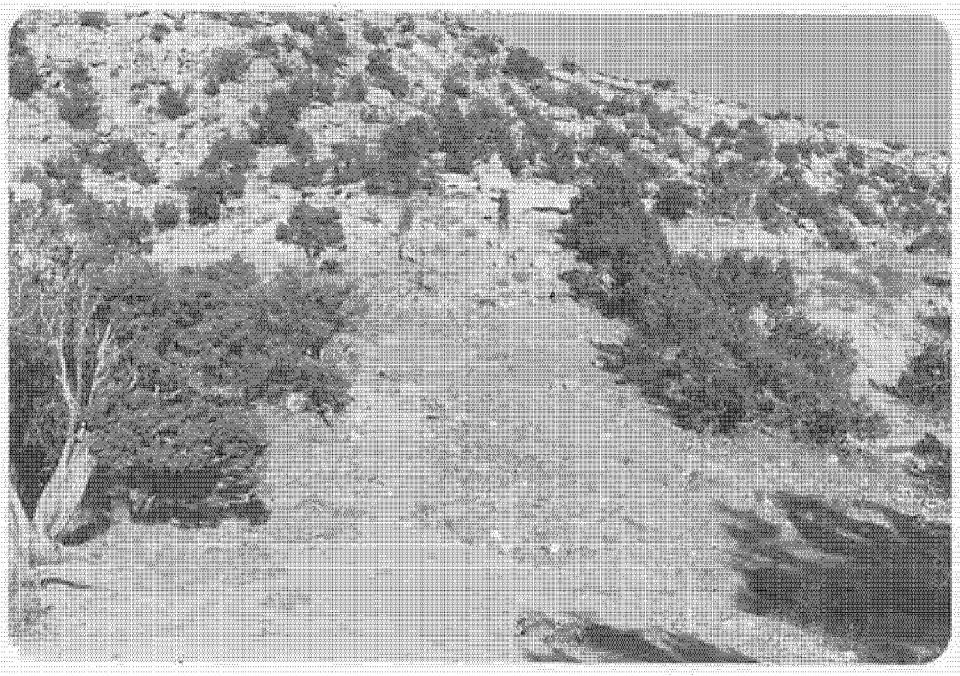
The Foutz 1 consists of a stub adit with a northward heading driven into a nose of the Westwater Sandstone member of the Morrison fm. (see photos a & b). This working is about 20' wide and 6' long; height is difficult to determine due to slumping, but is presently about 3½'. Radioactivity is low, about 2 x background, and no uranium mineralization was noted. The dump appears disproportionately large for the size of the workings, being of the order of 150' x 100'.

Photo (a) Looking N-NE at access road to Foutz 1; person in photo standing on mine dump.

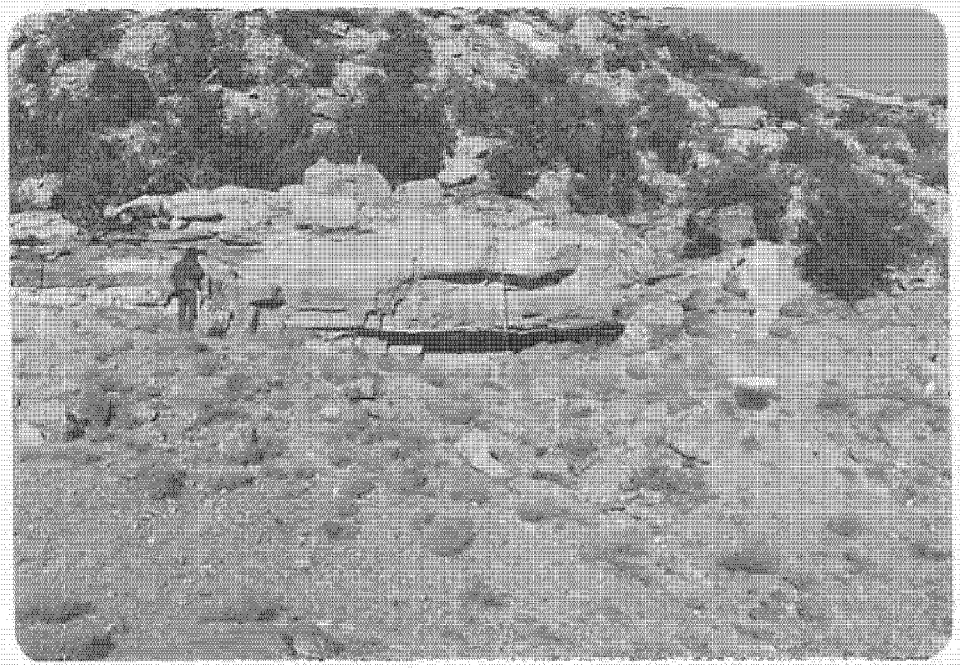
Photo (b) Looking N, into beginnings of adit on Foutz 1 claim, Sec. 4.

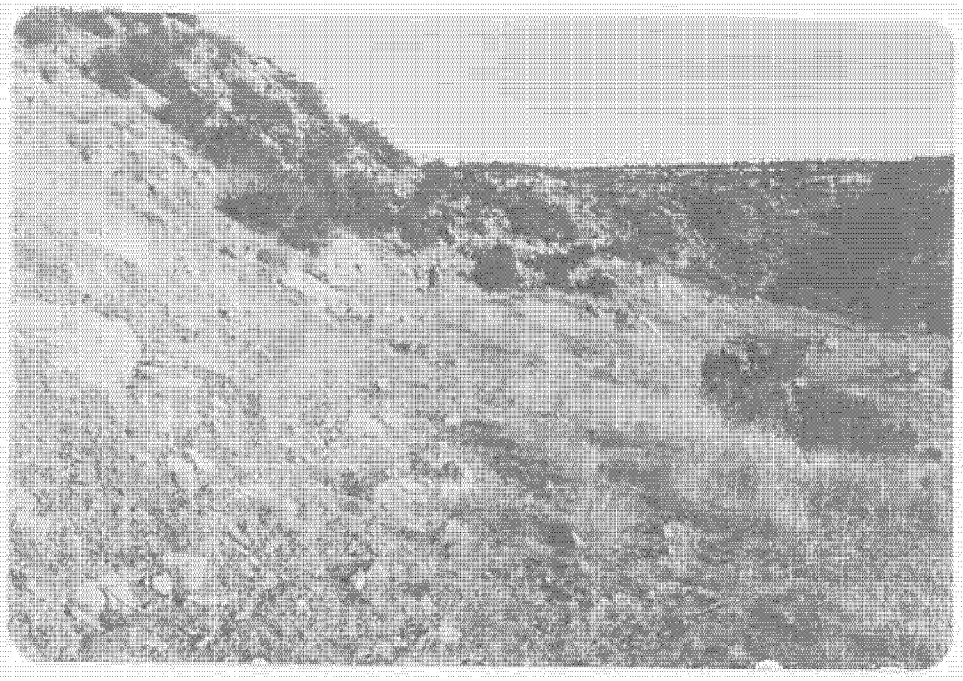
The Foutz 2 lies adjacent to the #1, about 300' to the west. A 110' long E-W dozer cut is the primary workings (see photo c); south trending adit referred to by Hilpert, 1969, is not in evidence. Scintillometer readings in the cut were about 120 cps (or 2 x background) and no uranium mineralization was noted.

Photo (c) Looking E at 110' long bulldozer cut on Foutz 2 claim.

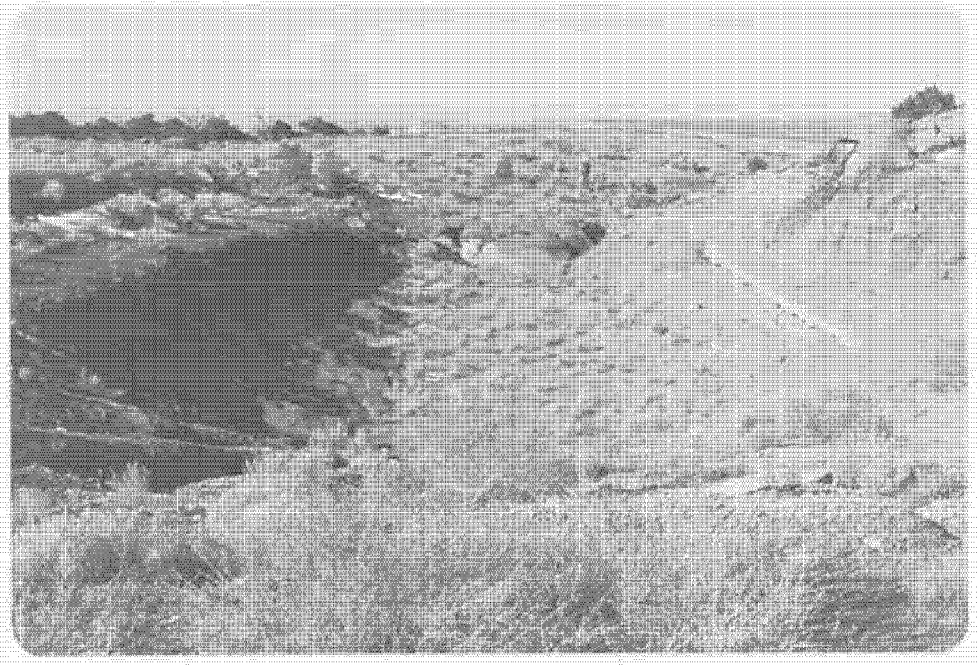
The Williams and Reynolds is an open pit 40' wide north to south, 125' long east to west, with the north face being 20' high, and the south face 10' high (photo a). The dump directly west of the pit is 75' x 100' x 8' high (photo b). Several smaller waste and ore piles are found to the east and south of the pit.

Photo (a) Looking west at the William and Reynolds open pit.

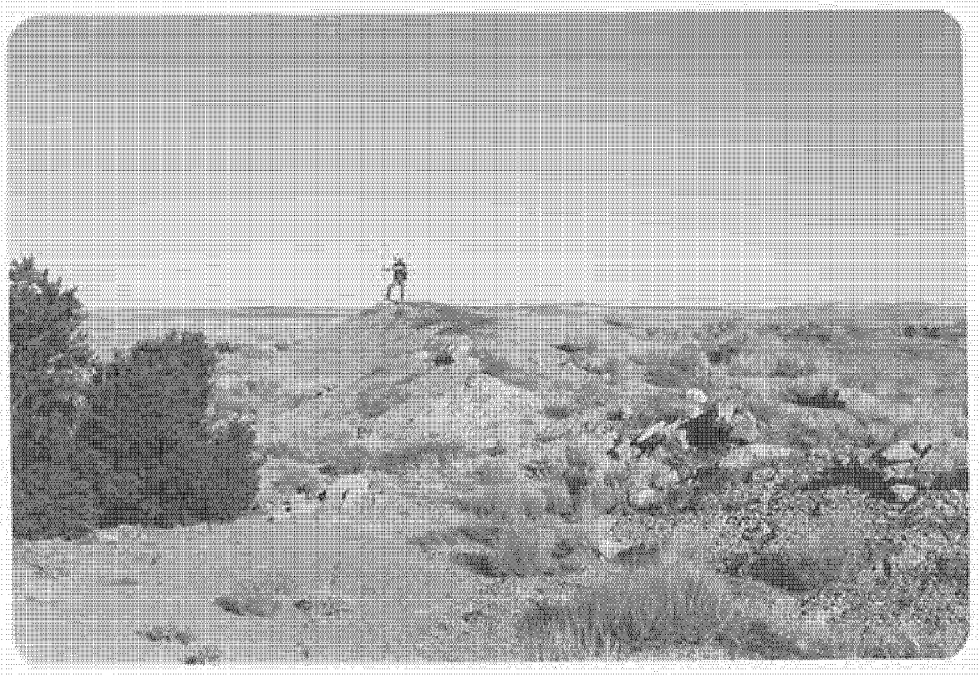
Photo (b) Looking north at the western dump of the William and Reynolds open pit.

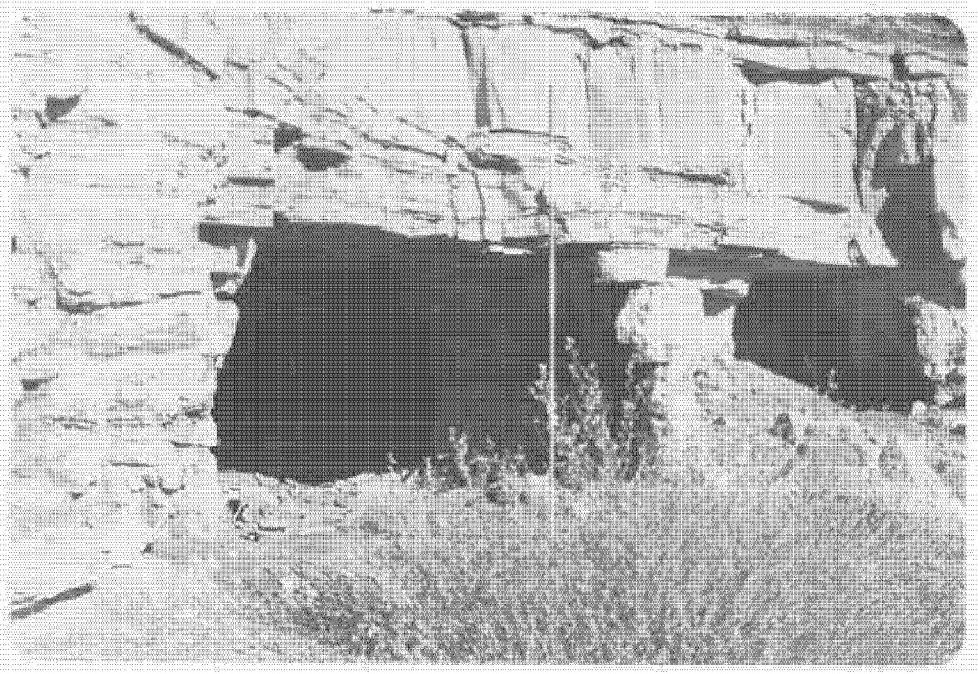
Photo (a) Looking northward into westernmost workings of Rimrock #2 group; entrance to main adit is 6' high; stub adit on right is only 3' deep.

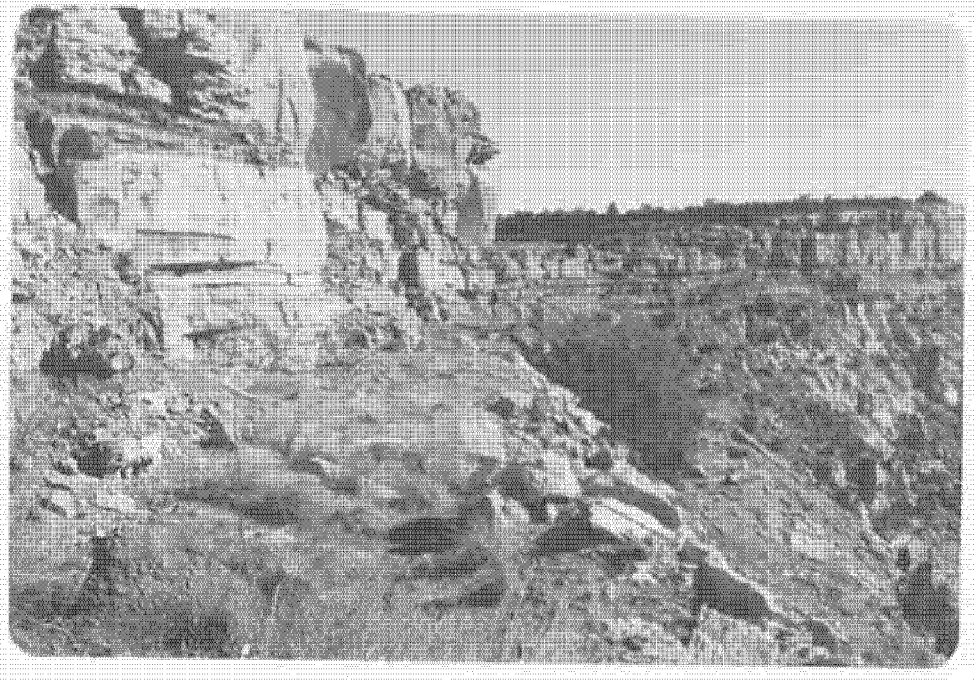
Photo (b) Looking eastward from the westernmost workings showing mine level road; note person on road for scale.

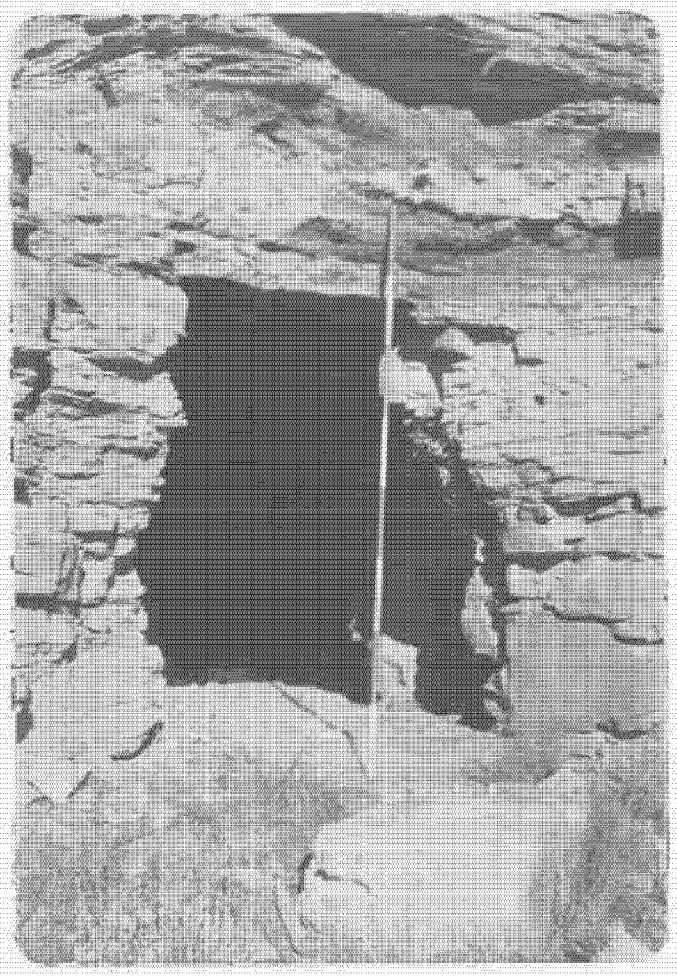
Photo (c) Next adit to east of workings shown in (a).

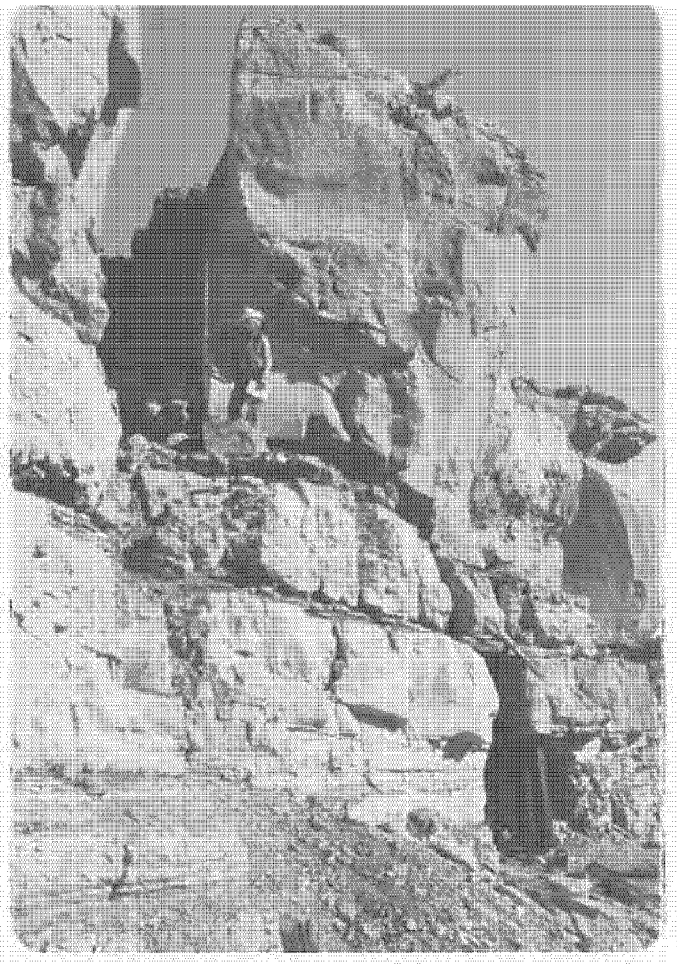
Photo (e) View northeastward at main adit showing portal at lower right and notched cliff for ore hoisting at upper left.

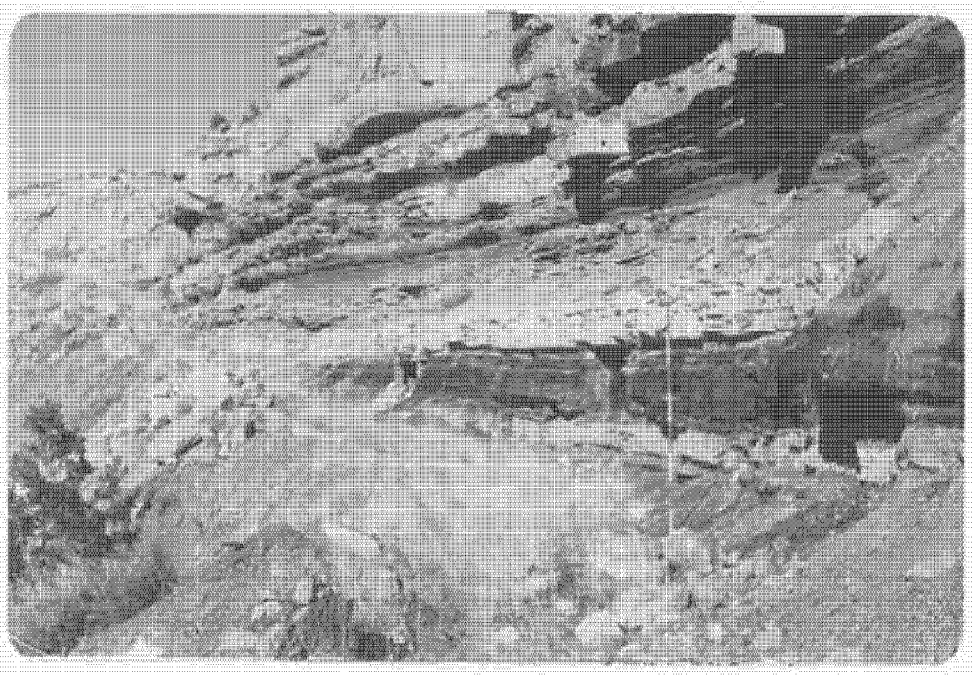
(4) 1500' east of the above is another group of closely spaced adits that extend for several hundred feet along the carbonaceous zone outcrop and approach the east sec. line or perhaps cross it. The first is shown in photo (g). It is driven in the thickest and lowest carb. shale zone, here about 4' thick; it is reached by the road descending to the east from the mesa top as shown in photo (g). The adit is 7' high, 4' wide, is timbered the first 20', and goes back a total of 60' or more; scintillometer readings up to 1700 cps. were noted. Immediately east of this adit is another small adit, partially caved at entrance, that has a 5' x 6' opening and goes back nearly 100' feet (see photo h); scintillometer readings ranged from 1000 to a high of 2600 cps.

Photo (g) Looking westward at adit with timbered portal (left of center) and dump of another adit at far right.

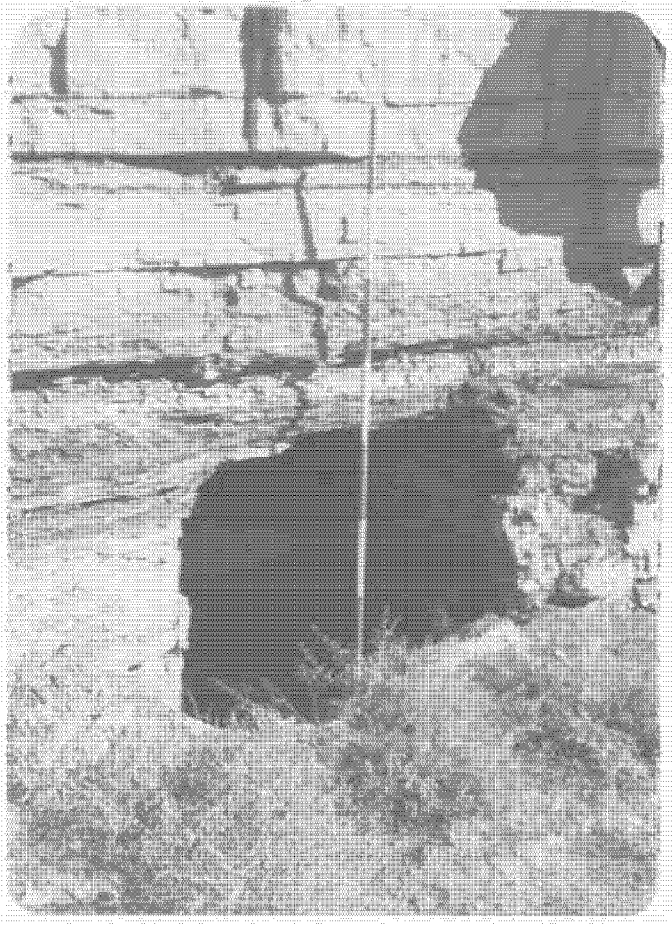
Photo (h) Looking northeastward at the adit just off the right edge of photo (g).

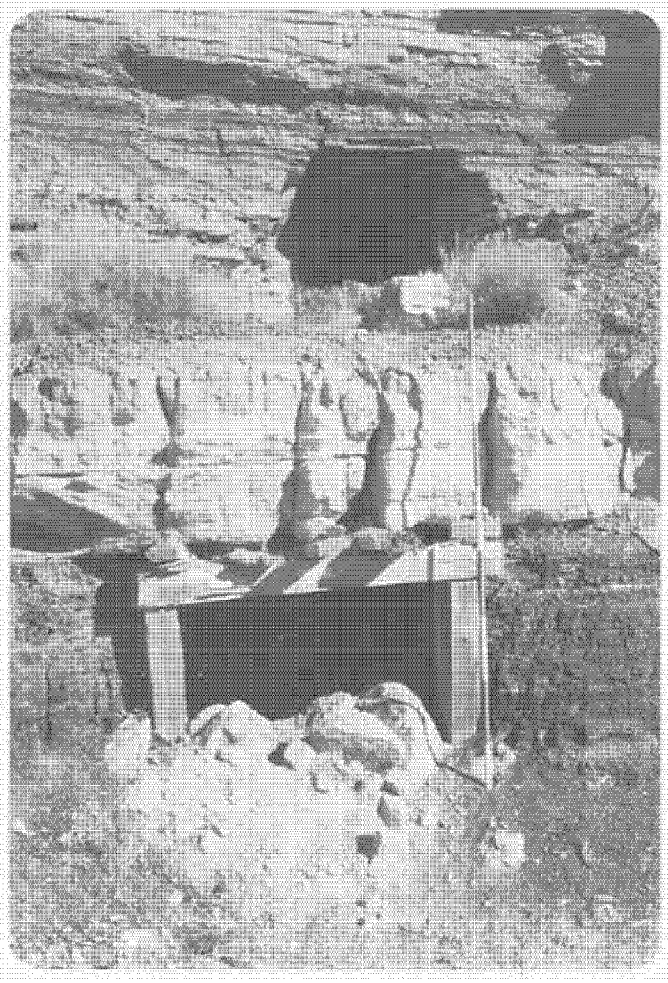
Photo (i) Looking northward into timbered adit in group of eastern sec. 4 workings; note small adit begun above timbered portal.

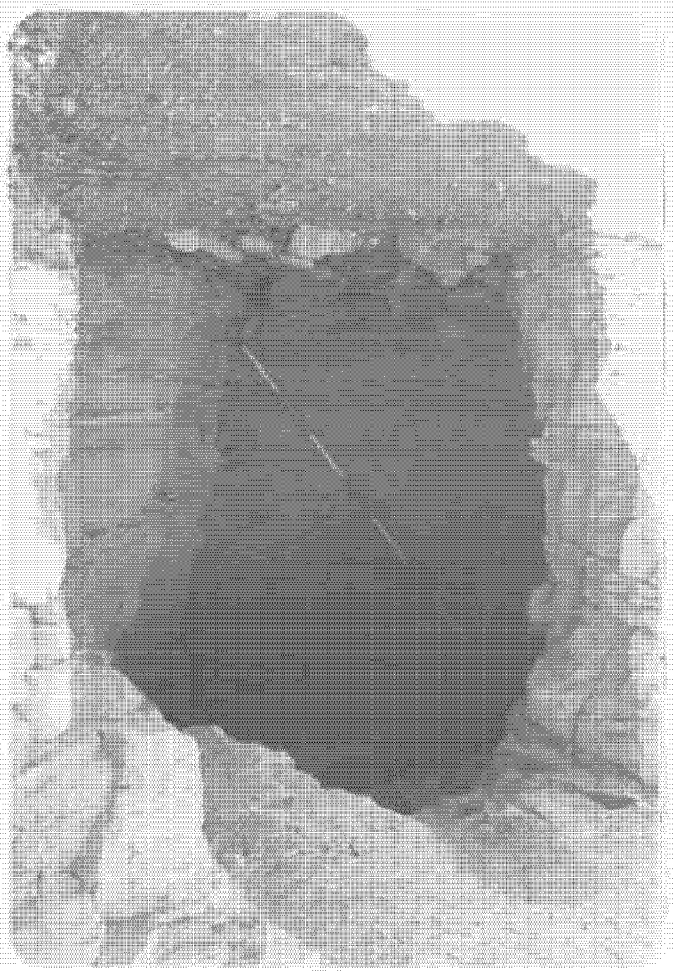
Photo (j) View northward into easternmost adit of the sec. 4 Rimrock workings.

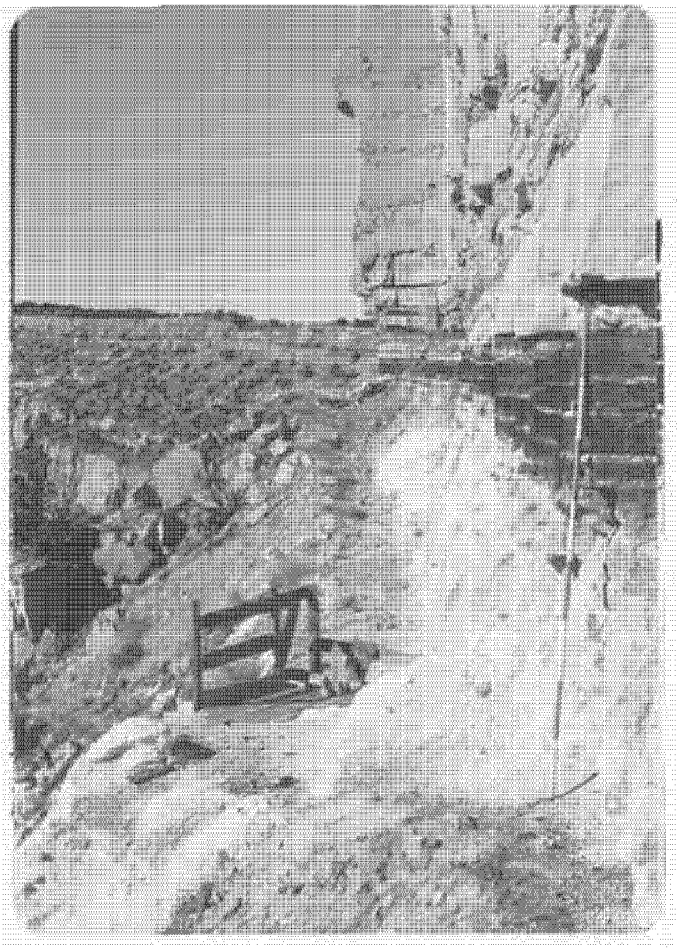
Mineralization is in a coaly, carbonaceous shale zone 15-20' above the base of the Dakota Sandstone (photo a). A yellow-green mineralization (perhaps tyuyamunite) was noted on some of the carbonaceous material. Scintillometer readings on the road below the adits averaged 220 cps, while the large adit had a maximum reading of 2,200 cps and the eastern adit had a maximum reading of 3,100 cps.

Photo (a) Looking west at access to the Santa Fe Christensen. Note wooden platform in foreground, and Christensen adit circled in background.

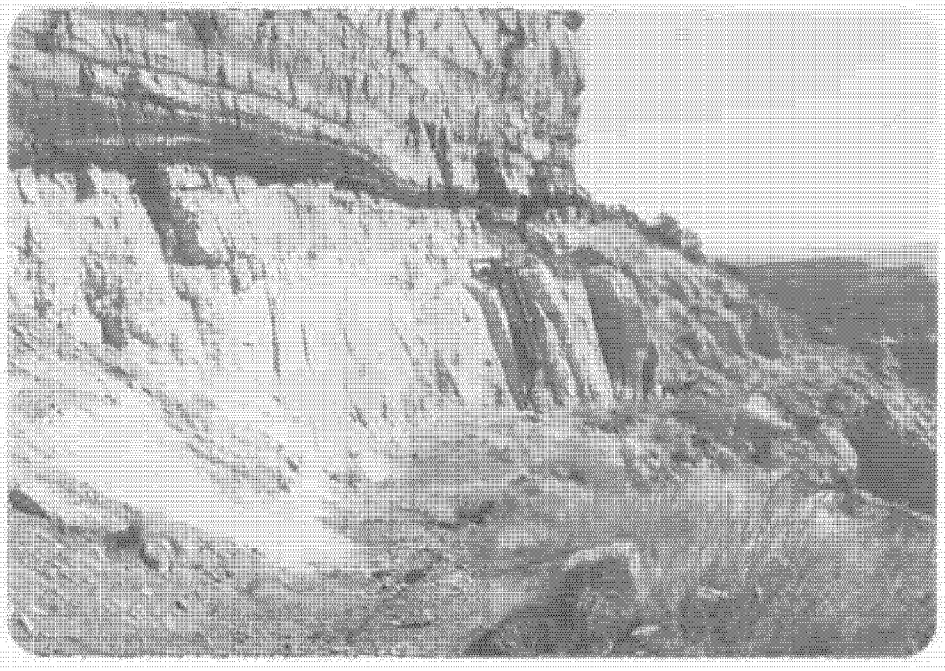
The workings consist of two adits located 25' above the road surface, which must be reached by a wooden ladder (photo b). The westernmost, and largest of the adits is 6' x 6' x at least 60' deep (photo c). The portal and the first 15' of the adit is timbered. The second adit is 125' east of the larger western adit, and is 4' high x 6' wide x 15' deep (photo d). Ore was brought to road level through an ore chute (photo e), located between and below the two adits. No dump was noted below the workings, indicating that most of the material was removed by truck.

Photo (b) Looking east at ladder leading to Santa Fe Christensen adits (circled). The ore chute (lower circle) is just to the right of the ladder.

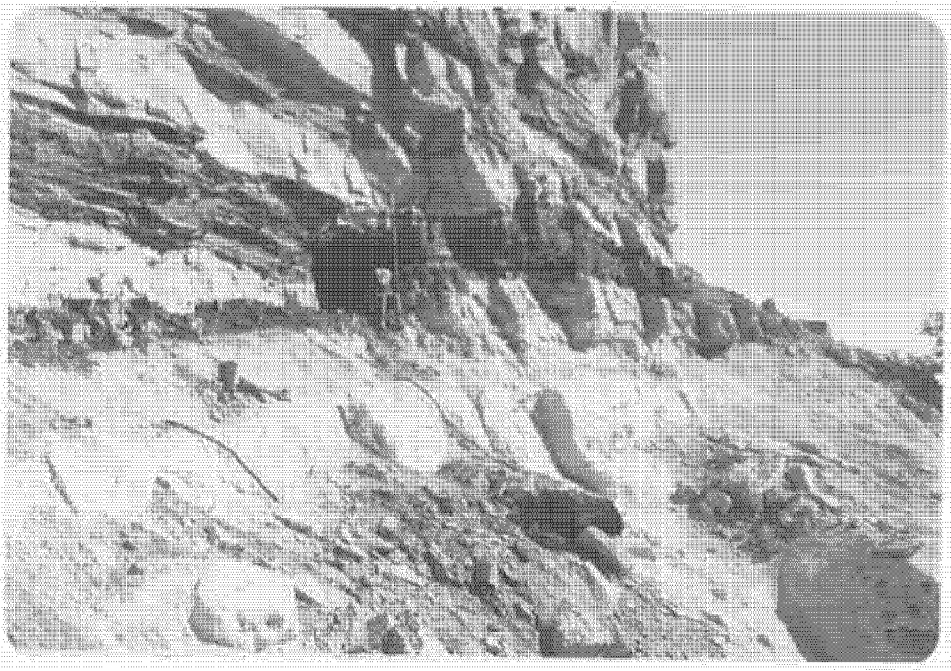
Photo (d) Looking east at the smaller adit on the Santa Fe Christensen workings. The adit is 125' east of the larger adit.

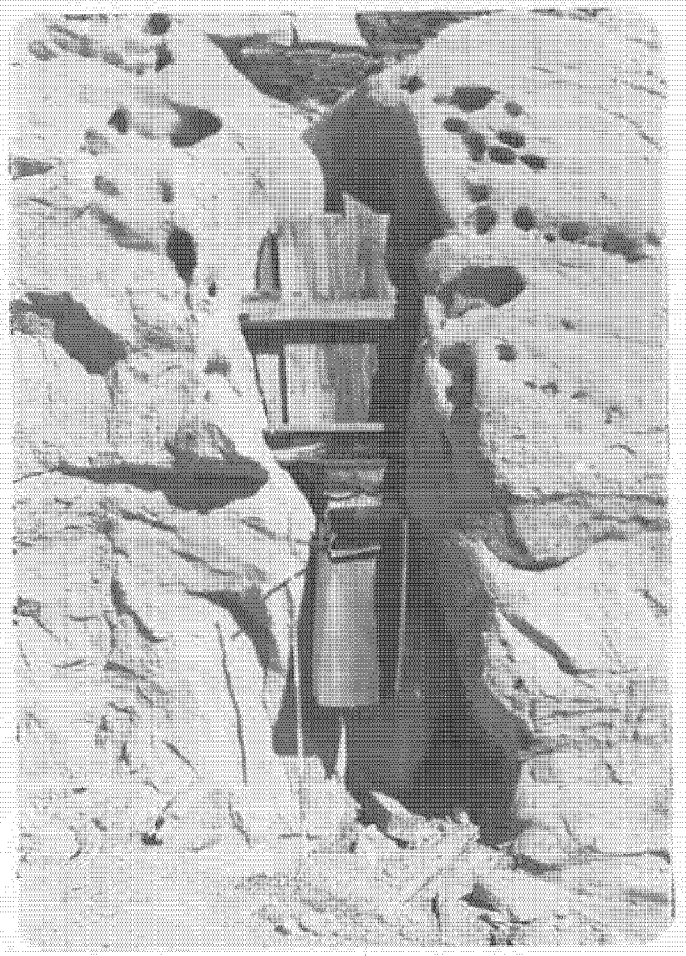
Photo (e) Looking north at the ore chute below the two Santa Fe Christensen adits.

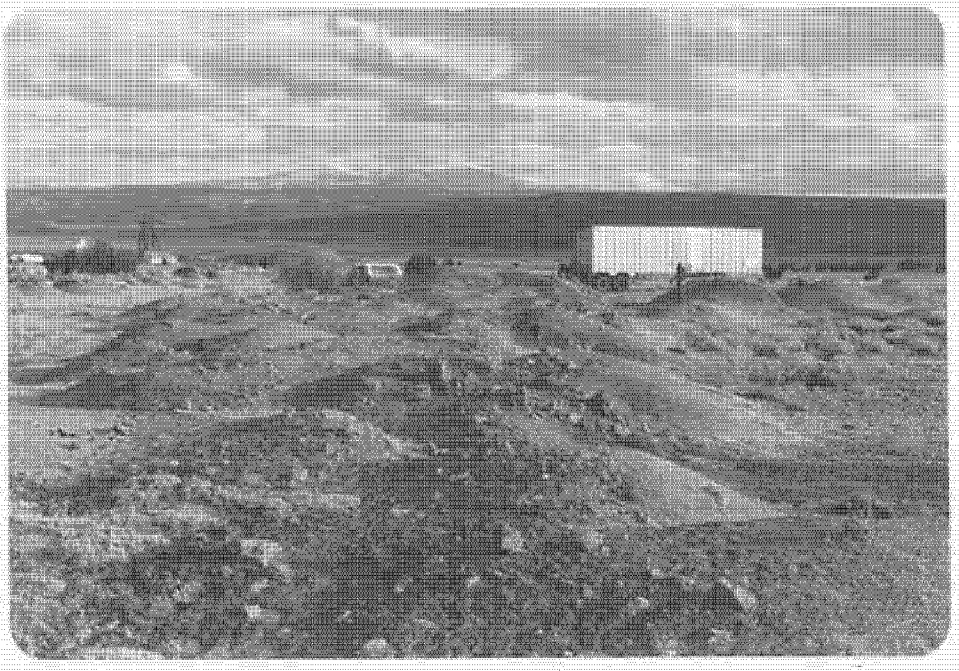
Photo (c) Looking northward at a dumping area just north of the mine shaft. Trailer rig is property of Koppen Mining Construction Co.; Mt. Taylor in background.

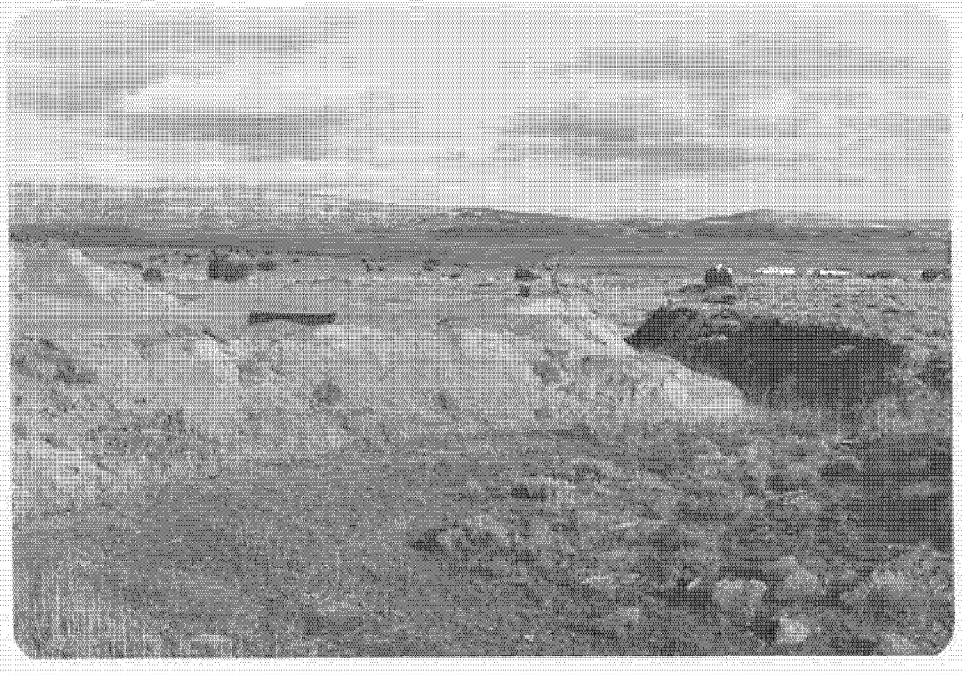
Photo (d) Looking eastward down small drainage that passes near southern edge of the dump area. Note person on left bank of drainage for scale.

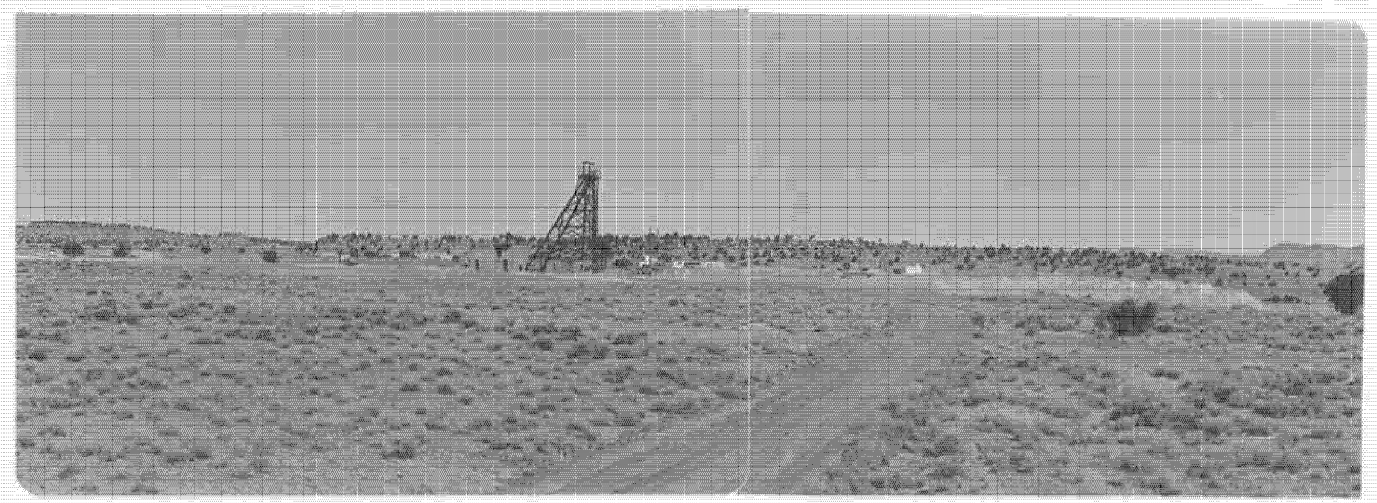
The metal Headframe, several buildings, and a sizeable tailings dump remain at the site (see photo a). A portion of the dump is comprised of very low grade ore, unacceptable at the mill at present. No detailed measurements were made at the site due to the very recent closing. Scintillometer readings along south edge of the dump area ranged from 300 to 600 cps., or up to 9 x background. Mine is on federal land.

Photo (a) Looking northward at the Spencer Mine site and tailings dump.

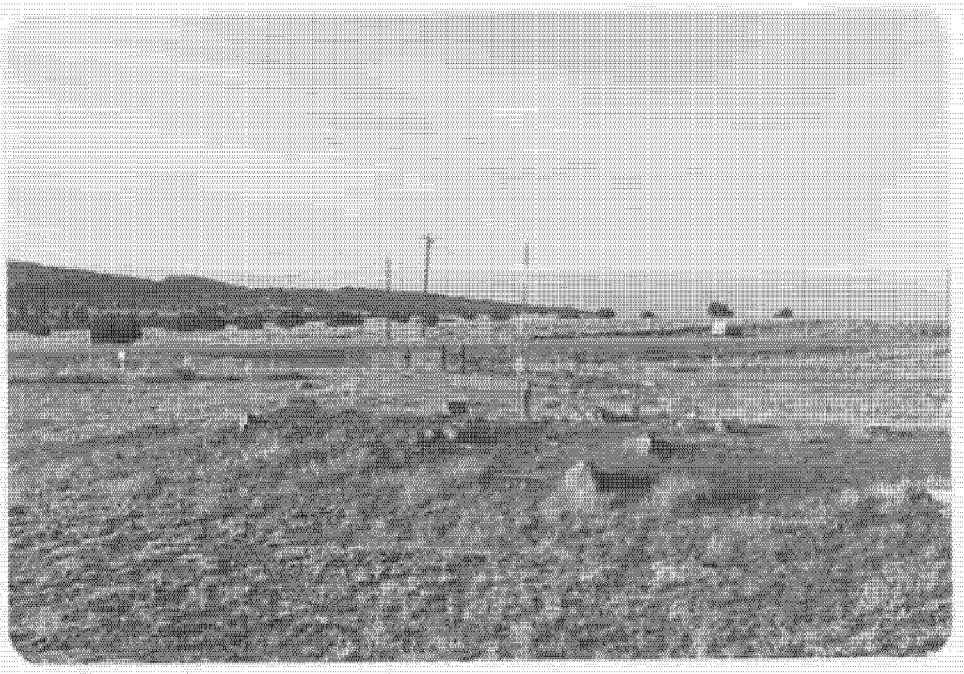
Photo (a) Looking southwest at Hogan Mine shaft site; note highway no. 53 in background and range pole (center) for scale.

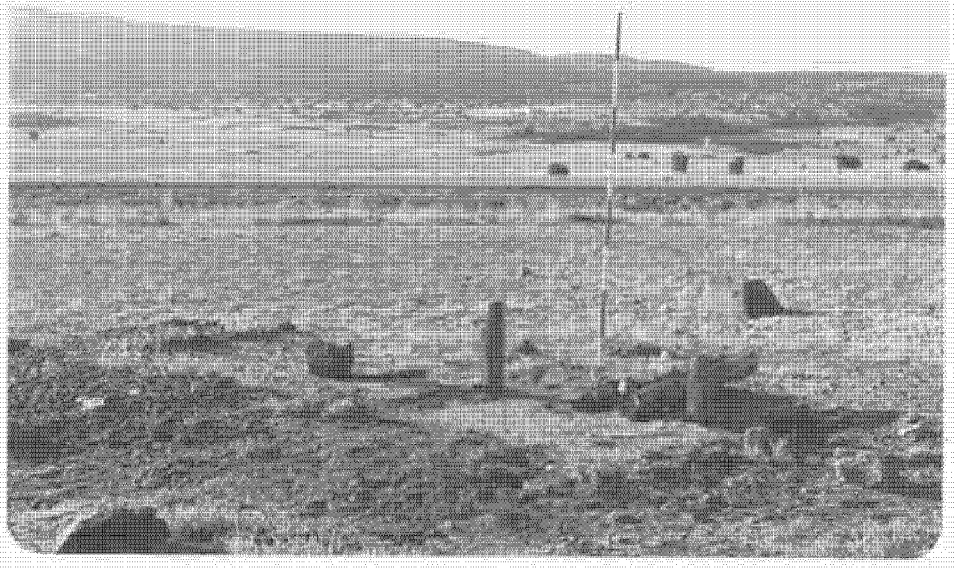
Photo (b) Close-up looking south at concrete slab over the mine shaft. Note head frame footing behind slab to right. A small amount of caving has begun near corner of slab at right. Marquez Mine is visible at center background.

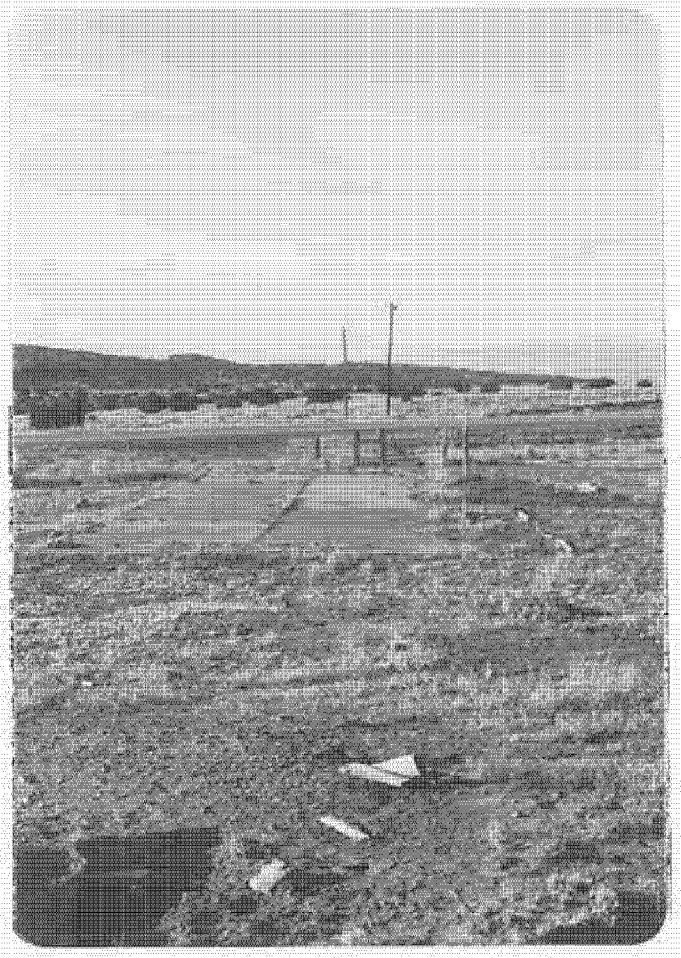
Photo (c) Looking southwest at concrete slab for hoisting equipment and maintenance shop.

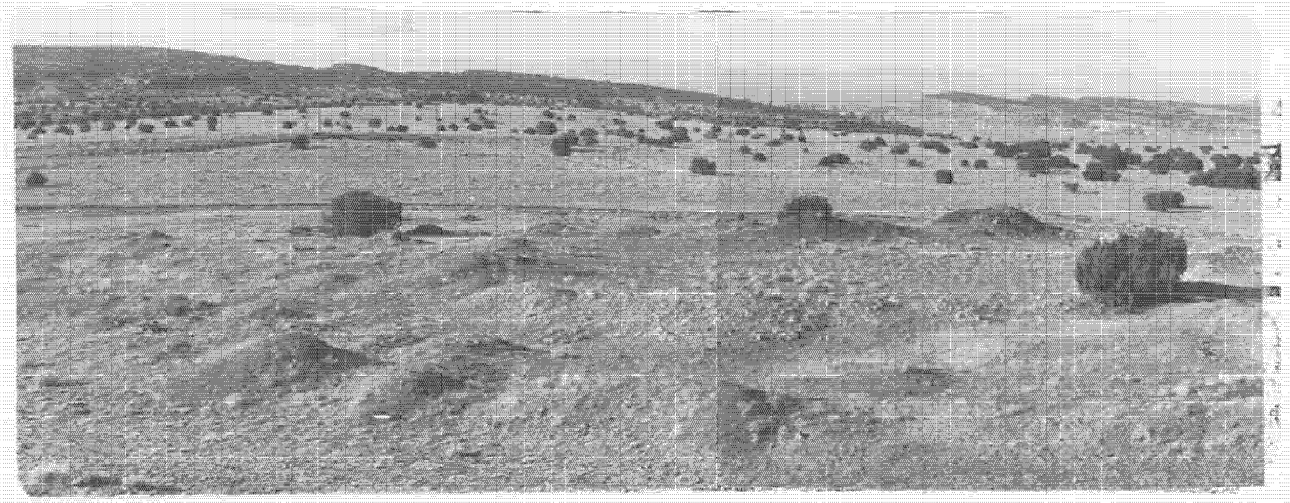
Photo (e) Looking westward showing dump area with small scattered 3'-4' high waste piles; area measures 220' N-S, but there are patches within that have no waste material. Ambrosia Lake junction (numerous light colored buildings) is visible at right in the distance 1½ mi. away; note range pole at left of center for scale.

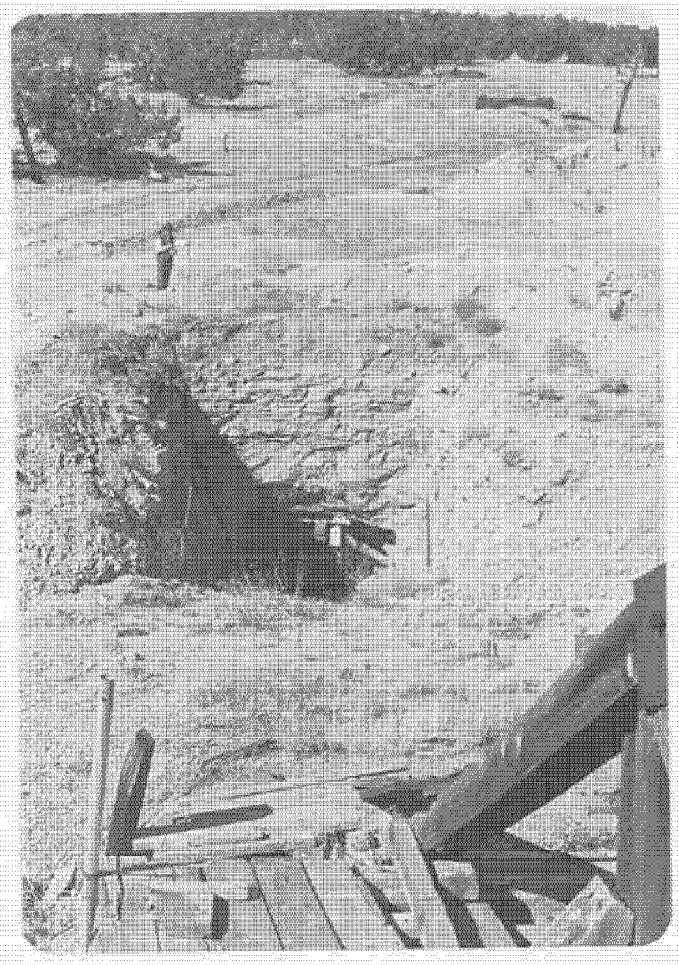
Photo (a) Looking westward into Gossett Incline from the headframe; it is presently in use as upcast air ventillation shaft for Poison Canyon Mine.

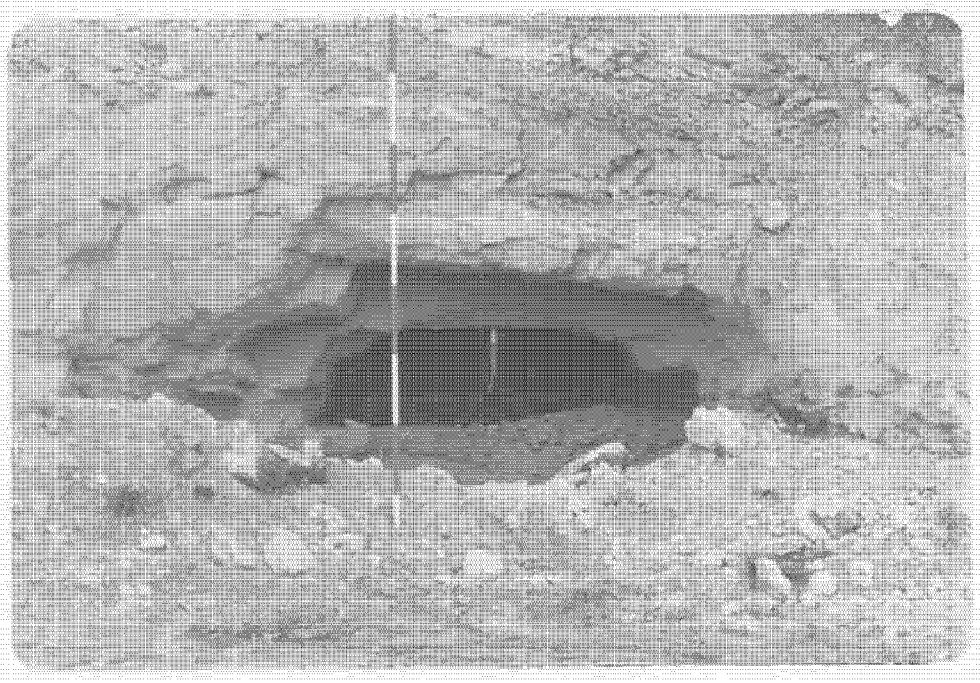
Photo A Looking northward at easternmost workings at Blue Peak; adit is 3½' high, 10' wide, 12' long; (may be only powder magazine but scintillometer read 1700 cps).

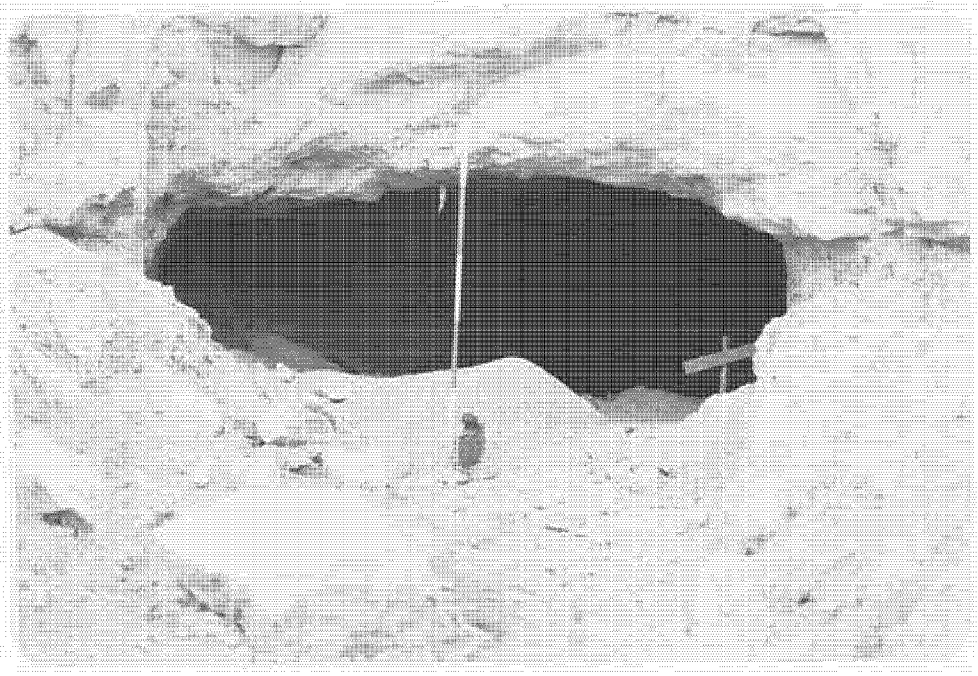
Photo B Looking northward at second adit 85' west of A; portal is 4' high, 9' wide and tunnel continues on a N 25° W trend for at least 100'.

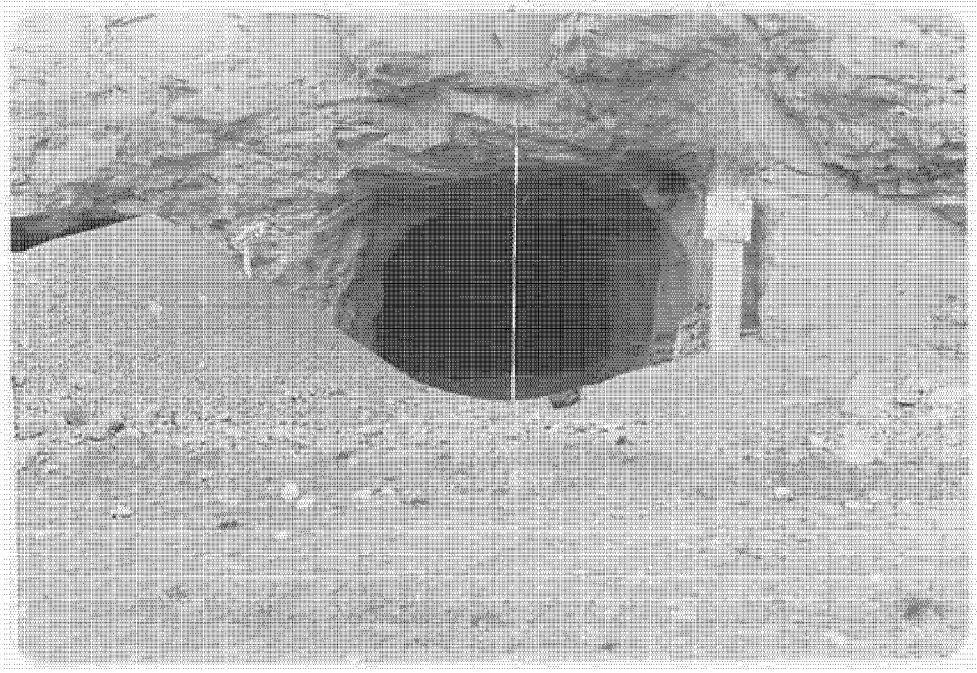
Photo C Looking northward at 3rd adit going west; portal is nearly 6' high, 7' wide, and continues on a N 15° W trend for as far as light goes (at least 75').

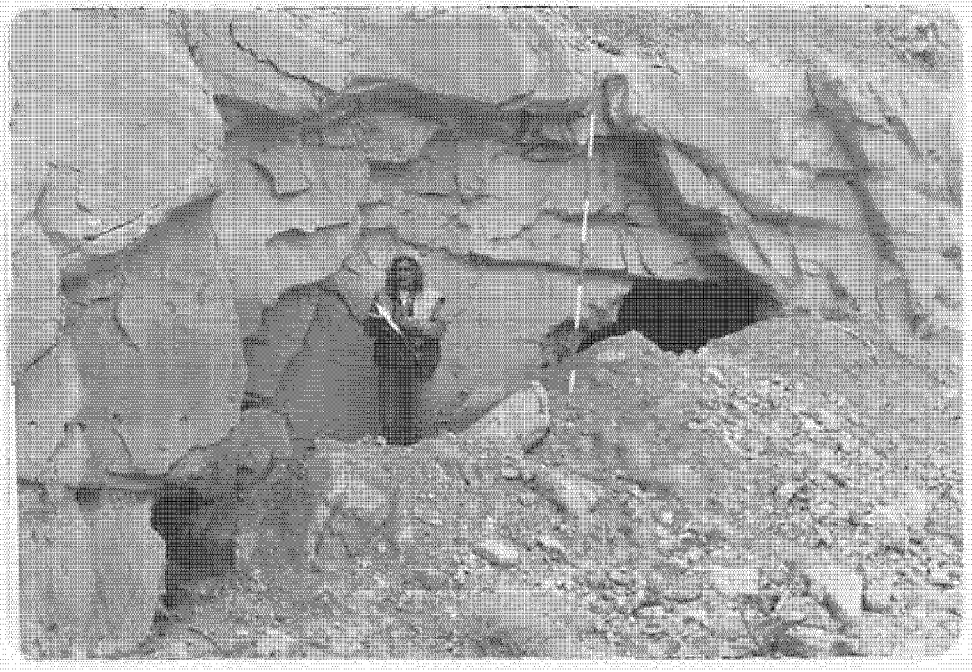
Photo D Looking northward at 4th workings in series, 200' west along outcrop from No. 3 in C; probably consists of a pair of gopher holes, each about 3' deep, but left one has caved or has been blasted.
