ABANDONED OR INACTIVE URANIUM MINES IN NEW MEXICO

A report of investigation carried out between August 1979 and May 1980 under contract with the New Mexico Energy and Minerals Department.

New Mexico Bureau of Mines and Mineral Resources
Open-File Report 148

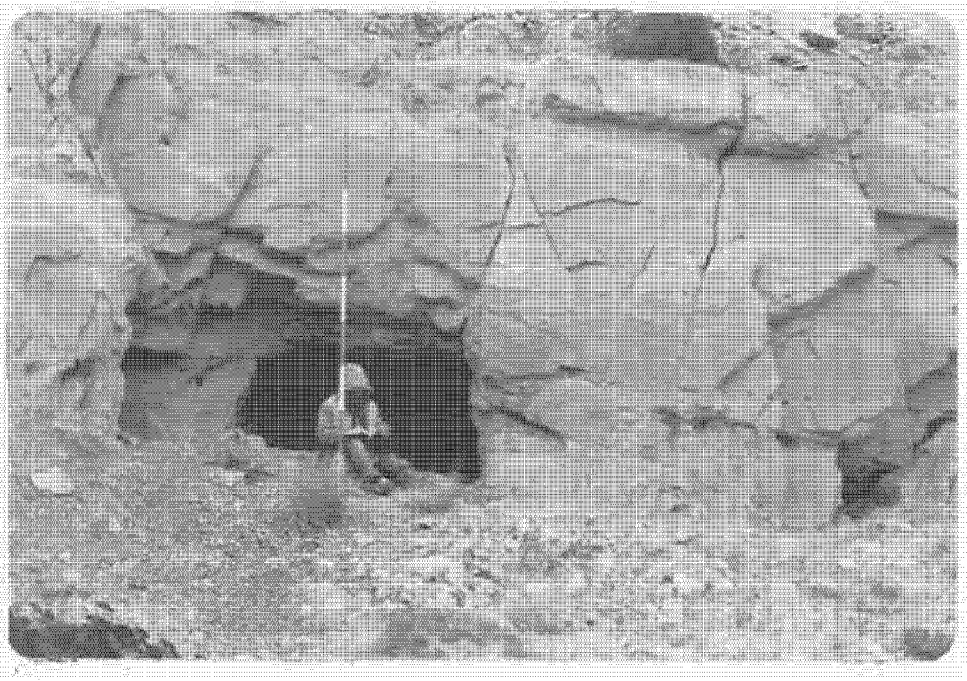
Photo E Looking northward at 5th workings, 15'-20' west of No. 4 shown in D; portal is 4' high, 6' wide, but adit is a stub going in only 4'.

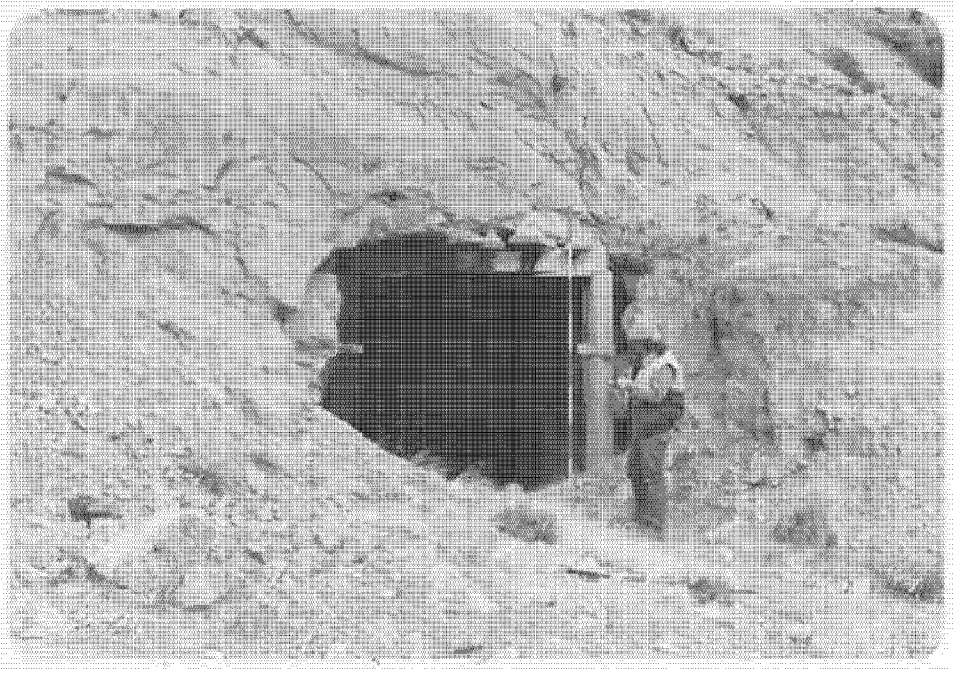
Photo F Looking northward at last or westernmost adit on Blue Peak workings, 85' west of stub shown in E. Portal is 7' high, 8' wide, and adit continues on a N 15° E trend for at least 75' at which point there may be some room and pillar structures.

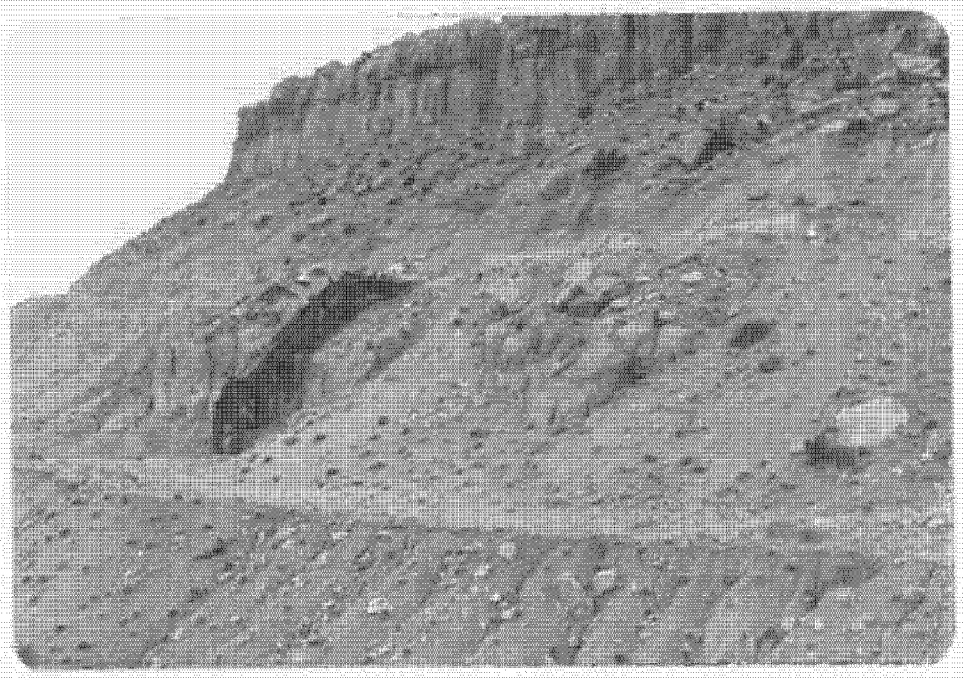
Photo G View westward along south facing escarpment into which Blue Peak adits were driven (upper cut); wooden ore chute extends from adit level down to loadout level, a vertical distance of about 40'.

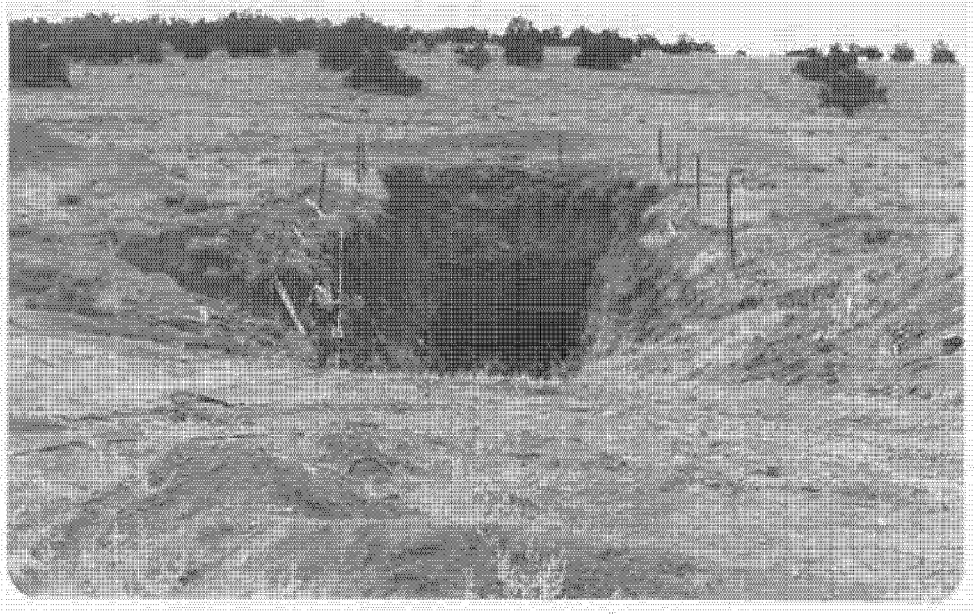
Photo (a) Looking southward at decline, Mesa Top 7 workings.

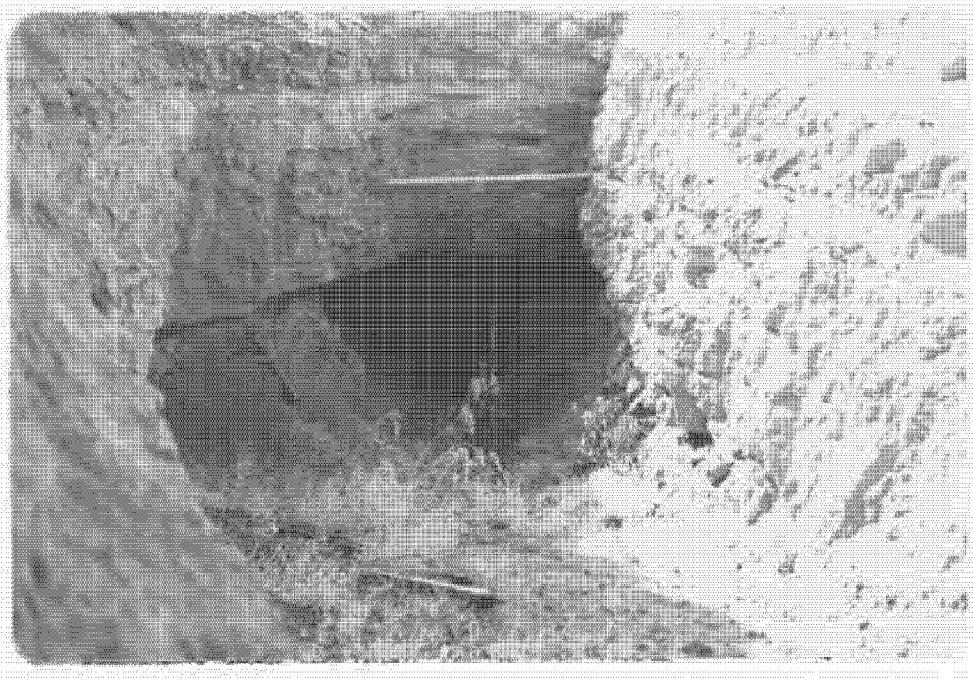
Photo (b) Close-up of decline shown in (a); portal is about 10' high, 14' wide.

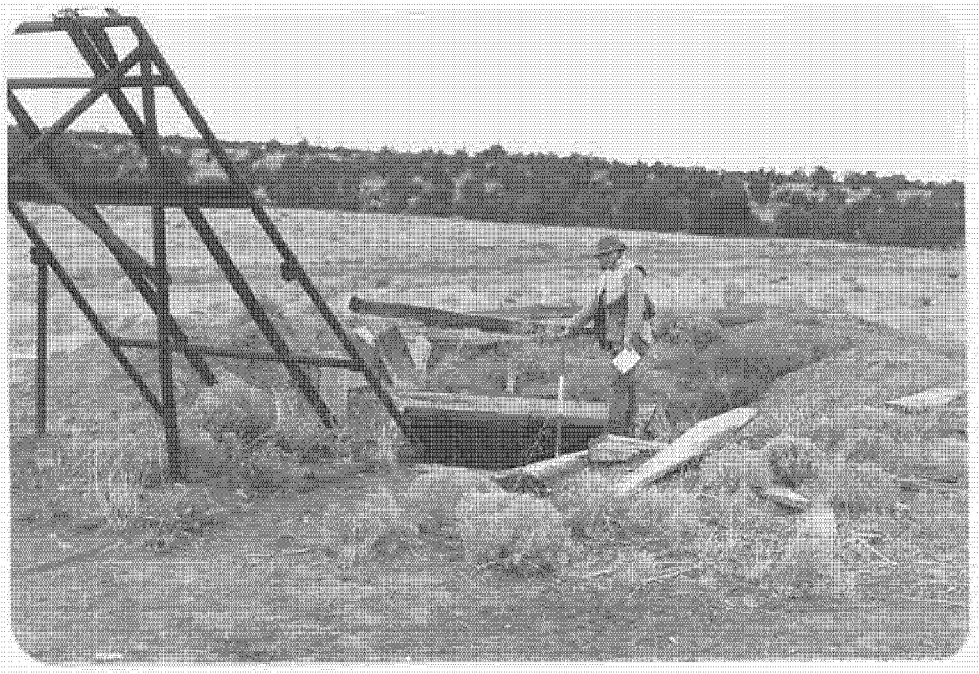
Photo (e) Close-up of headframe and inclined shaft shown in (d).

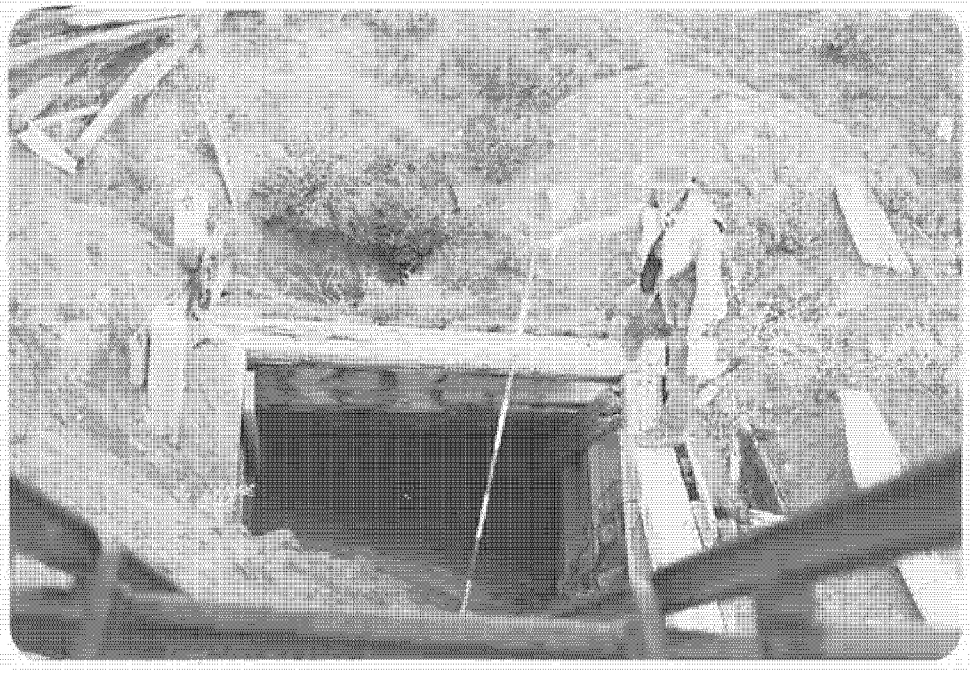
Photo (f) Close-up of inclined shaft shown in (e).

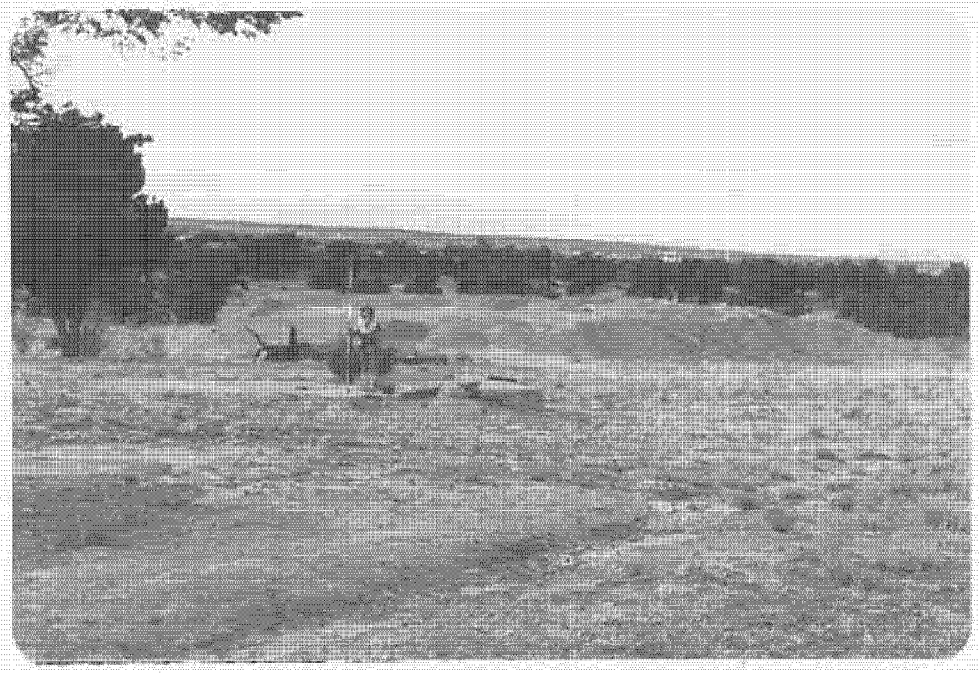
Photo (k) Looking westward at the Malpais raise site, about 900' northeast of Mesa Top 18 shaft; note mine dump in middle distance.

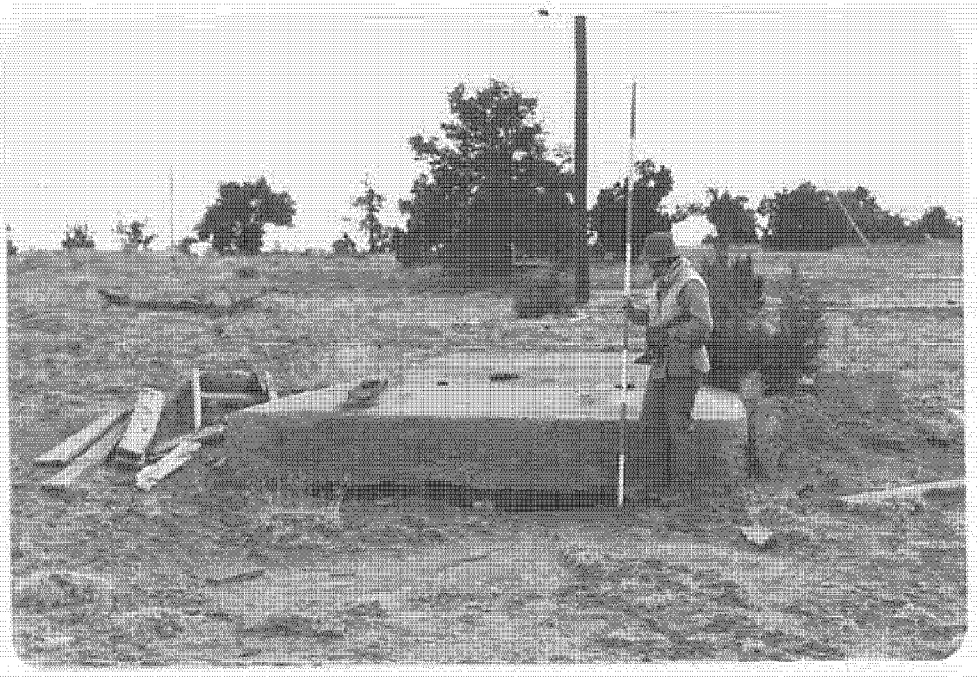
Photo (L) Close-up of raise shown in (k); some erosion around base of concrete covering is noticeable on north edge.

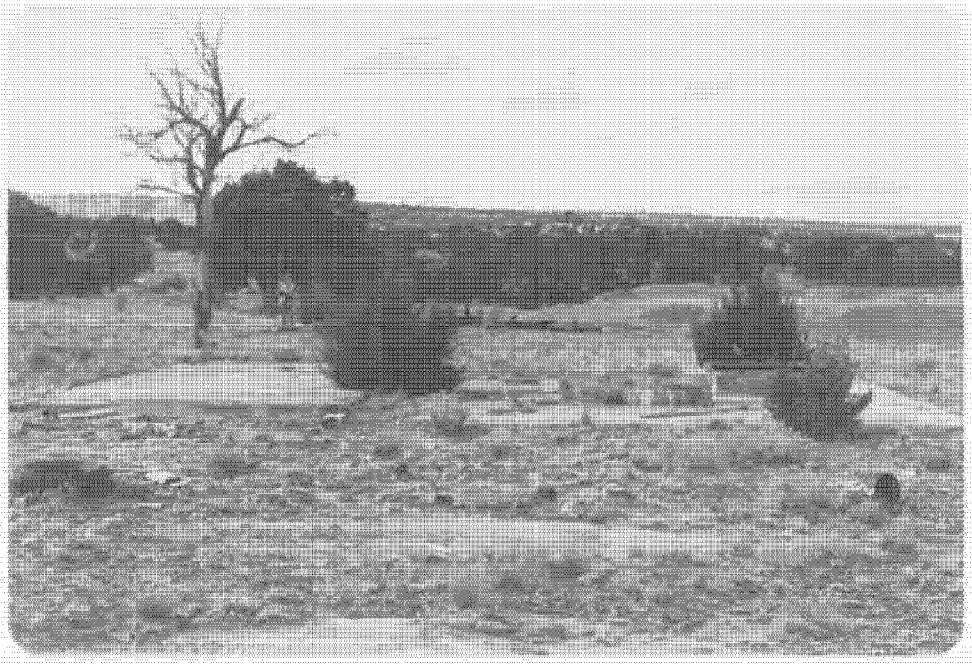
The shafts (one shaft and one raise) in the E½ W½ sec. 20 are the Mesa Top 18 workings of Hilpert (1969). The raise was not constructed until about 1960 and Hilpert does not refer to it. The main shaft area is shown in photos (g) through (j). The shaft site is enclosed with a 5' high wire mesh fence recently reinforced with steel posts as the wooden posts are decaying. The shaft is covered with deteriorating wooden planks (photo h) but appears to have been about a 6' x 8' opening. The mine dump and load out area are west and southwest of the shaft (photo i). Scintillometer readings in and around dump ranged up to 2,000 cps. A 30" diameter metal lined ventillation shaft and escapeway is located about 275' southwest of the shaft (photo j); a small door to the escapeway is open and ladder inside is still usable but temperatures are high inside-a warm draft blows. The Malpais Raise, or hoisting shaft, is located about 900' northeast of the main shaft and is shown in photos (k) through (n). The shaft is covered with a concrete slab, but some washing was noted at north edge indicating a potential problem (photo L). The mine dump lies several hundred feet west of the shaft and is 120' x 180' and up to 9' high. Scintillometer readings at the dump edge ranged between 500 and 2,200 cps (background <100 cps). A close-up of the mine dump is shown in photo (m). A concrete slab about 40' long, remains at the site; it was probably a foundation and floor of hoisting shed and/or machine shop, (photo n).

Photo (n) foundation and concrete slab remaining at Malpais raise site.

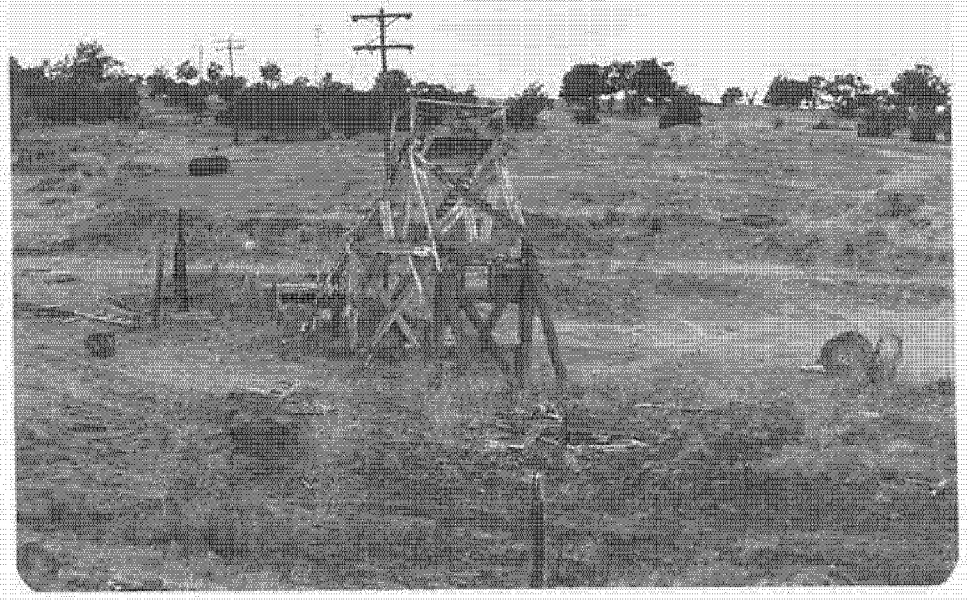
Photo A Looking southwest at wooden headframe at Dog Mine; note person with range pole at left of headframe for scale.

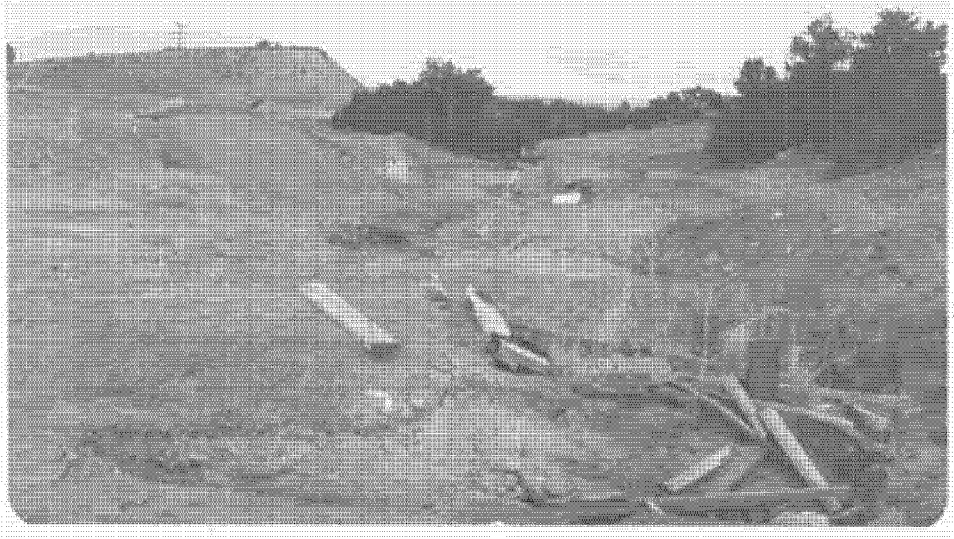
Photo D Looking northward from shaft site at small waste piles and timber along north flowing drainage line.

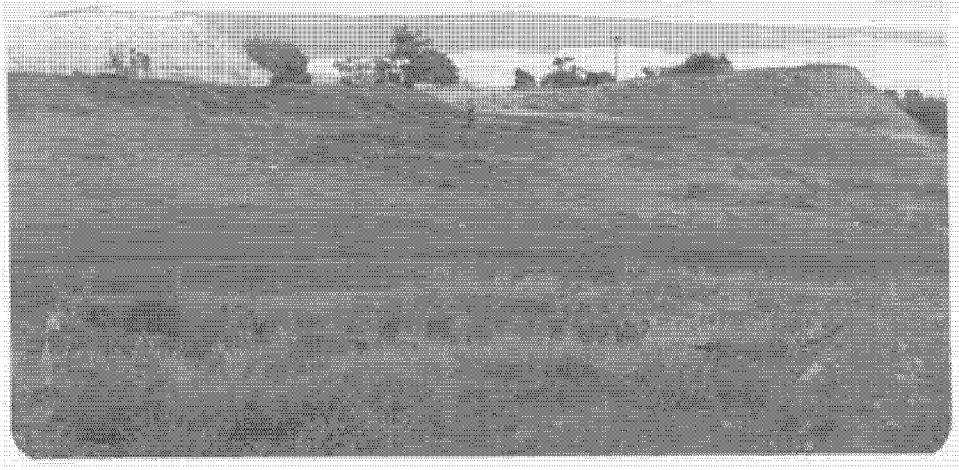
Photo E Looking northward at the two ramp shaped mine dumps; one on right (east) extends nearly to small drainage line. The one on the left (west) is about same size and is shown from other direction in F below; note person at center for scale.

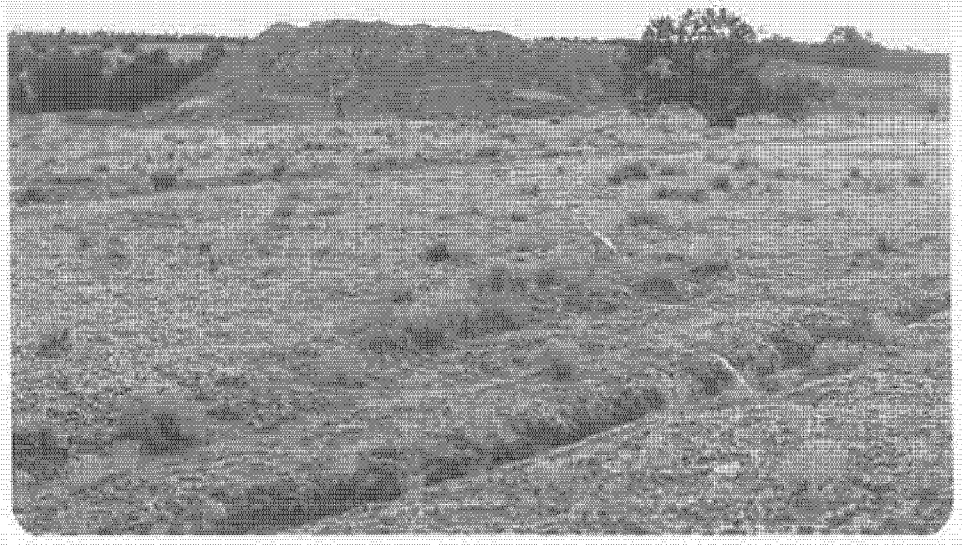
Photo F Looking southward at westernmost mine dump (shown at left in E). Note person at toe of dump at left for scale.

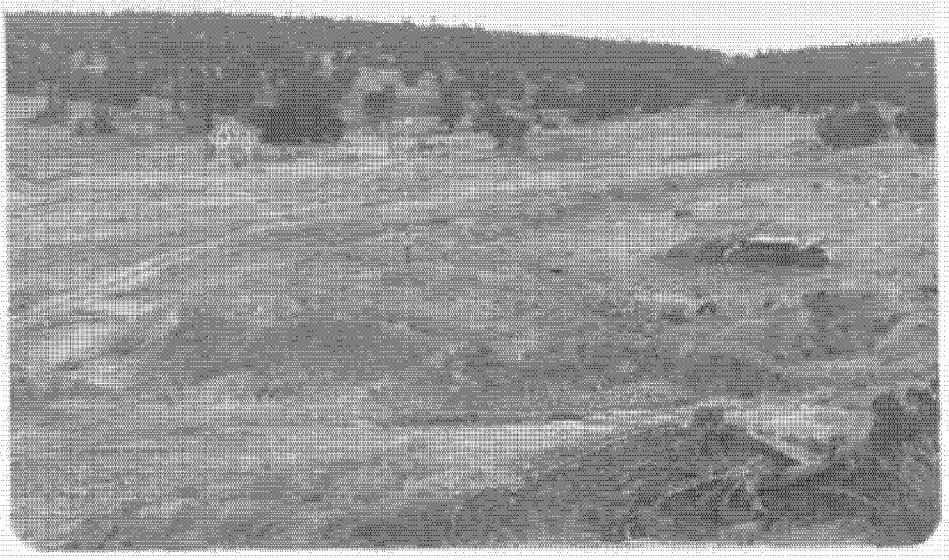
Photo G Looking southward at mine site from atop westernmost mine dump; ridge at center photo, marked by person, is composed of conical waste piles and extends for 280' along road. Note headframe and shaft at upper left, with drainage line to immediate left of it.

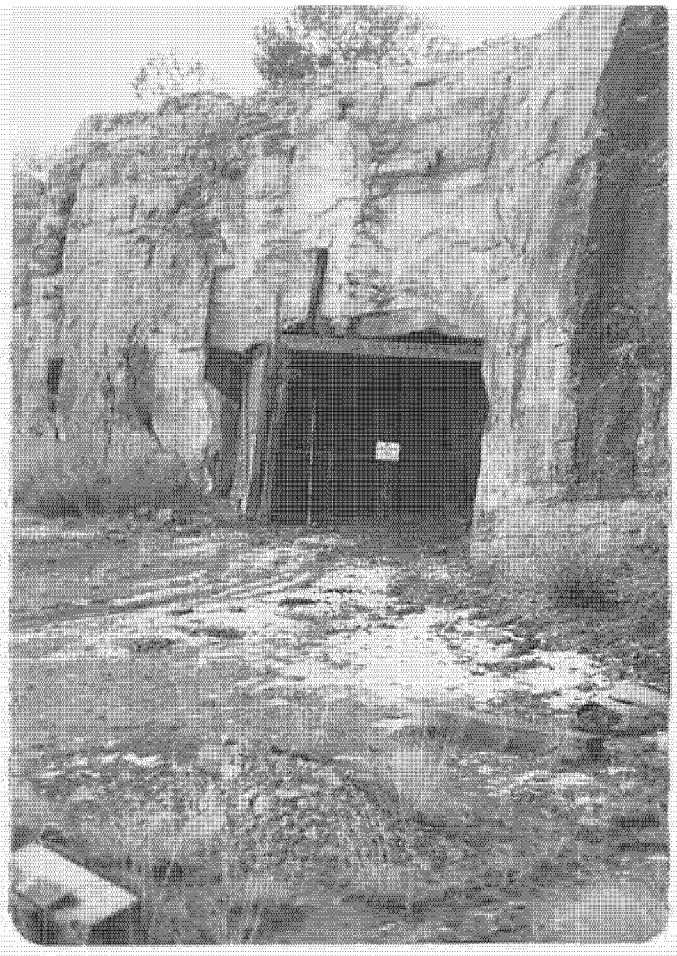
Photo (a) Portal of Marquez Mine in vertical cliff of Dakota Sandstone.

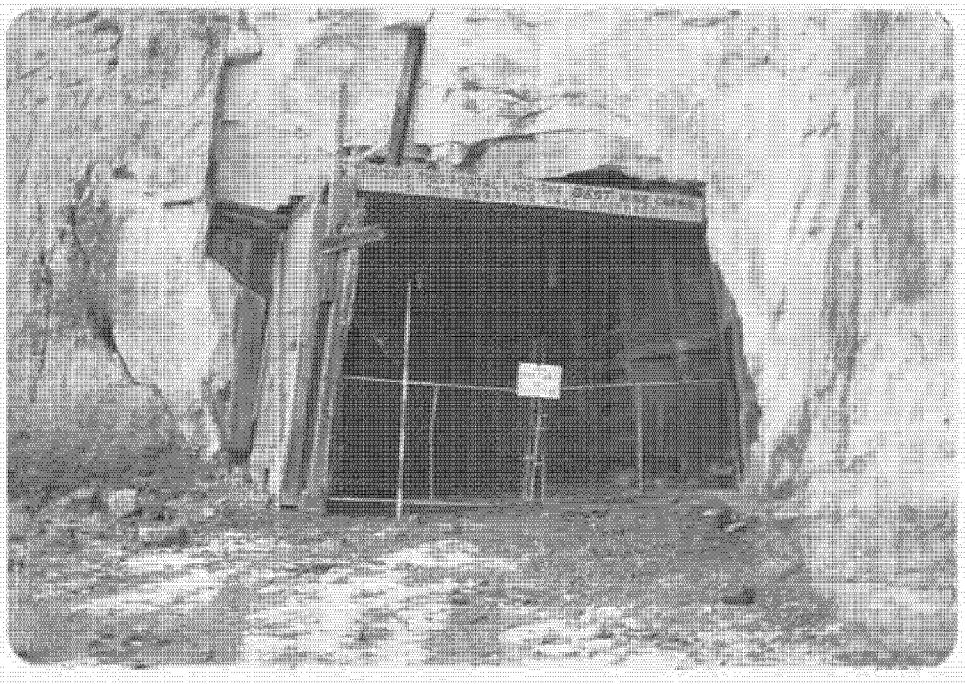
Photo (b) Close-up showing 11' by 15' portal secured by wire mesh gates; vertical timbers are 4" x 6", back is metal I beams crosswise with timbering lengthwise overlying. Note range pole for scale.

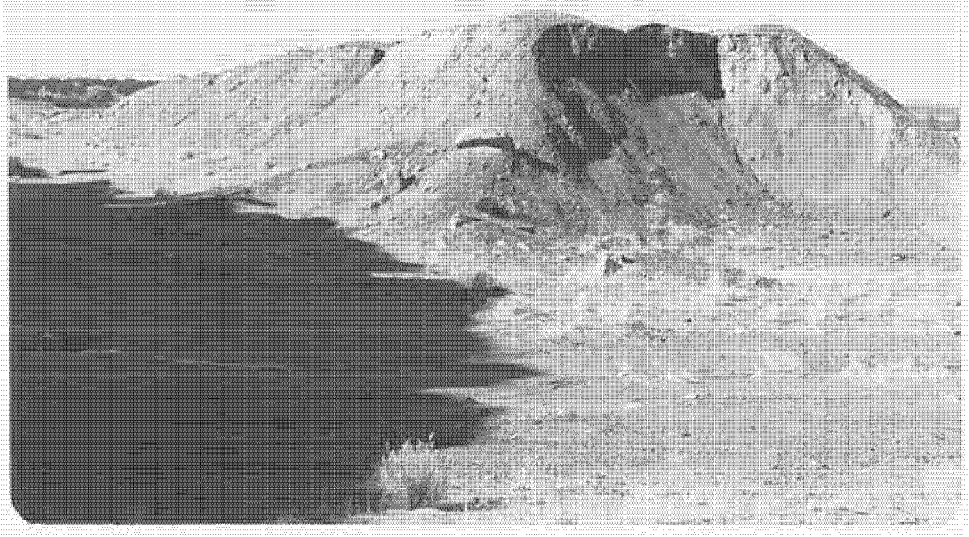
Photo (c) Looking westward at east face of dump; portal immediately behind viewer. Note range pole at left of dump for scale.

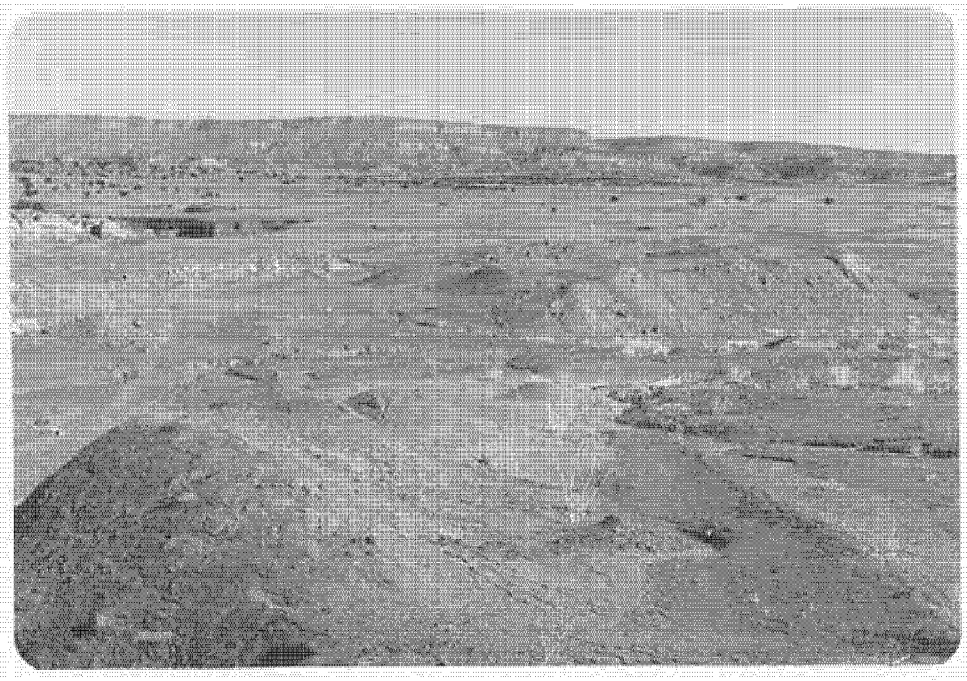
Photo (d) View eastward on upper surface of tailings dump showing ramp ascending from mine level at center right; note range pole at far left for scale.

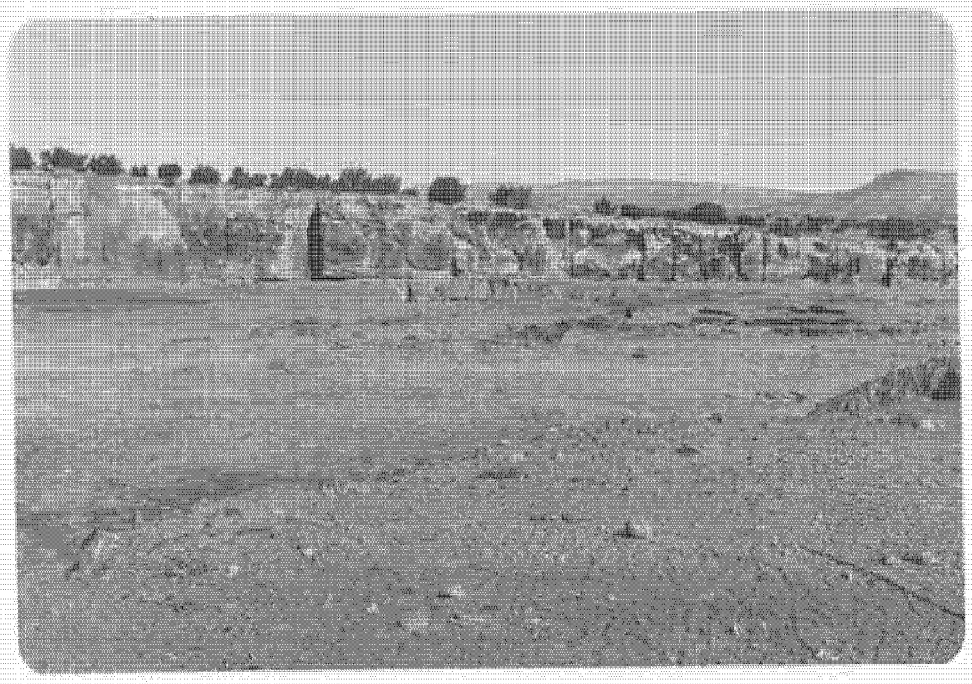
Photo (g) View northward from toe of tailings dump; San Mateo Creek is incised between bench in middle distance and sandstone cliff. Circle identifies area shown in photo (h).

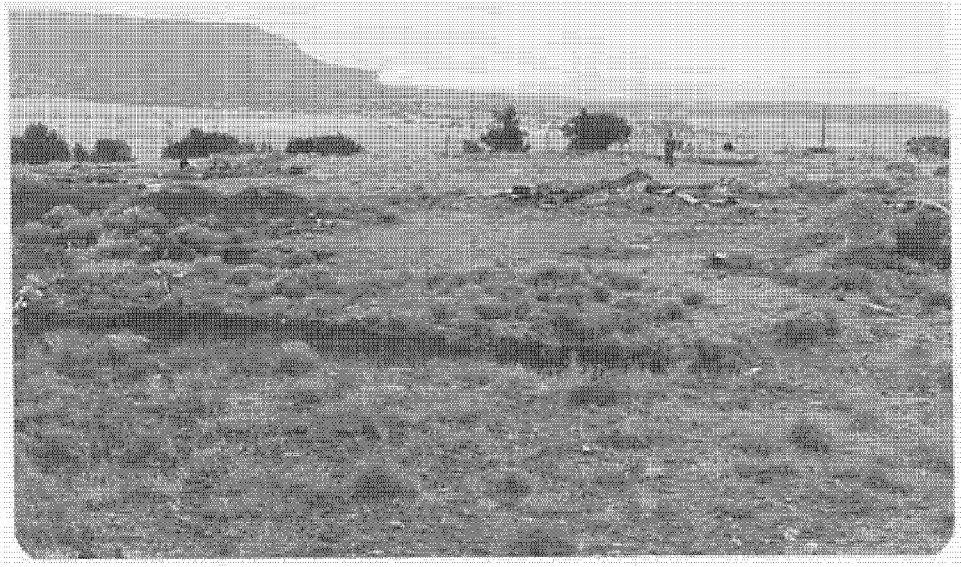
Photo A Looking SE into main shaft area; shaft is enclosed by fence immediately behind person to right of center; gully along south bank of drainage may be seen at left. Close-ups of shaft and drainage shown on following photos.

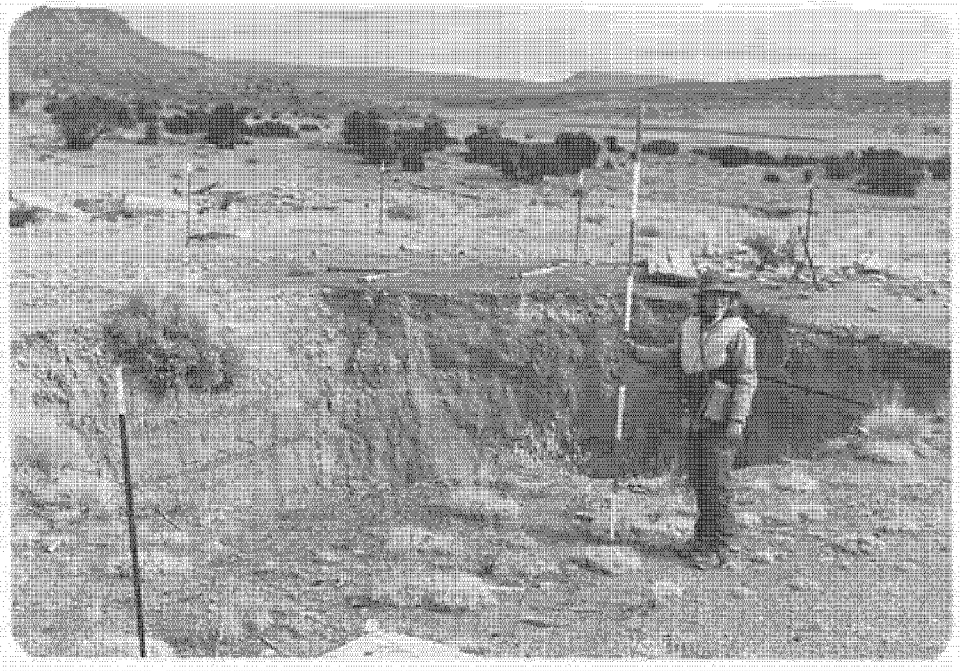
Photo B Look NE at caved shaft; enclosing fence is effective for livestock, not for people.

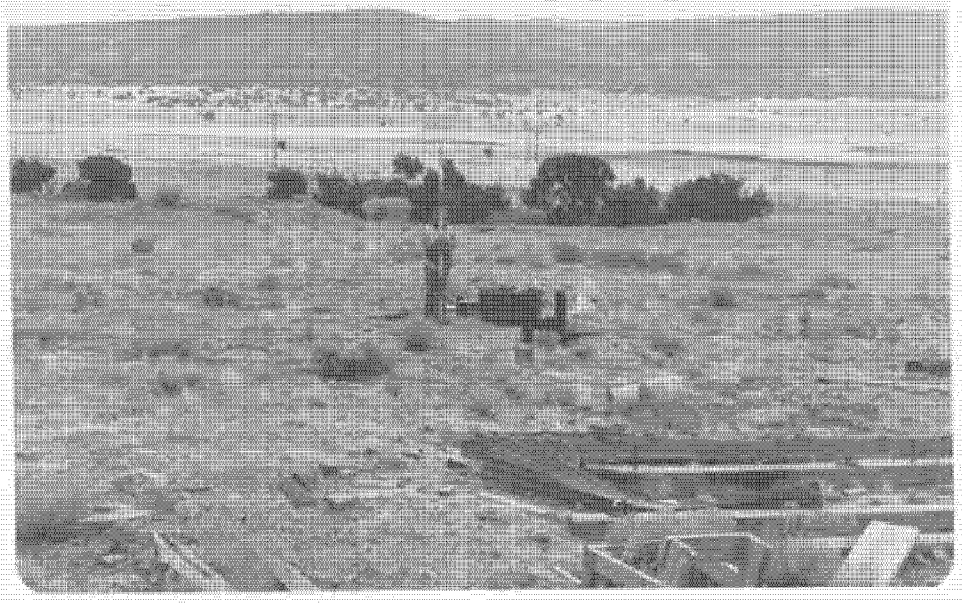
Photo D Looking east at hoisting shaft site, 1000' south of main shaft; a raised cylindrical metal lined vent protrudes about 1' above the concrete cover on shaft (arrow).

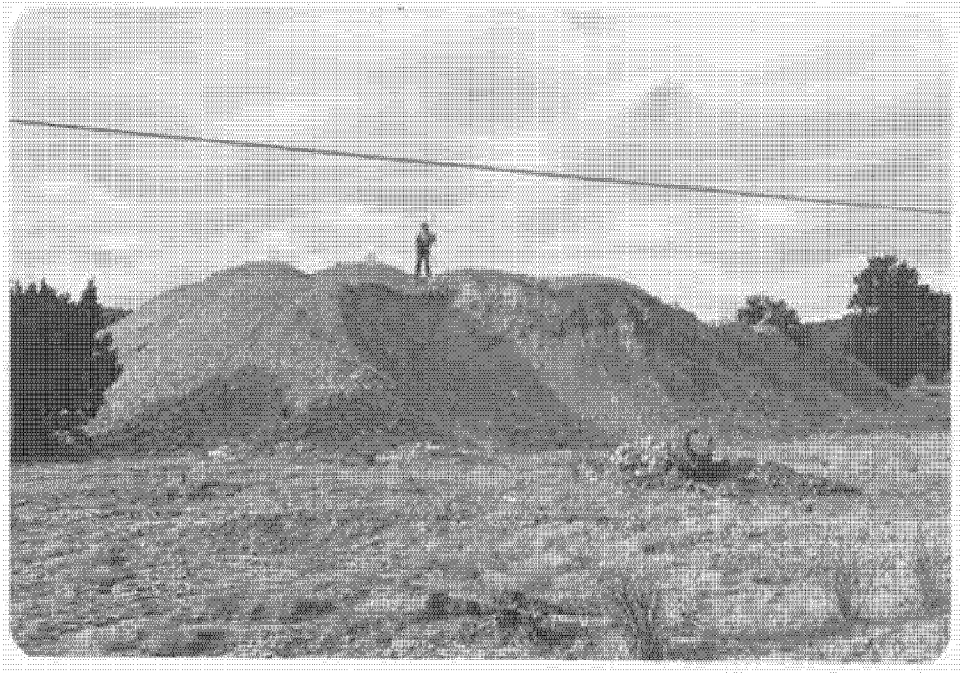
Photo B Looking northward at mine dump, here nearly 20' high; upper surface slopes gently to north.

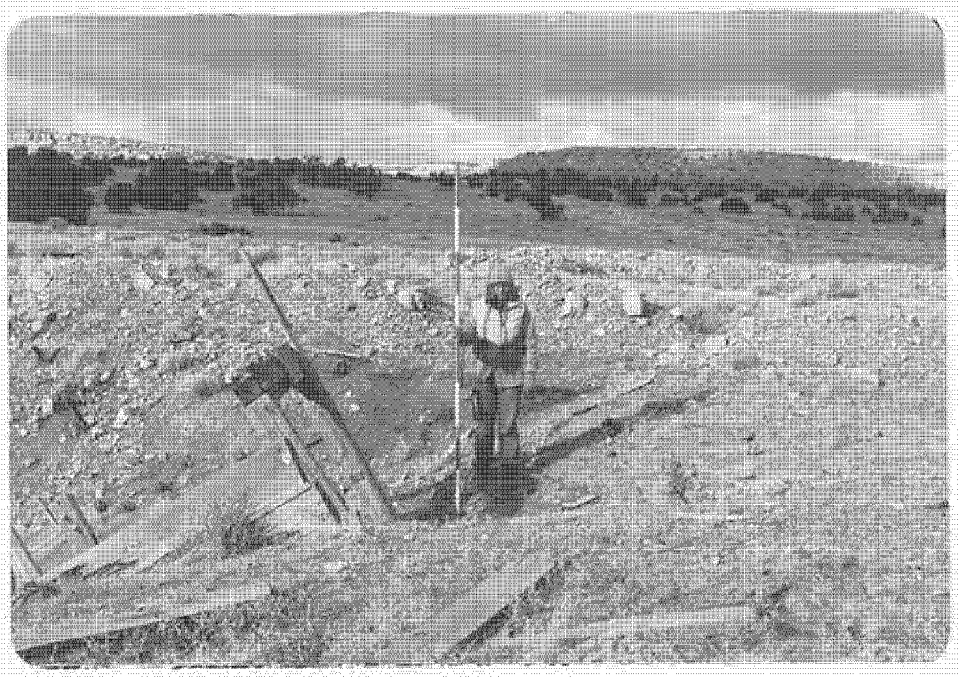
Photo (a) Looking north at entrance to incline; shaft slopes off to left at 30°.

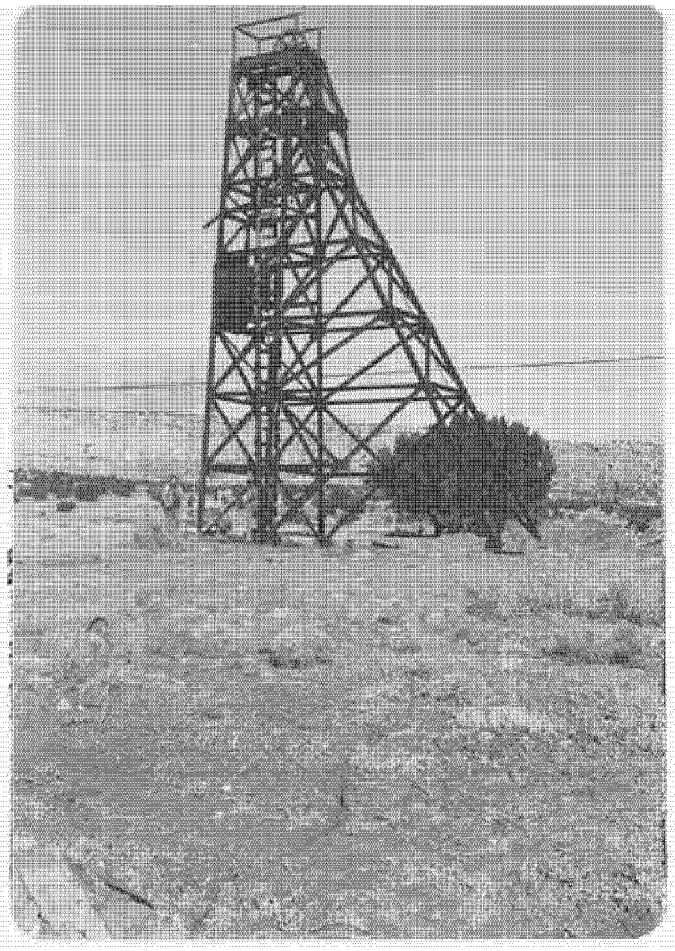
Photo (a) Looking northwestward at Bailey and Fife head frame, about 35' in height.

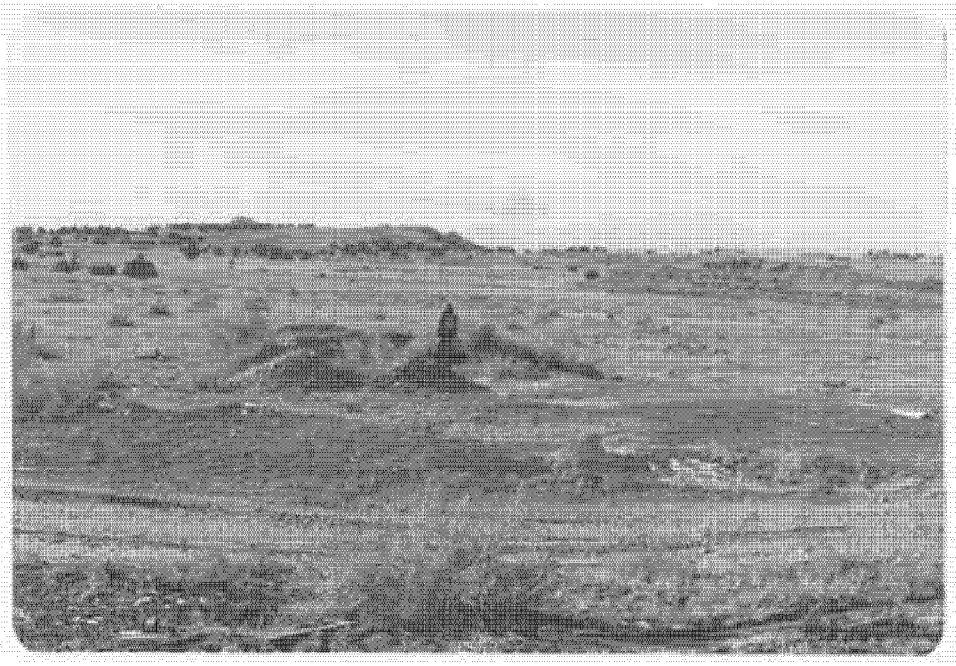
Photo D Looking southward at mine dump area south of the mine shaft.

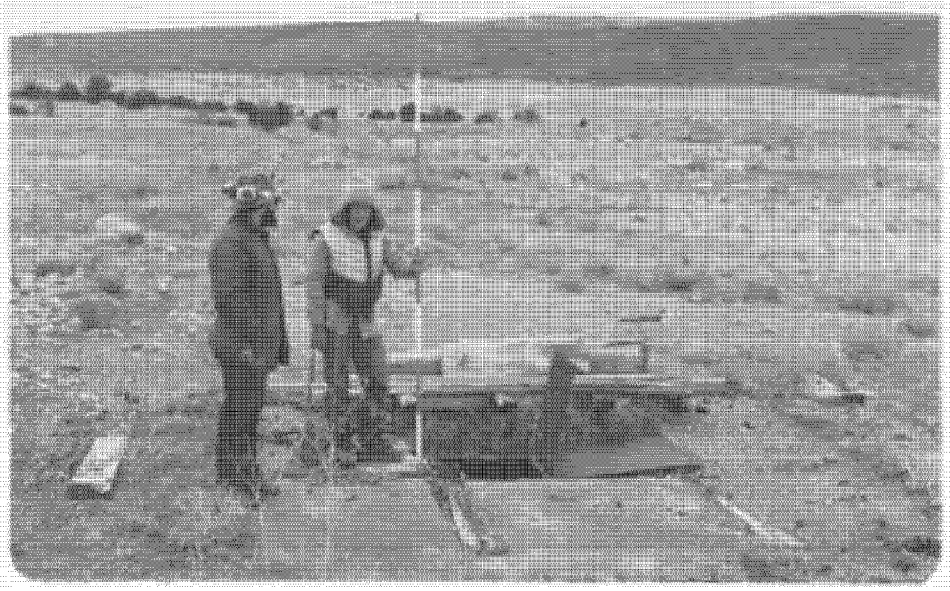
Photo (a) Close-up of T-20 shaft opening, showing concrete slab with rectangular opening covered with plate metal door.

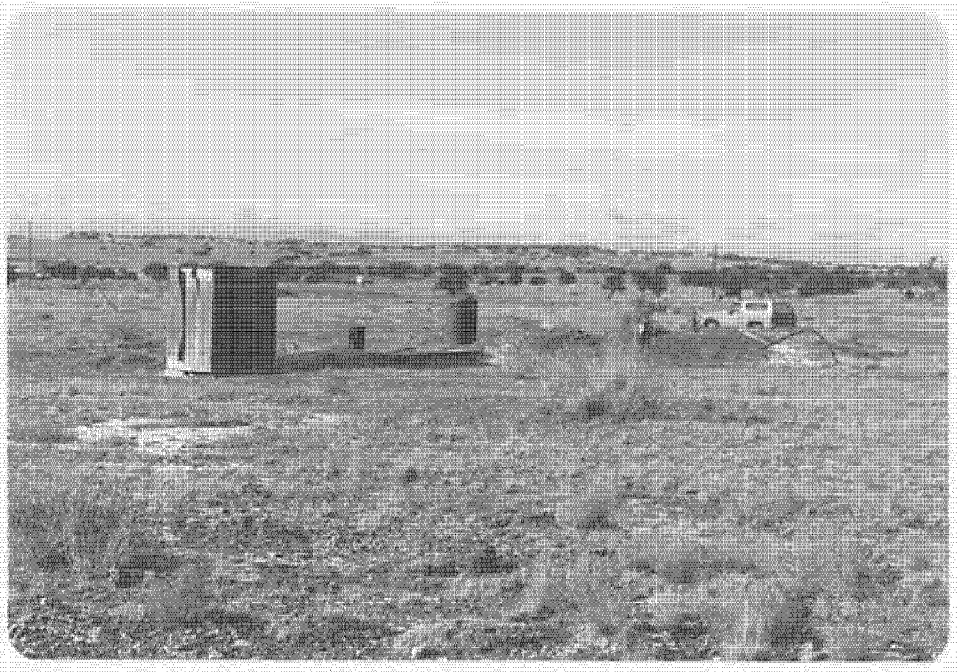
Photo A Looking southwest toward mine shaft site; shaft has been backfilled; note 30" diameter metal ventilation shaft just left of center with 10" diameter pipe left of it, and metal shed at far left.

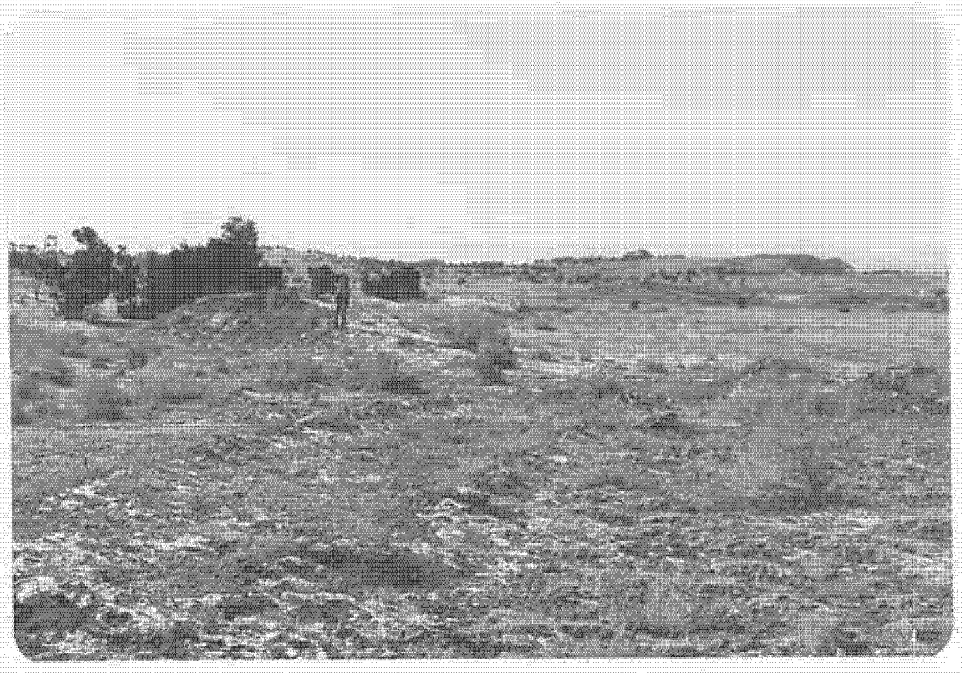
Photo B Looking southward from mine shaft area to mine dump at left; note person on dump for scale. A small drainage flows south through trees at far left in photo.

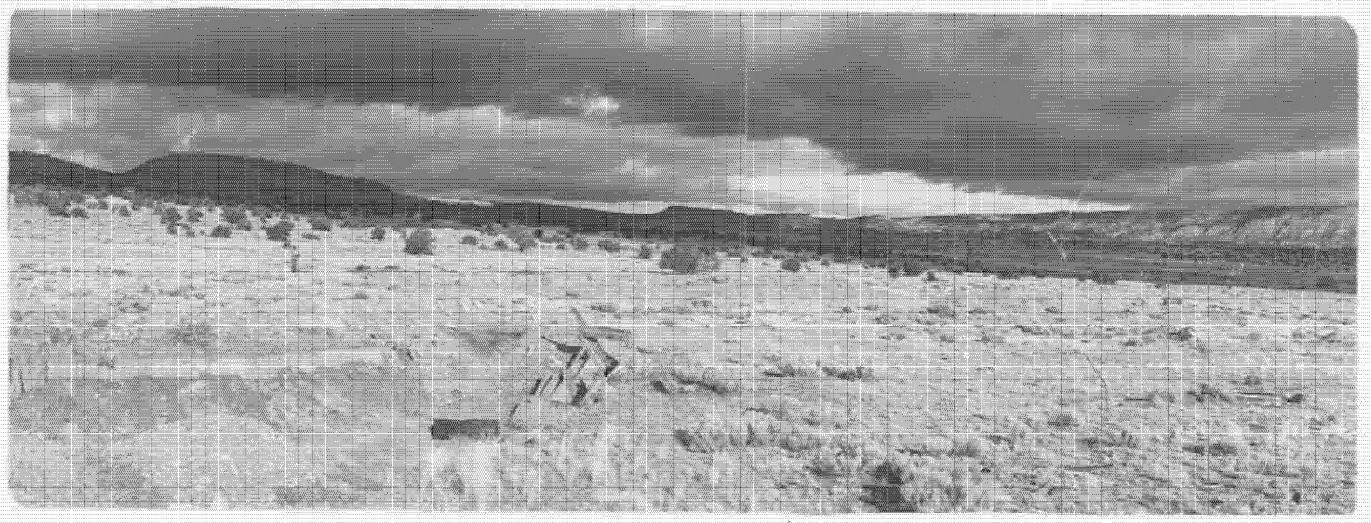
Photo (c) Looking northeastward at Flat Top Mine site showing (1) entrance to 30° incline (wooden framing) going off to left, (2) the small box cut just behind entrance to incline, and (3) scattered waste piles extending from left to right across picture in middle distance, note person at left for scale.

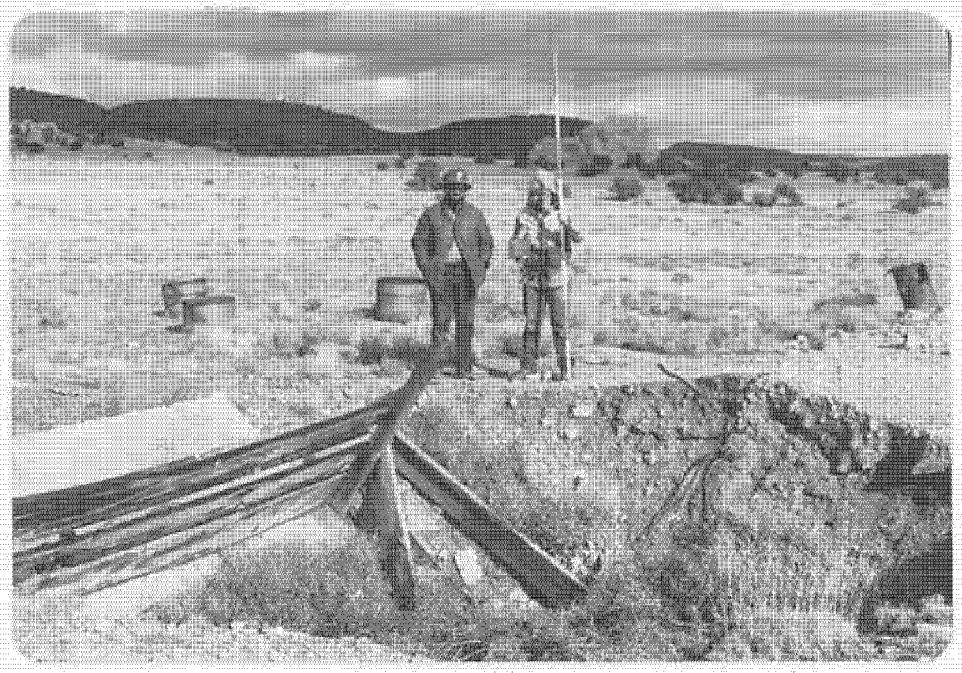
Photo (a) Looking northeast at caved mine shaft at Roundy site.

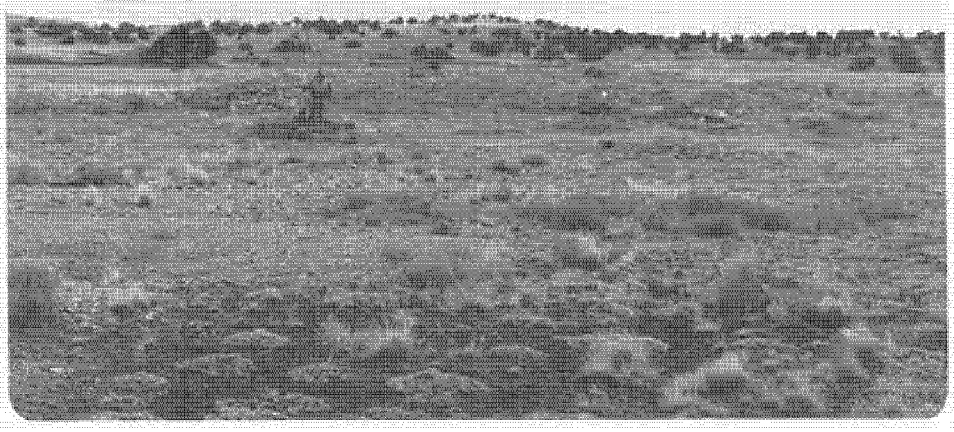
Photo (b) Looking southward at waste dump area several hundred feet south of shaft.

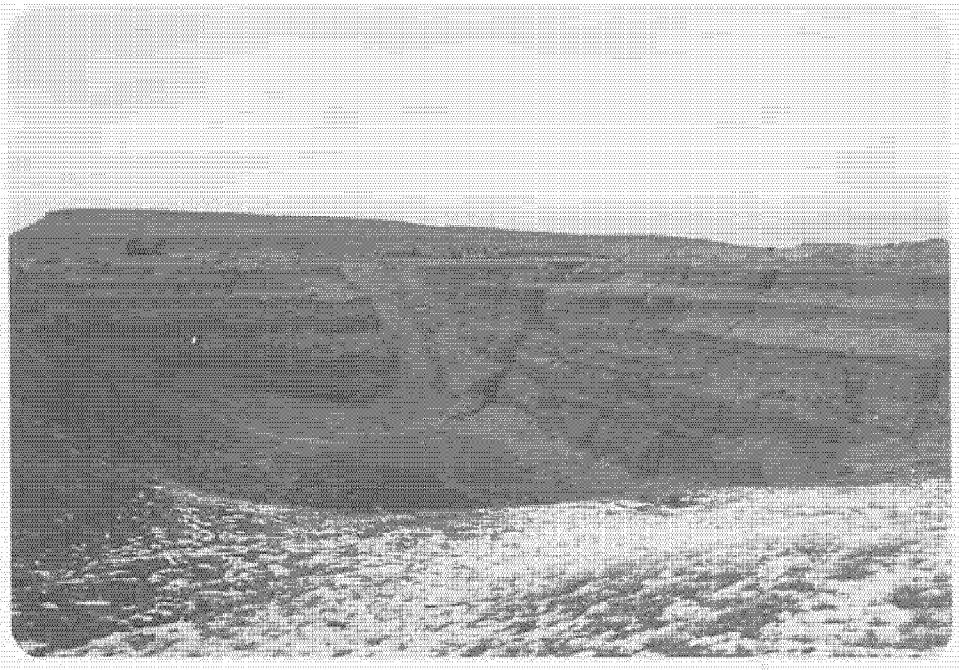
Photo (a) Looking SW into a 200' x 200', 45' deep cut in overburden; no rock exposed.

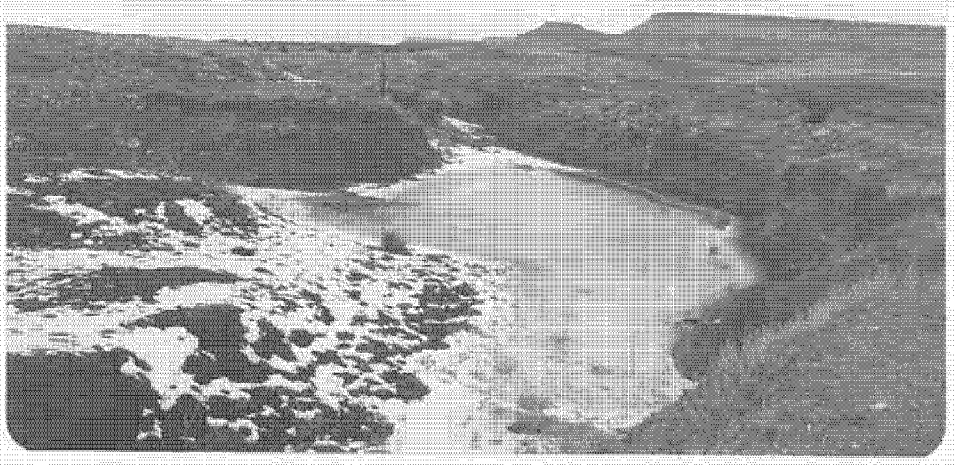
Photo (c) Shallow pit southeast of trench in (b), containing meltwater. Livestock tracks noted in area. Note person at left of center for scale.
