ABANDONED OR INACTIVE URANIUM MINES IN NEW MEXICO

A report of investigation carried out between August 1979 and May 1980 under contract with the New Mexico Energy and Minerals Department.

New Mexico Bureau of Mines and Mineral Resources
Open-File Report 148

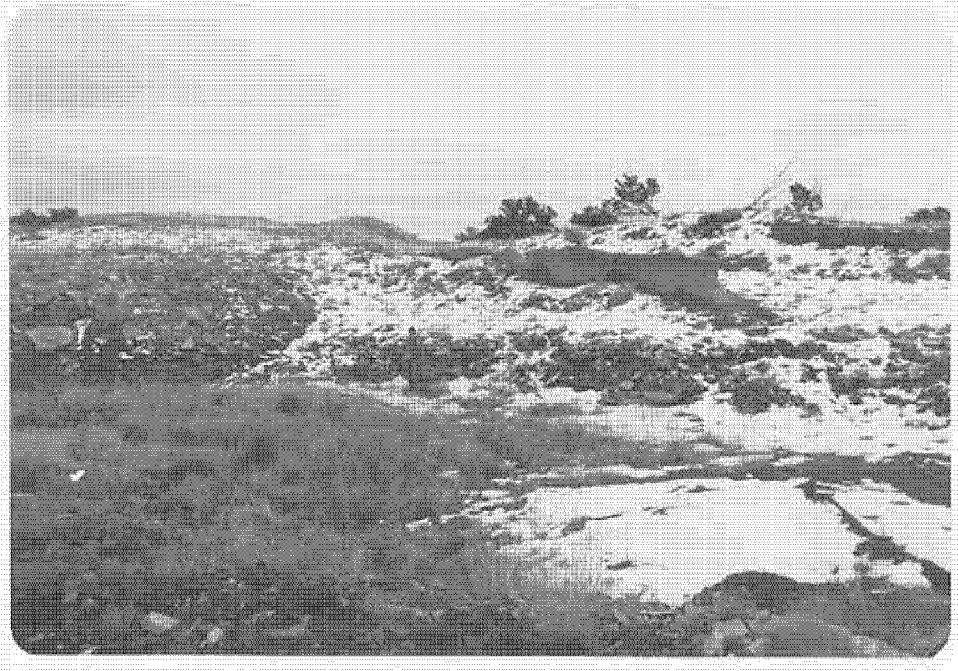
Photo (d) Small open pit, 60' x 100' just east of (c), near the southeast end of the Sec. 30 Strip Mine. Note person at left of center for scale.

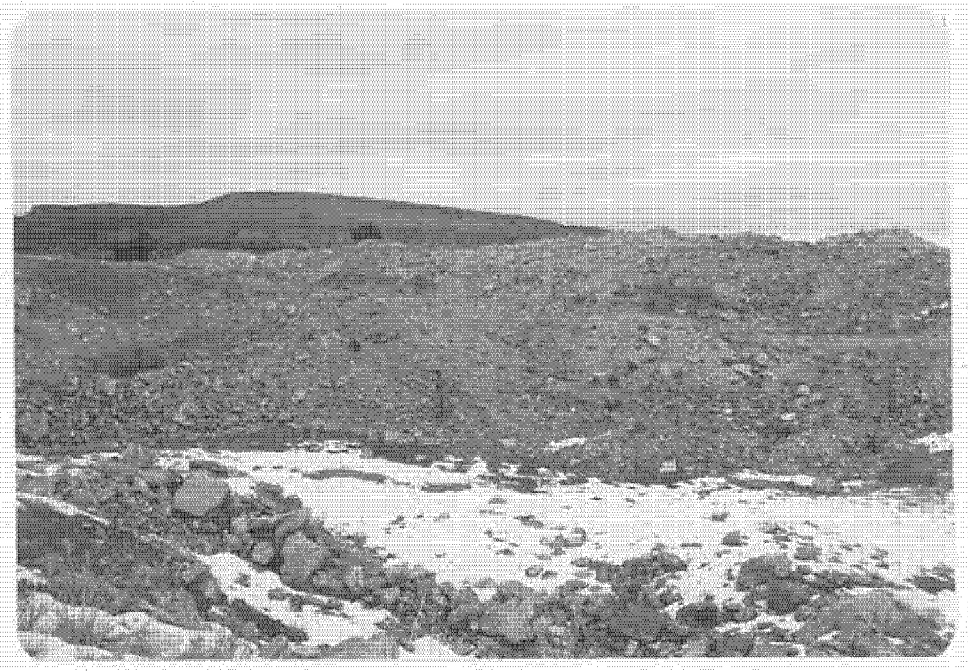
Photo (a) Looking westward at a 20' deep pit in the SW¼ 25; pit is about 175' long with gamma levels up to 2,200 cps; note person at center for scale.

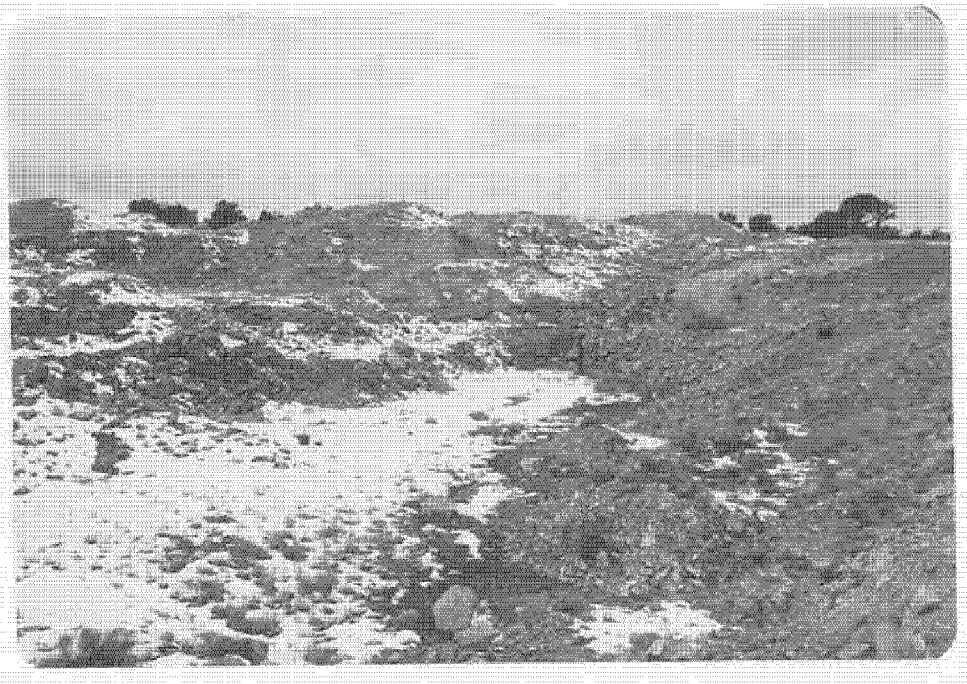
Photo (b) Looking southward immediate adjacent to (a); pit is 25' deep several hundred feet long, with gamma readings to 2,000 cps. Trees in background are near edge of mesa in the SW¼ 25.

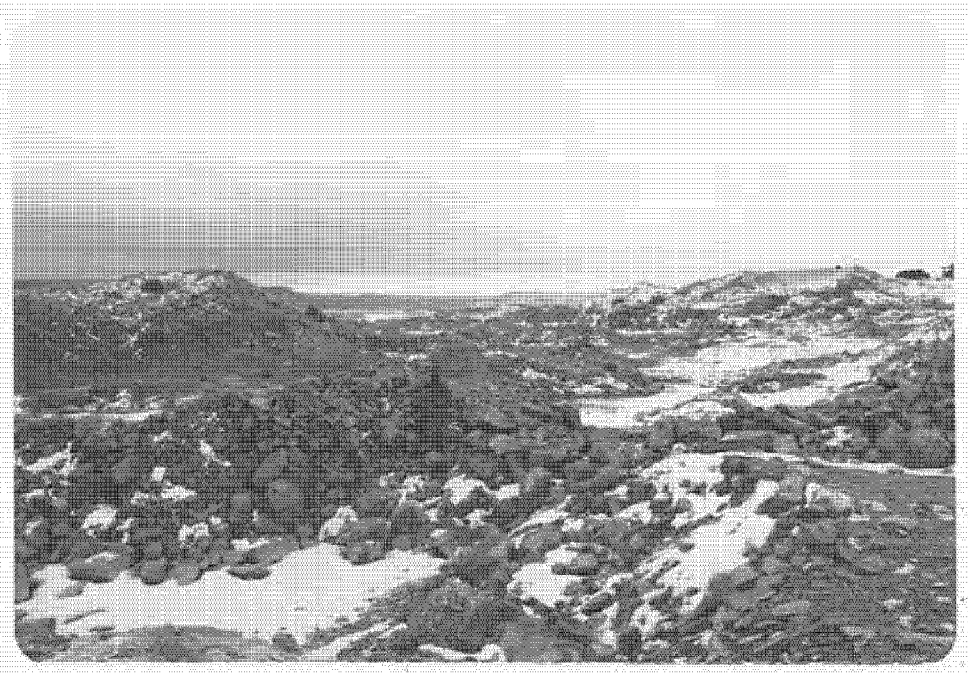
Photo (e) View of 12' high coarse waste pile composed of Todilto limestone fragments, gamma reading about 900 cps. Note person at center for scale.

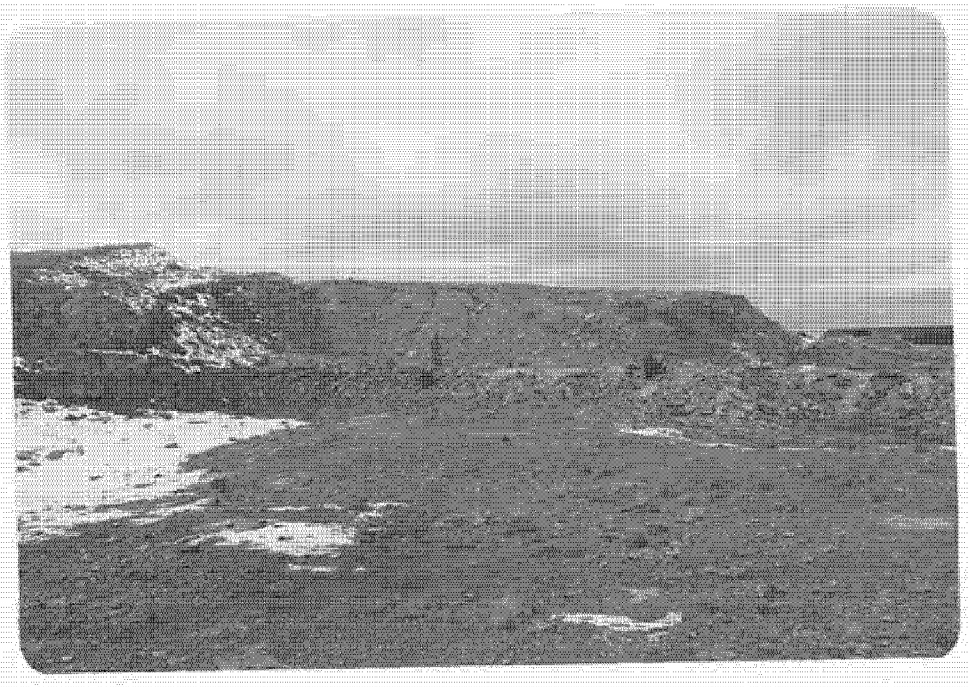
Photo (f) Spoils pile near center of section, several hundred feet north of area shown on preceeding pages. Pile is 18' high, 250' long. Note person left of center for scale.

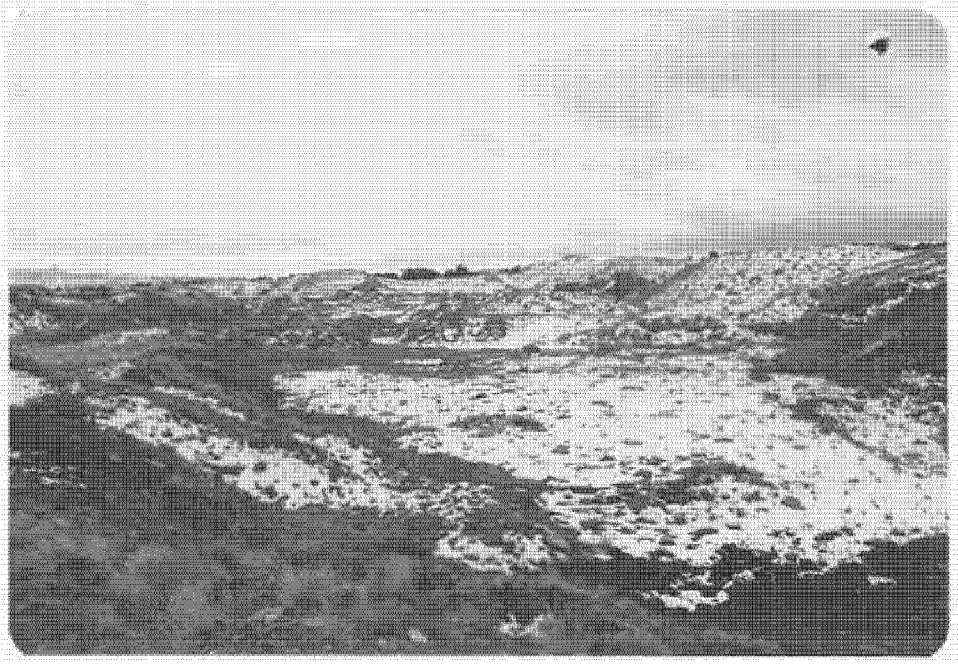
Photo (h) Looking southward from near center of section into area shown in photos (a) through (f). Disturbed area extends more than 1,000' into background.

Photo (i) Looking east in southeast ¼ 25 at 20' high, 300' long spoils pile along south side of pit; pit is shown below.

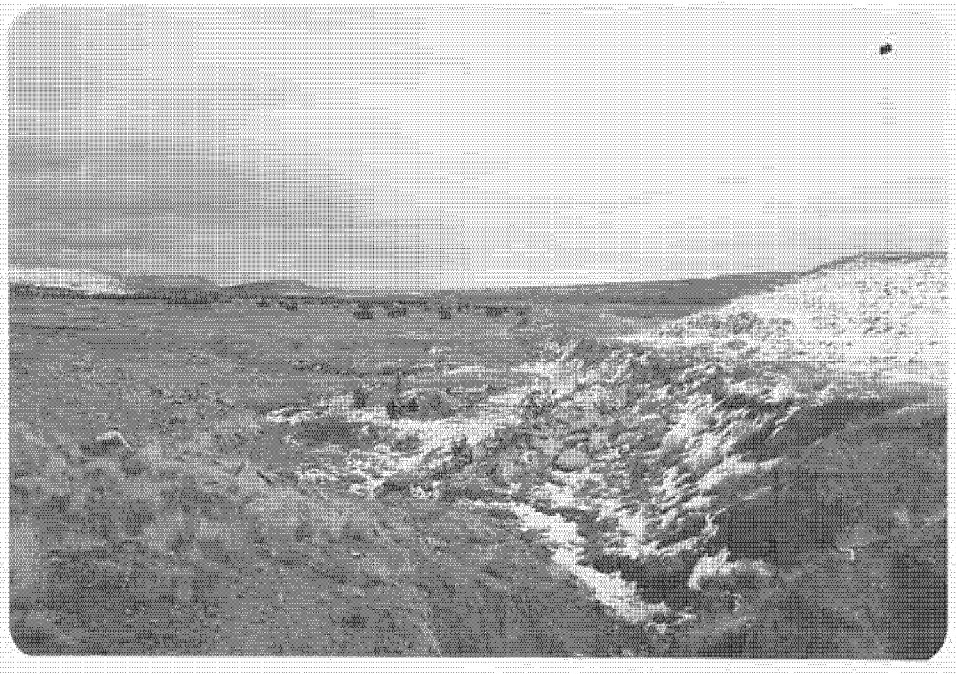
Photo (j) Looking east into 500' long open pit on north edge of spoils pile shown in (i). Pit averages 100' wide, gamma levels= 500-600 cps. Note person left of center for scale.

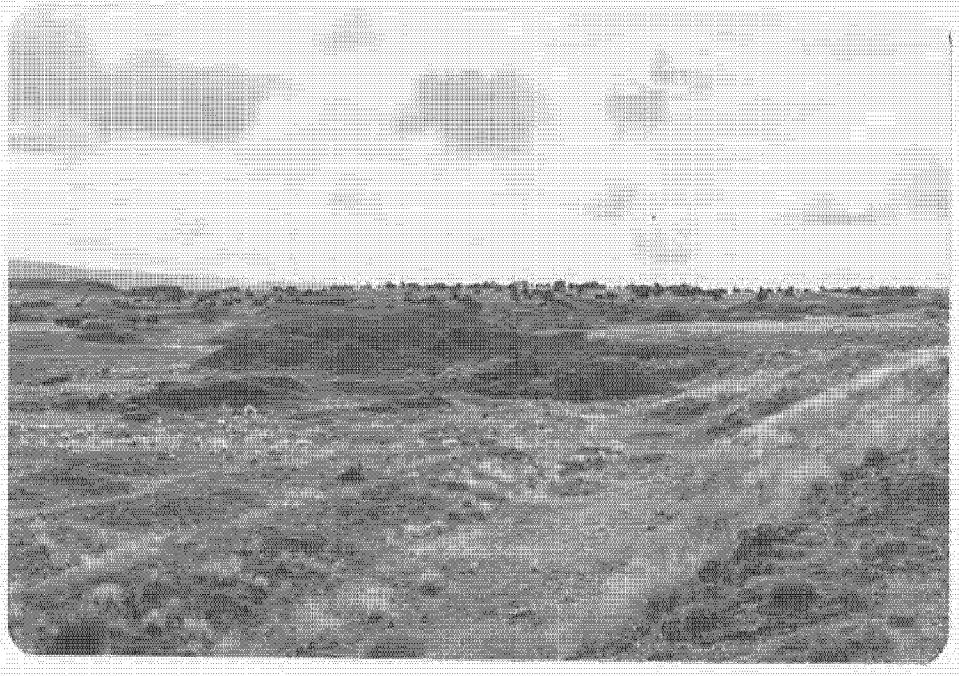
Photo (k) Looking southeast into an area about 500' northwest of center of sec. 25 just south of road showing extensive spoil piles and mine dumps. Note person at center for scale.

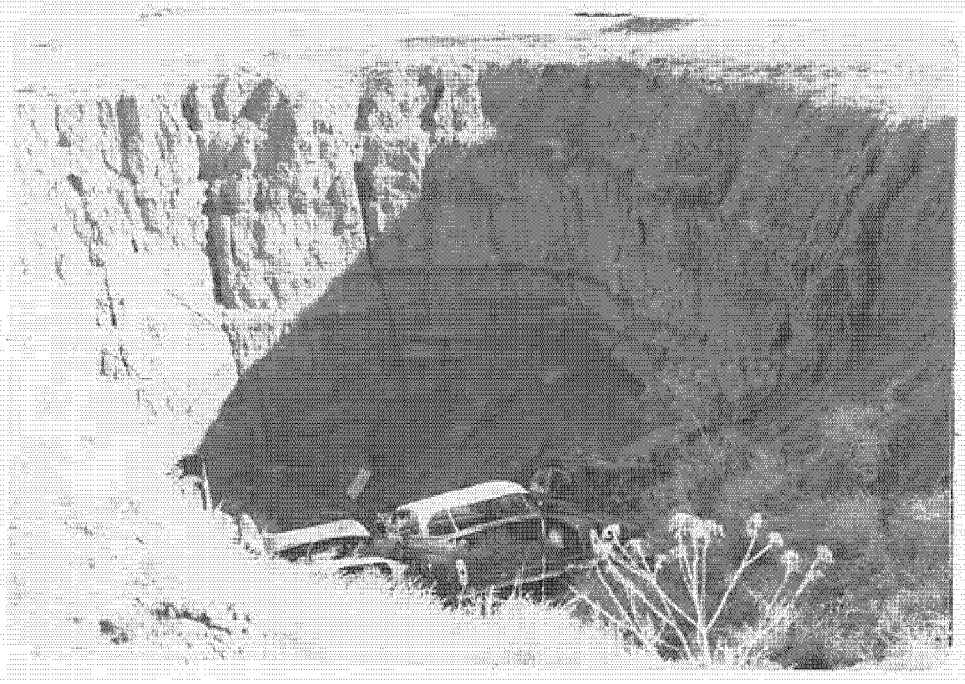
Photo (L) Additional workings near center of sec. 25; this pit is 25' deep and may have had decline diven at bottom. Highwall is in unconsolidated overburden. Site is just 75' south of main road, tumbleweed and blowsand have already buried several layers of auto bodies.

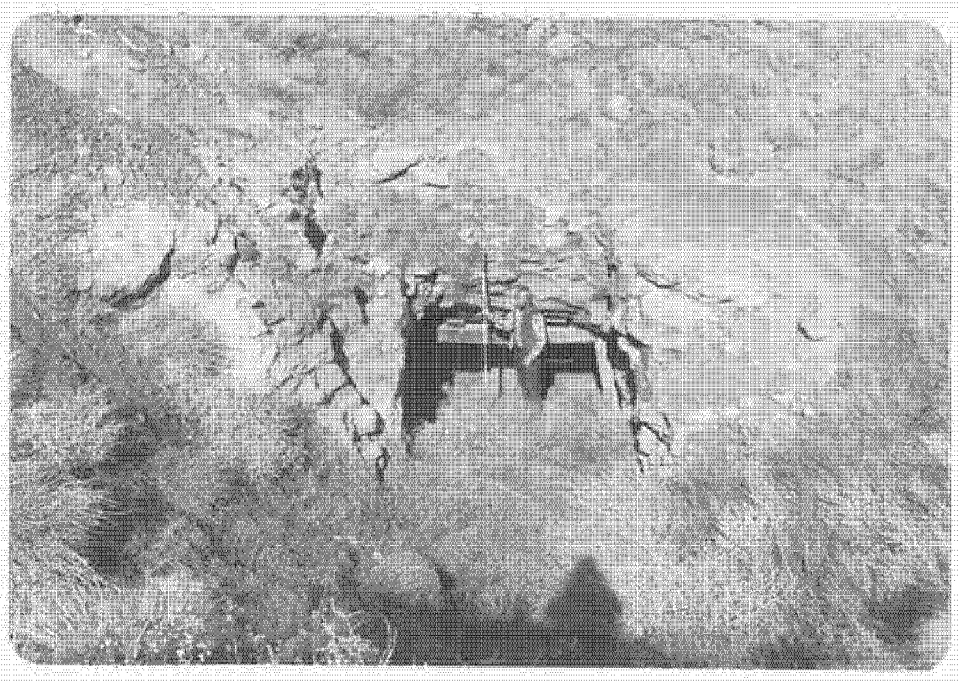
Photo (m) Decline driven northward at site about 400' south of road near center of section 25. Portal is about 8' wide, timbered, but silting in. Workings go back at least 170' at 6°-8° decline. Gamma levels=700 to 4,000 cps.

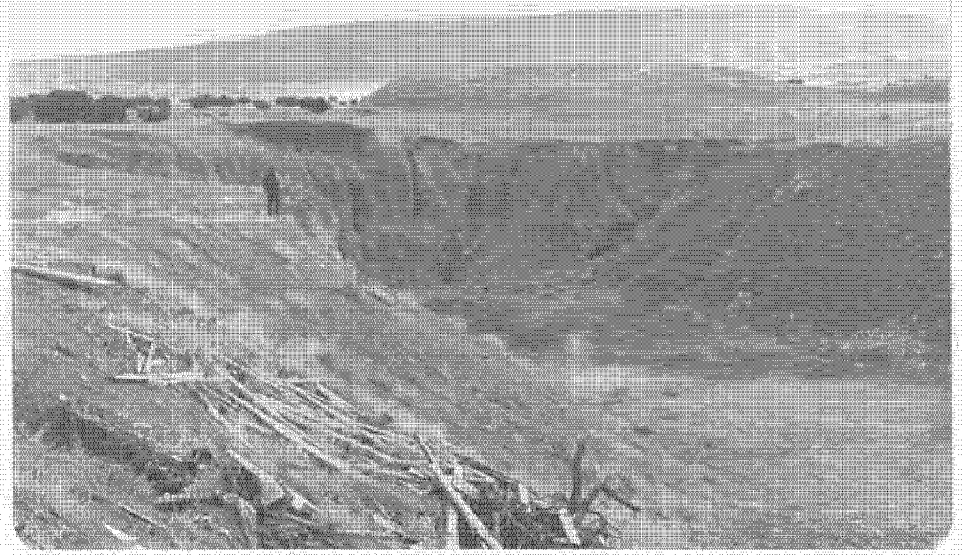
Photo (n) Open pit in overburden, 250' east of decline shown in (m); pit measures 150' x 350' and is 40' deep. Blow sand and wash have concealed bedrock on the floor.

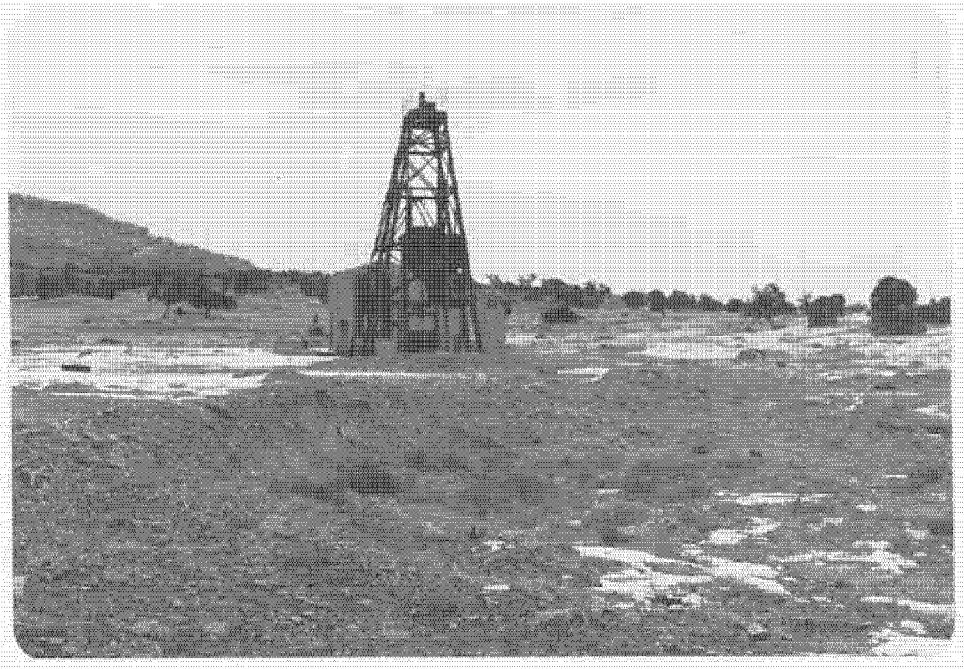
Photo (a) Looking north at head frame and hoisting shed at Sec. 25 shaft; note small dump area in foreground. Shaft is about 35' high.

Photo (b) Close up of head frame, showing the skip suspended over shaft at ground level, and small ore pile lying below chute where person is standing.

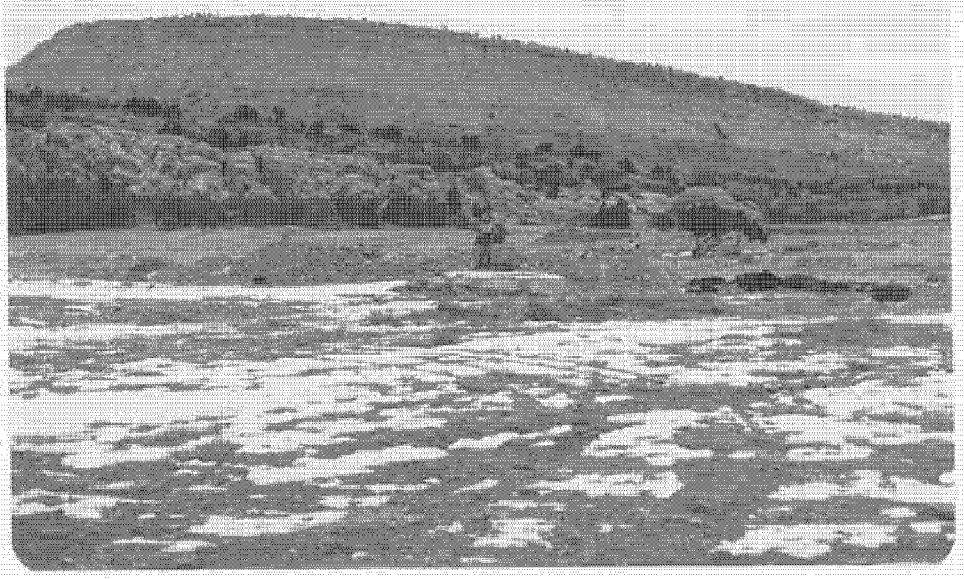
Photo (c) View to northwest of shaft and head frame, showing an extensive mine dump area that continues into the background, and an 8' x 20' concrete slab covering a small ventillation shaft and/or escapeway; person is standing on concrete slab.

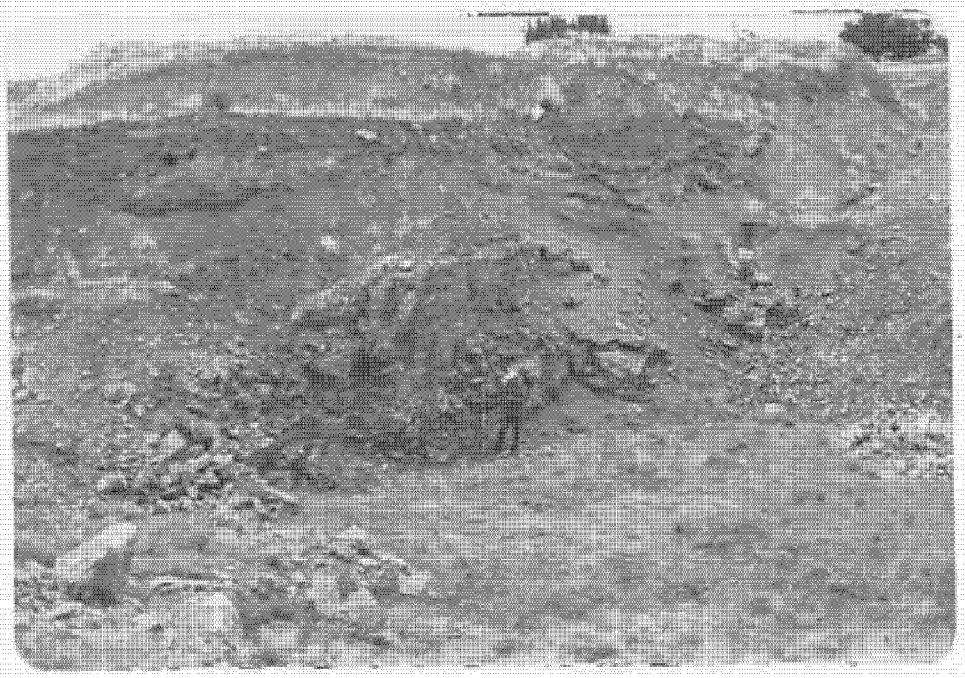
Photo (c) Looking SW at 30' deep, 100' diameter pit about 450' east of sec. 25-26 line; face counts range up to 2,000 cps. Highwall is half limestone, half overburden.

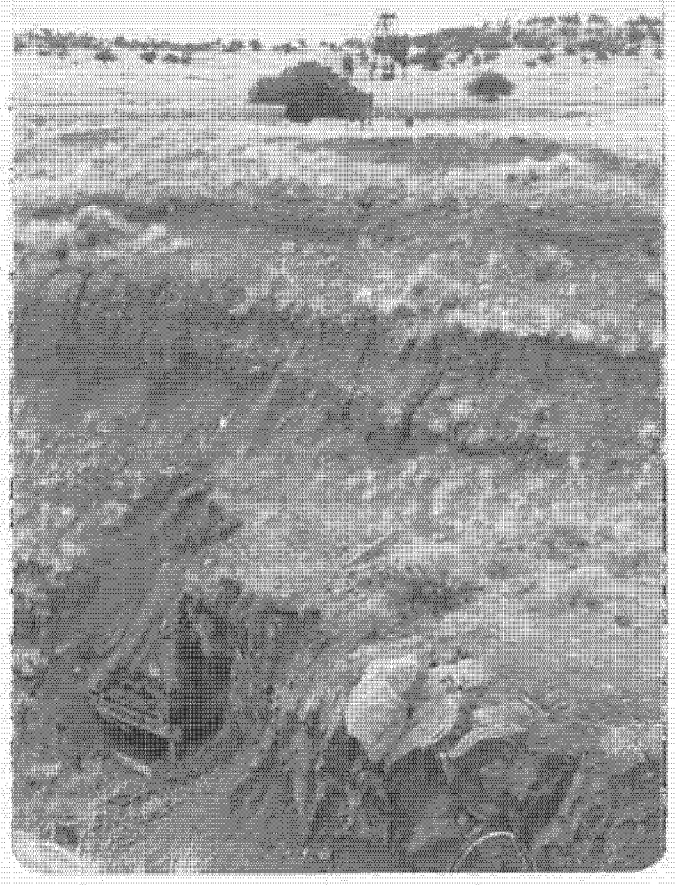
Photo (d) Looking northward into box cut with decline driven eastward at bottom. Close-up of decline is given on next page. Note section 25 head frame in background 1,000' away.

Addendum: A drainage by-pass was constructed to take the flow around the east edge of the workings and keep it out of the box cut with the decline (photo d). The flow re-enters the original stream bed just 500' south of the box cut, but some of the material used in diverting the stream and perhaps some of the waste material that was placed along its banks later is somewhat radioactive. In the example shown in photo (1) the waste material produced readings of 1,400 cps.

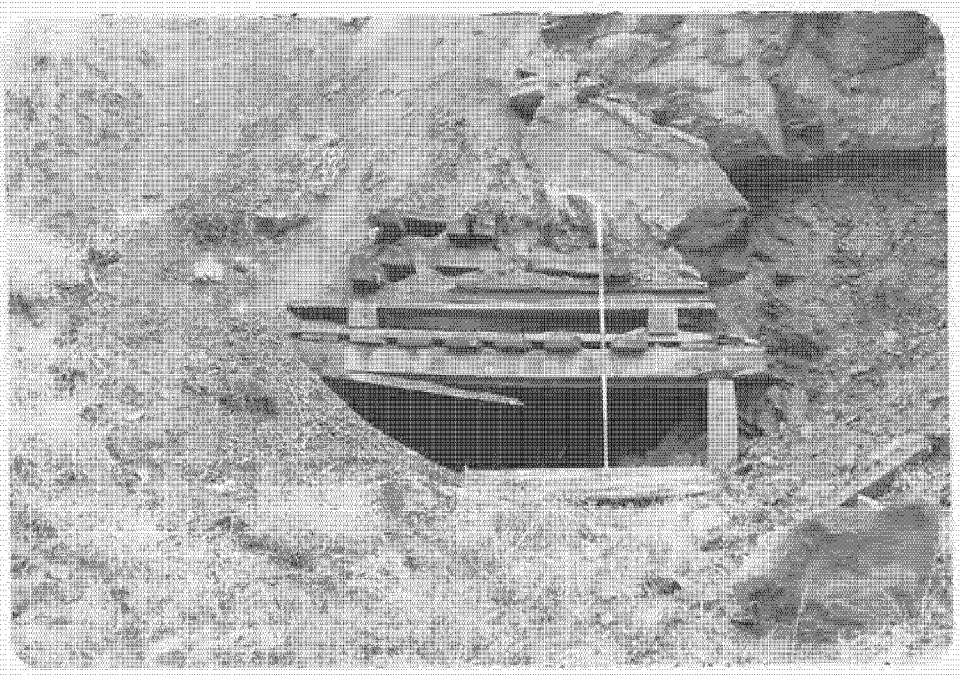
Photo (e) Close up of decline show in photo (d); present opening is less than 3' high. Note range pole for scale.

Photo (f) Caved vertical shaft 20' west of decline; hole is presently 22' deep. Note portion of range pole at left for scale.

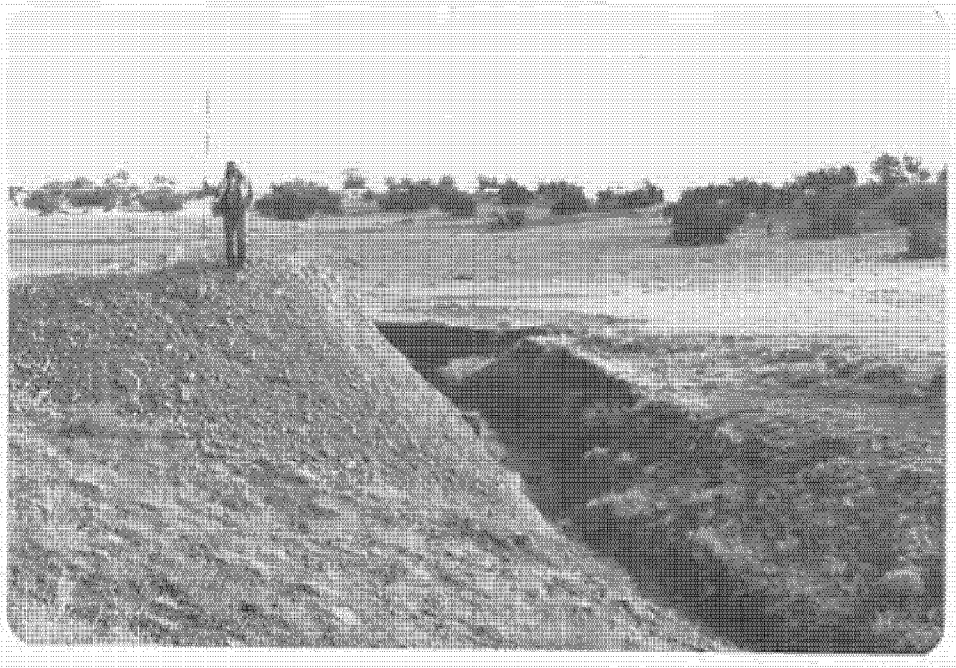
Photo (1) Looking northward at diverted drainage line flanked on west by waste pile.

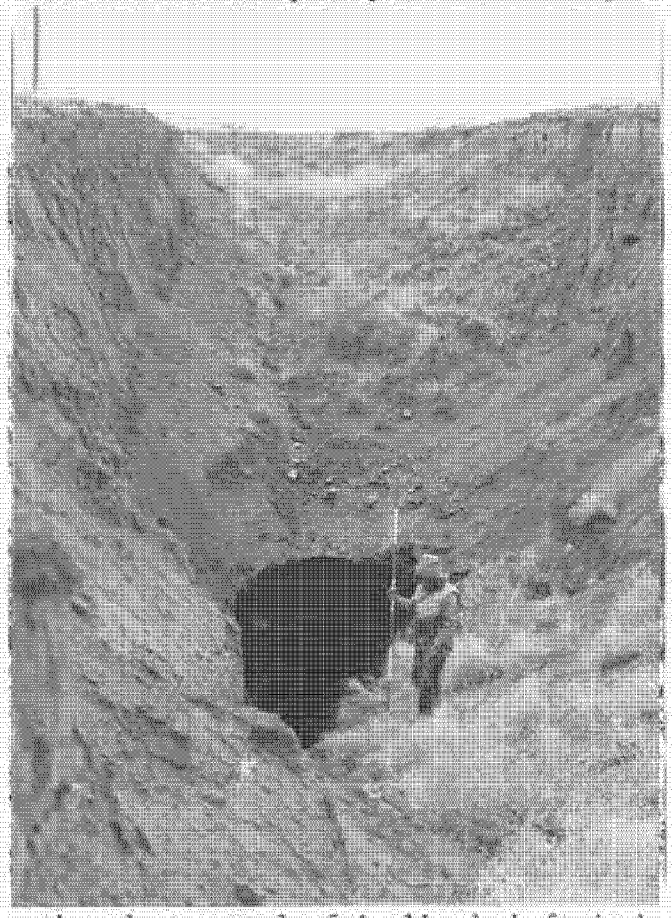
Photo (b) Looking southward at portal of inclined shaft in bottom of box cut.

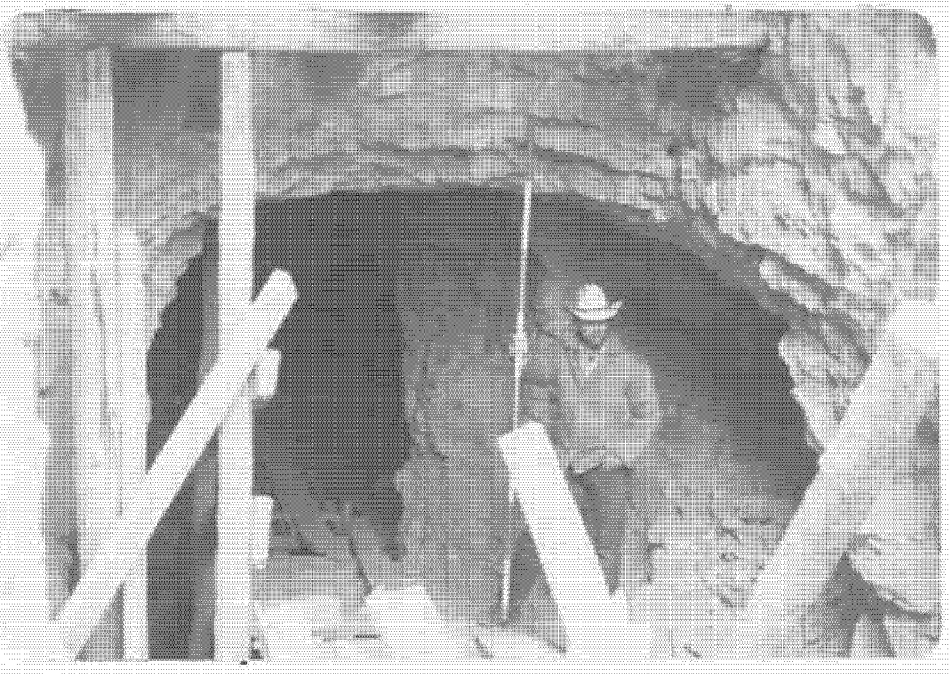
Photo (c) Inside portal of inclined shaft showing timbering and tracked haulage way.

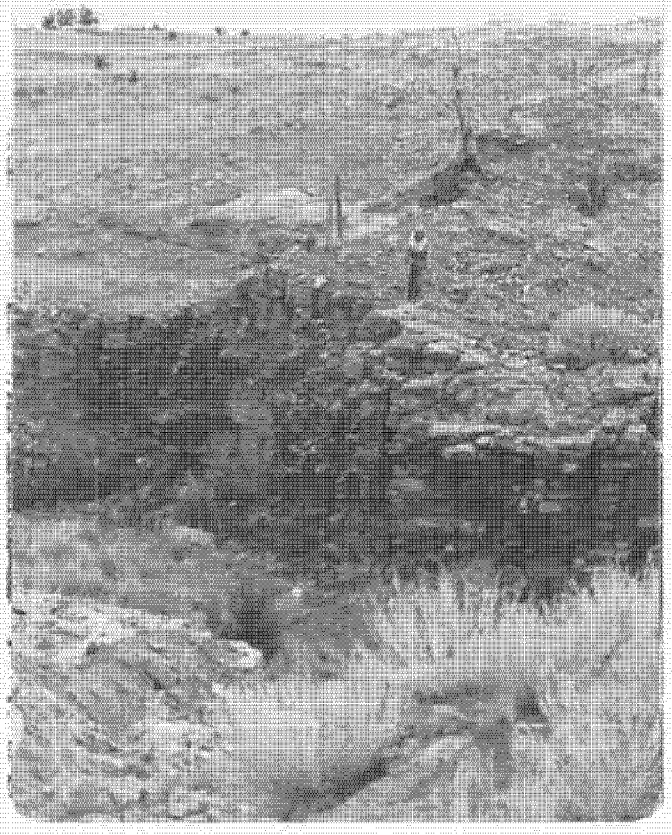
Photo (d) Open pit at section line several hundred feet east of shaft site; note person at right of center for scale.

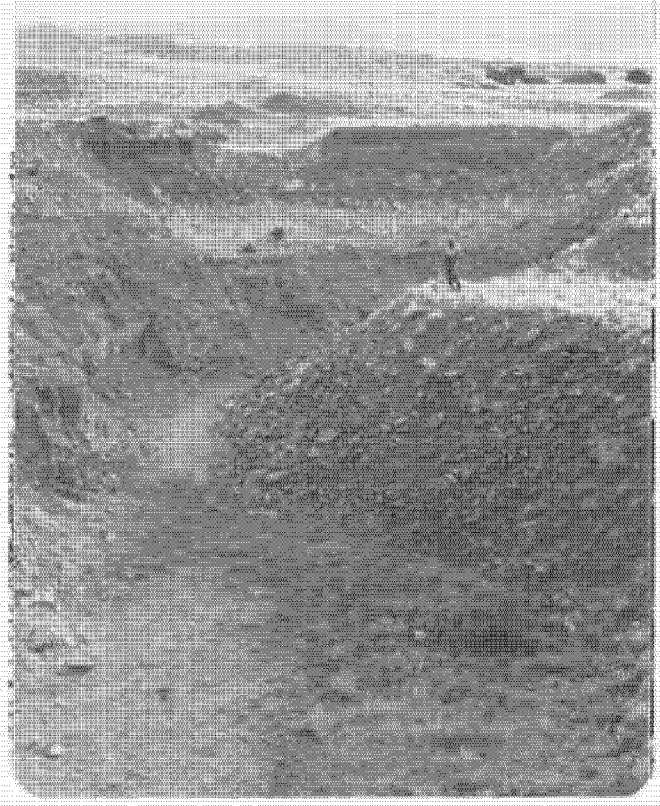
Photo (b) Looking southwest very near the Sec. 23-26 line at 30' deep sinuous trench; face counts up to 1,500 cps.

Photo (c) Looking eastward into small box cut 18' deep, showing some fold structures in the Todilto; unconsolidated overburden runs to 12'-14' thick locally. Face counts here run as high as 4,800 cps.

Photo (d) Looking east into a 450' long, 35' deep pit at eastern edge of area described in this report; dump from Hanosh incline may be seen at upper right. This locality is very near north line of Sec. 26. Note person at bottom of pit for scale.

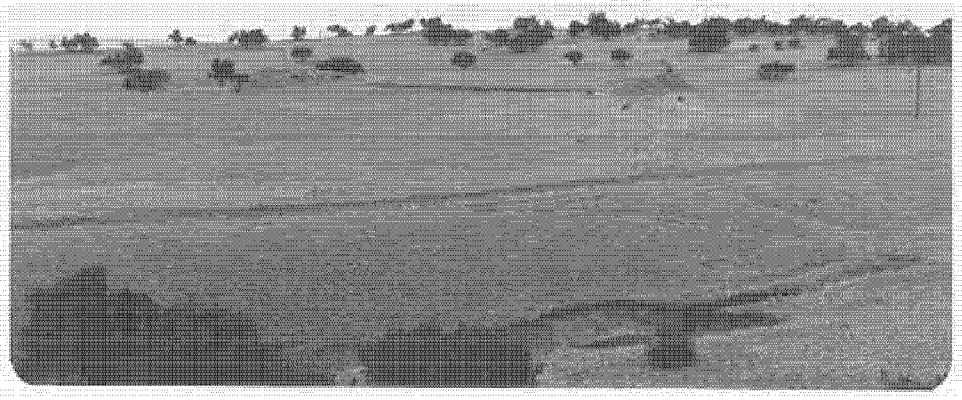
Photo (e) Looking southward at an example of "undisturbed ground" at this locality, except for small prospect pit with 8' high waste piles at each end, in center middle distance.

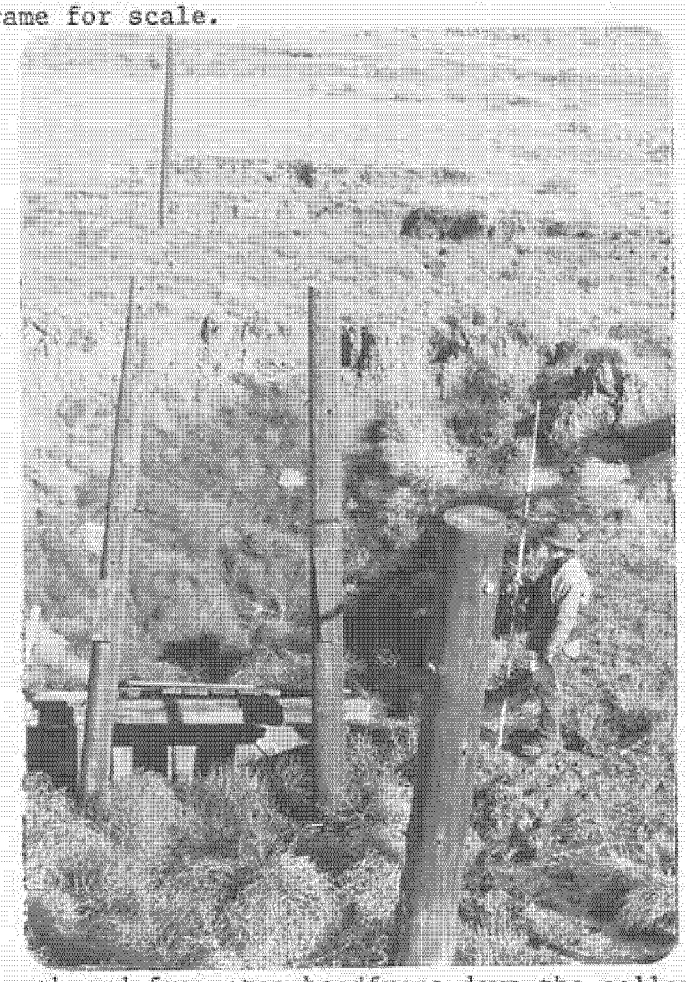
Photo (b) Looking northward from atop headframe down the collapsed decline. Note 3 separate collapse features, the first one being at the portal.

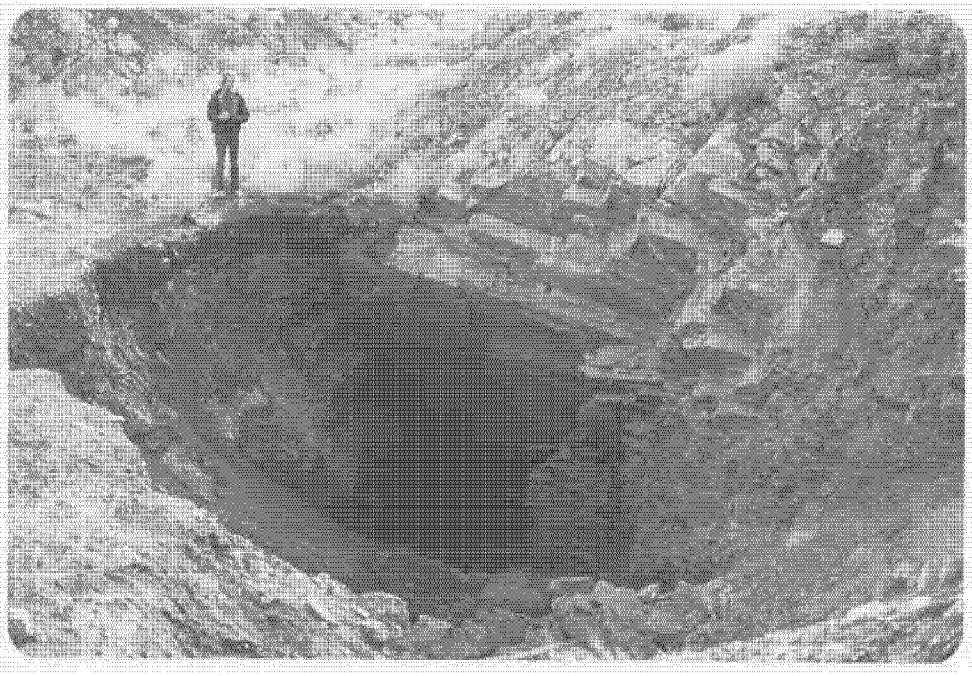
Photo (b) Close-up of decline; caved at 25' down.

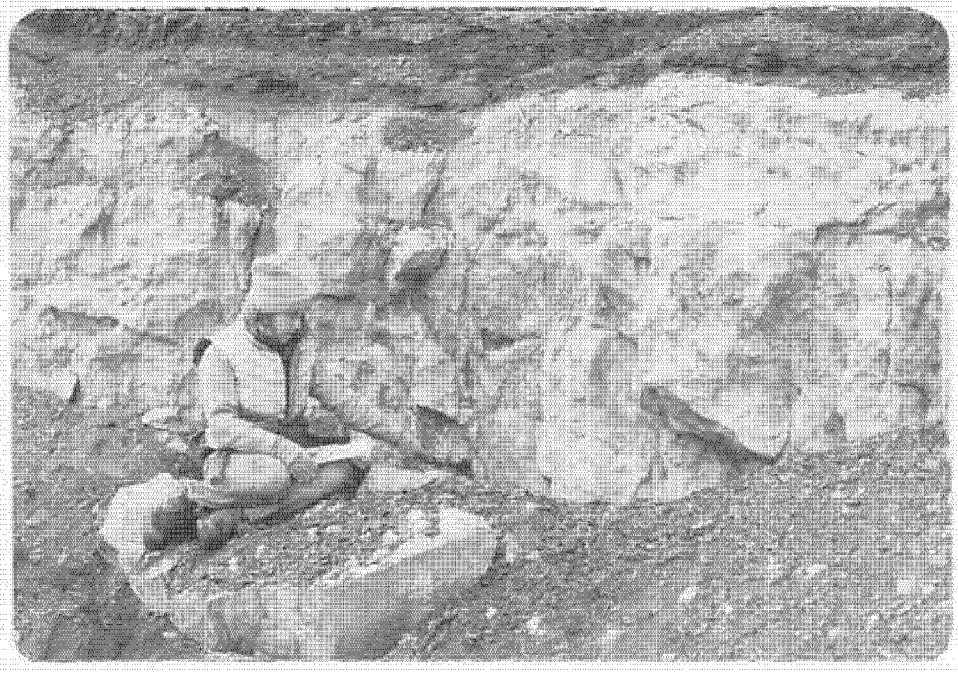
Photo (b) Caving at portal of adit near center of cut shown in photo (a); person is pointing to remaining small opening.

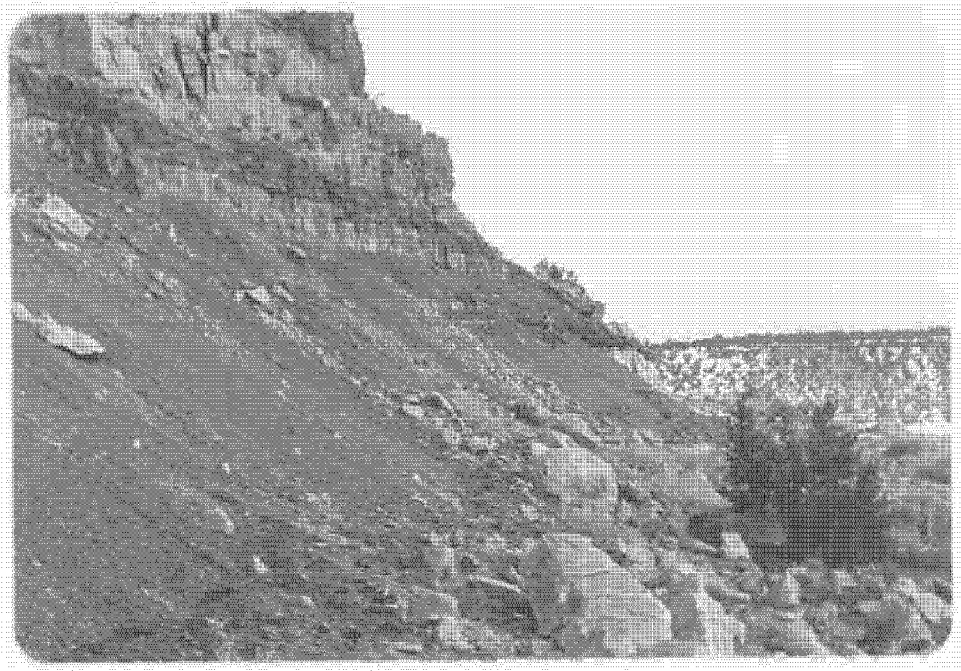
Photo (a) Looking eastward along bench cut at sec. 35 Strip Mine; most of face is natural exposure now made somewhat unstable by 25' cut in soft carbonaceous shales. Note person (center) for scale.

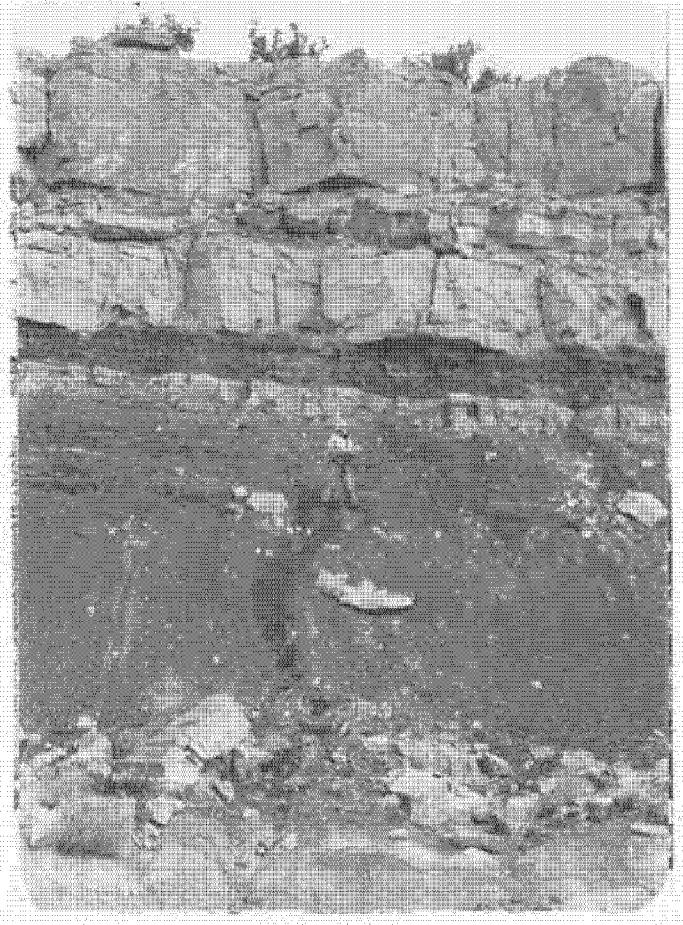
The highwall (photo b) and the dump slope are both somewhat unstable; waste material will eventually reach the drainage line in Rincon Canyon.

Photo (b) View northward showing a 15' thick sequence of carbonaceous shale just above floor of cut.

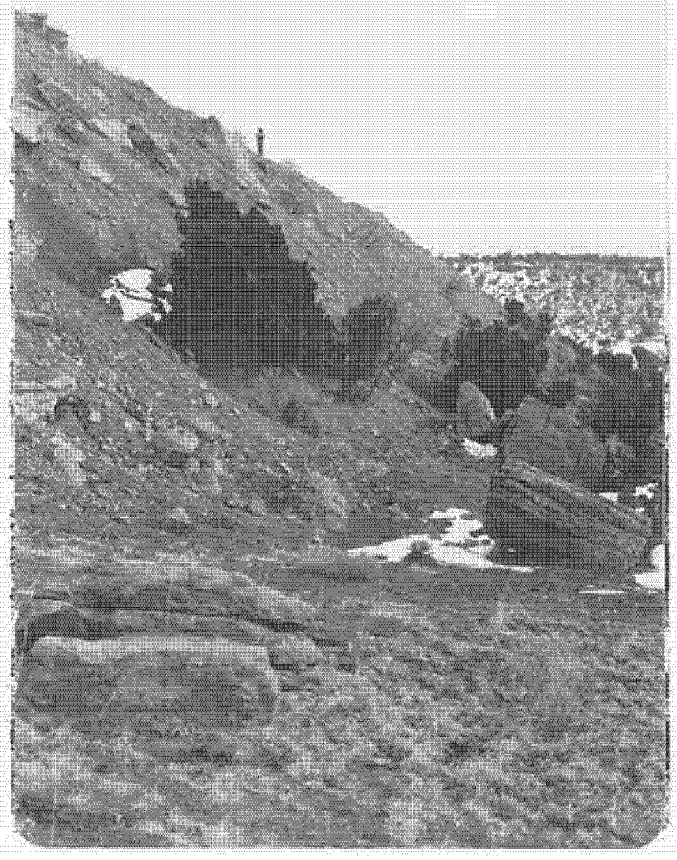
Photo (c) View northeastward from valley floor showing 50' "high" veneer of mine waste on slope.

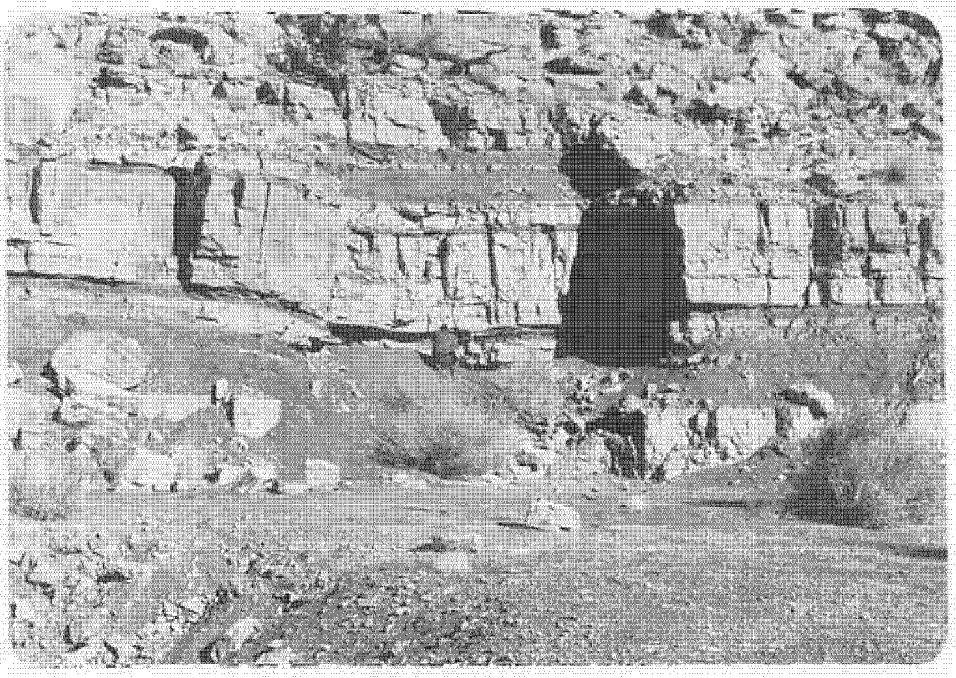
Photo (a) Looking northward at partially caved entrance to westernmost adit at the Febco Mine.

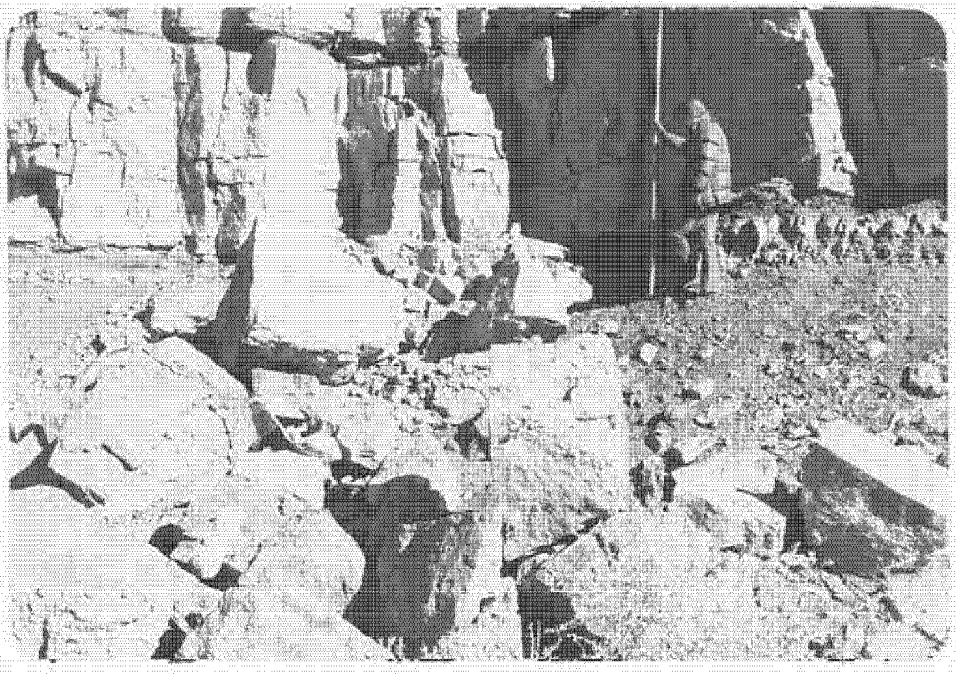
Photo (b) Looking northward at caved entrance to second adit (going eastward) in series of four.

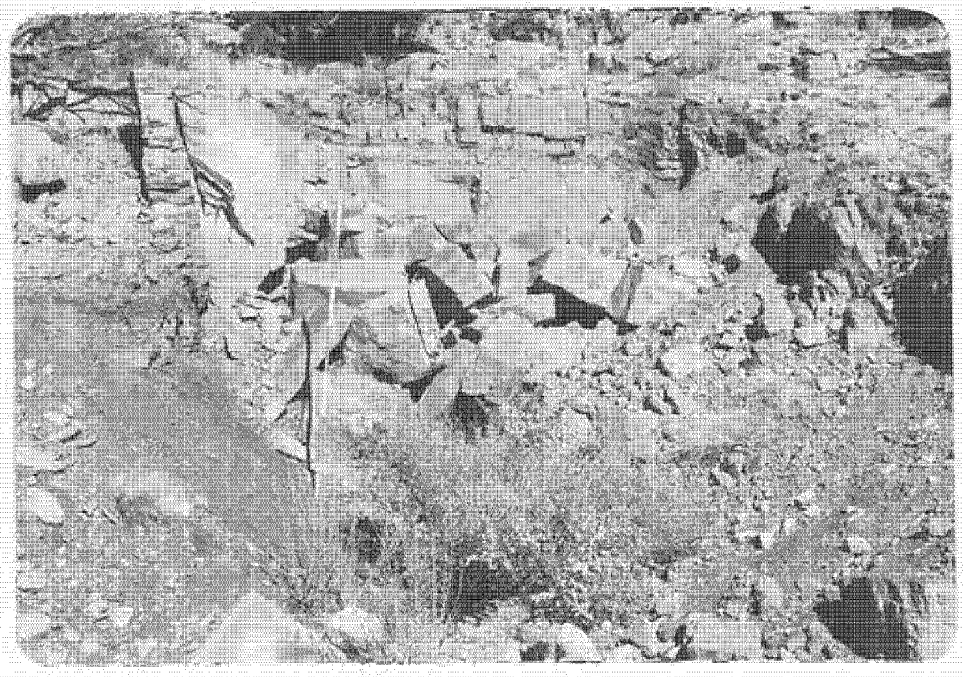
Photo (c) Looking northwestward at caved entrance to third adit in series (going eastward).

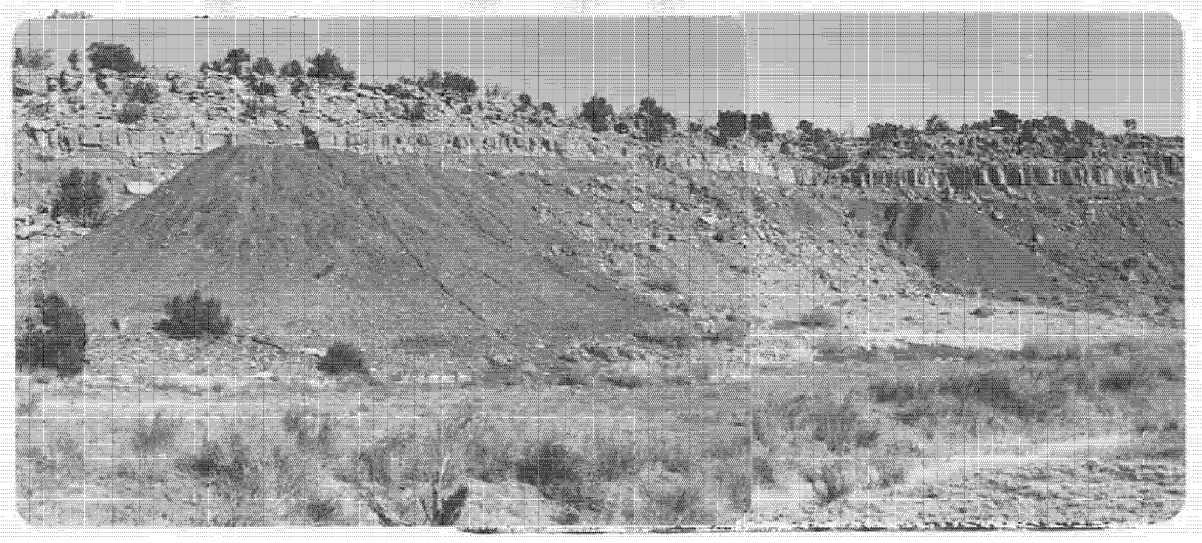
Photo (d) Looking northward at caved entrance to fourth adit (easternmost) in series of four.

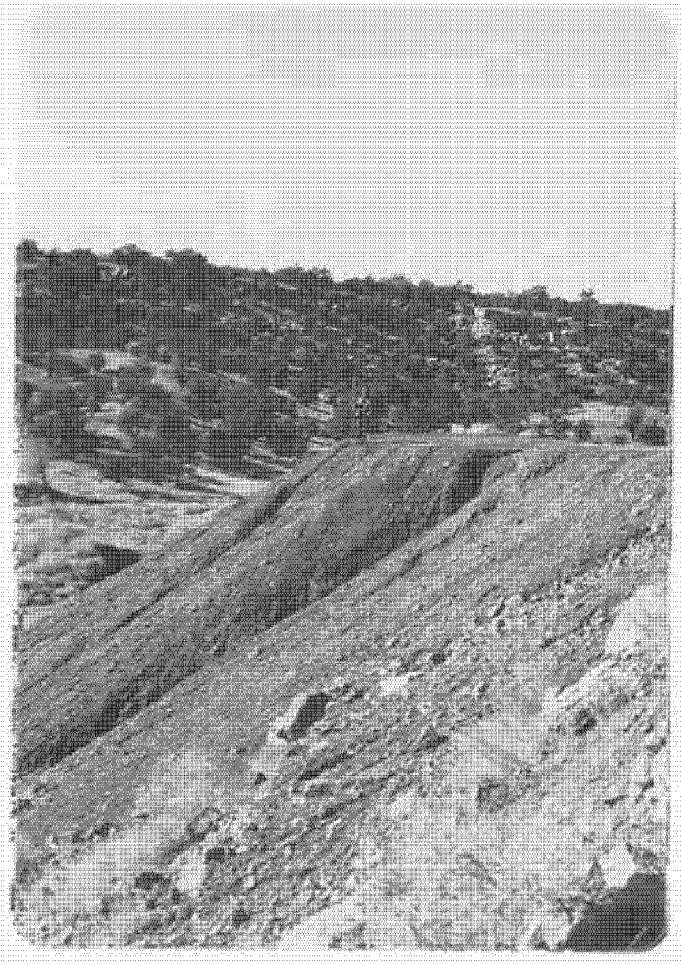
Photo (e) Looking north-northeastward at Febco Mines showing tailings dump from largest adit at left, and the coalesced tailings dumps from the other 3 adits at right. Dump at left is 60' high, but is spread thinly. (For close-up see photo (f)).

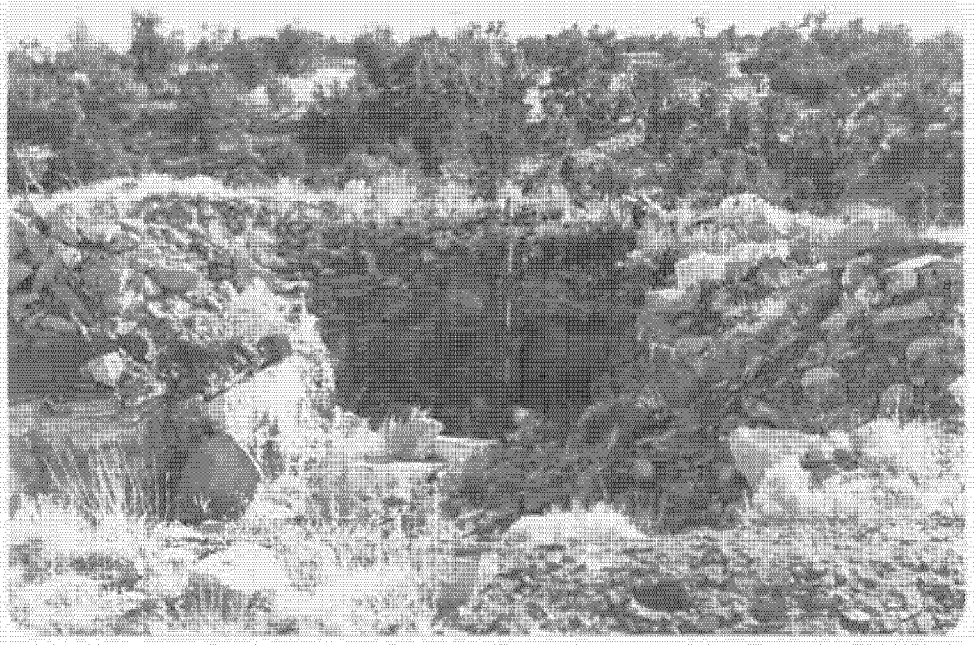
Photo (a) Looking south into 8' x 35' trench at southern edge of Silver Spur workings; note range pole for scale.
